October 26, 2021

**Re: Storm Damage Assessment
Harborview Homeowner's Association Property – New Orleans, Louisiana
Claim No.: 4186938
Date of Loss: August 29, 2021
SDII Project No.: 8125715**

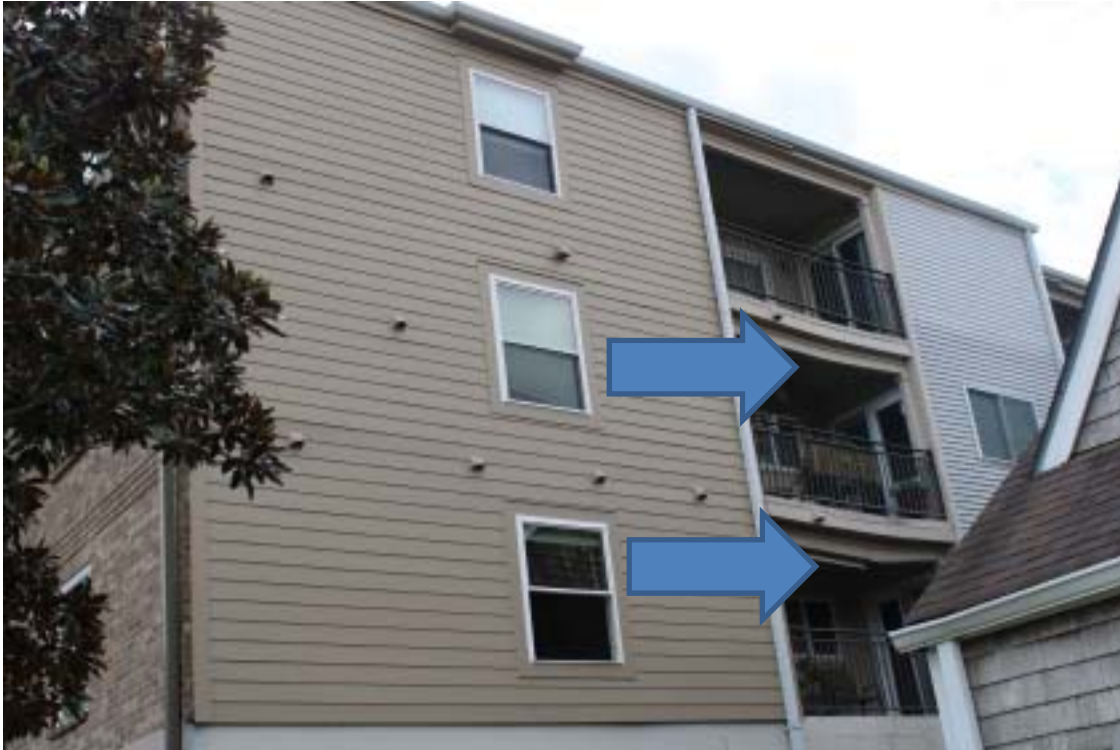
Photograph 3 - Northwest corner of building – Note upper side galleries and deflection indicated

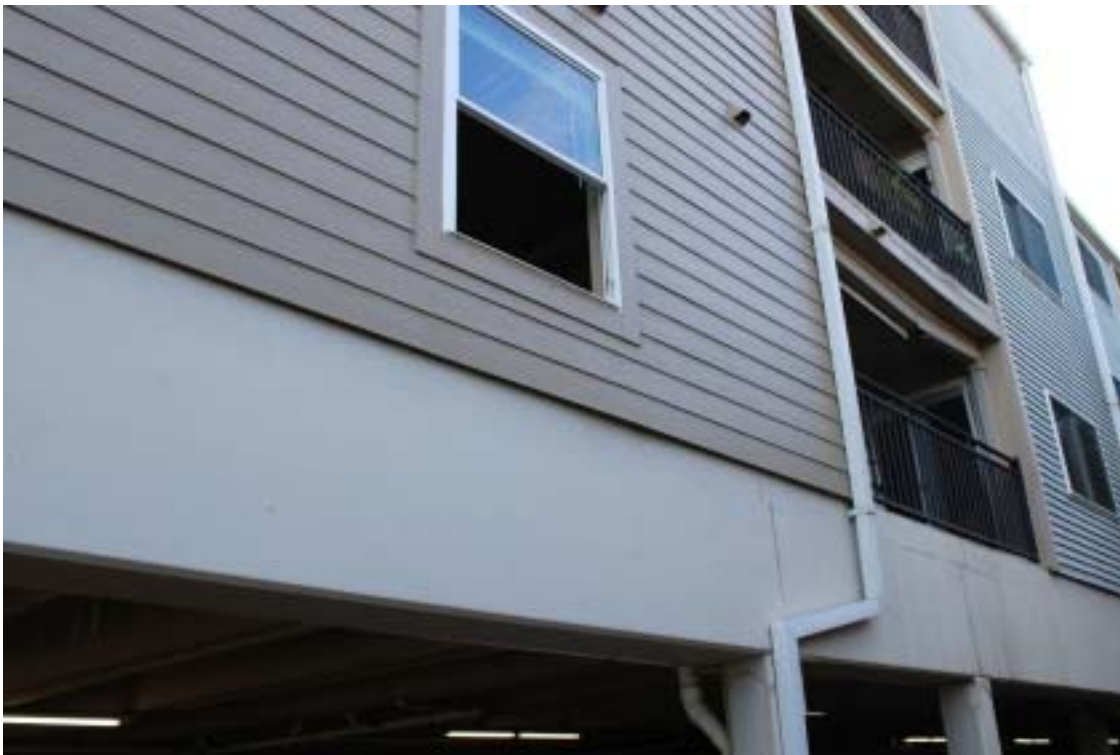
Photograph 4 - West side of building – Note upper side galleries – 1 of 3

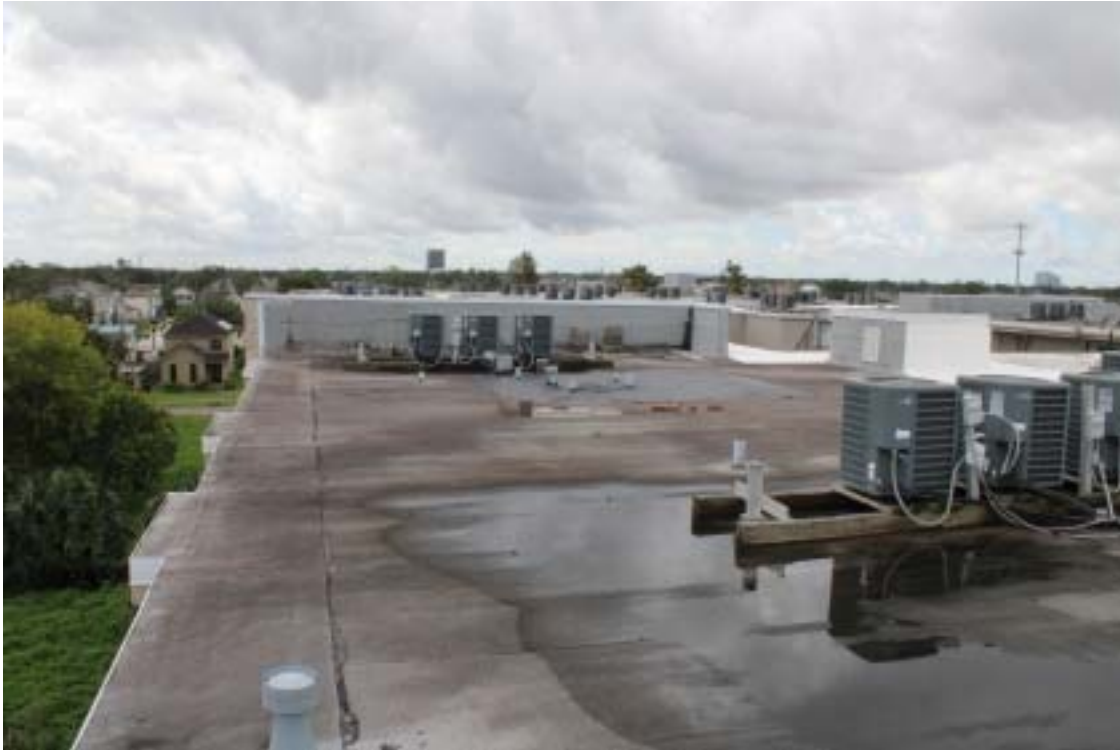
The roof was found to have aged surfaces with evidence of re-coated areas throughout. There were also ponding areas of over 100 square feet on the roof, each indicating that the insulation had compressed over time or that the roof was not properly installed. Historical aerial images indicate that the areas of resurfacing had been added piecemeal since 2015.

Photograph 15 - Rooftop from northeast corner – Note standing water

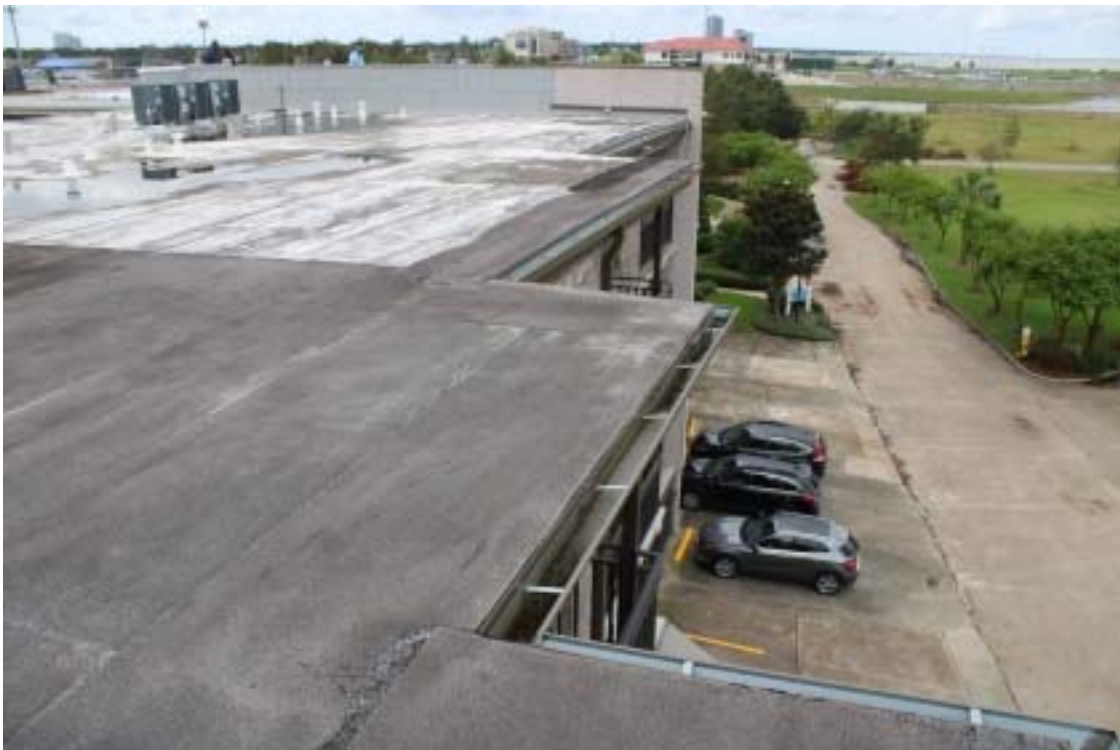
Photograph 16 - Rooftop from northeast corner – Note patched area

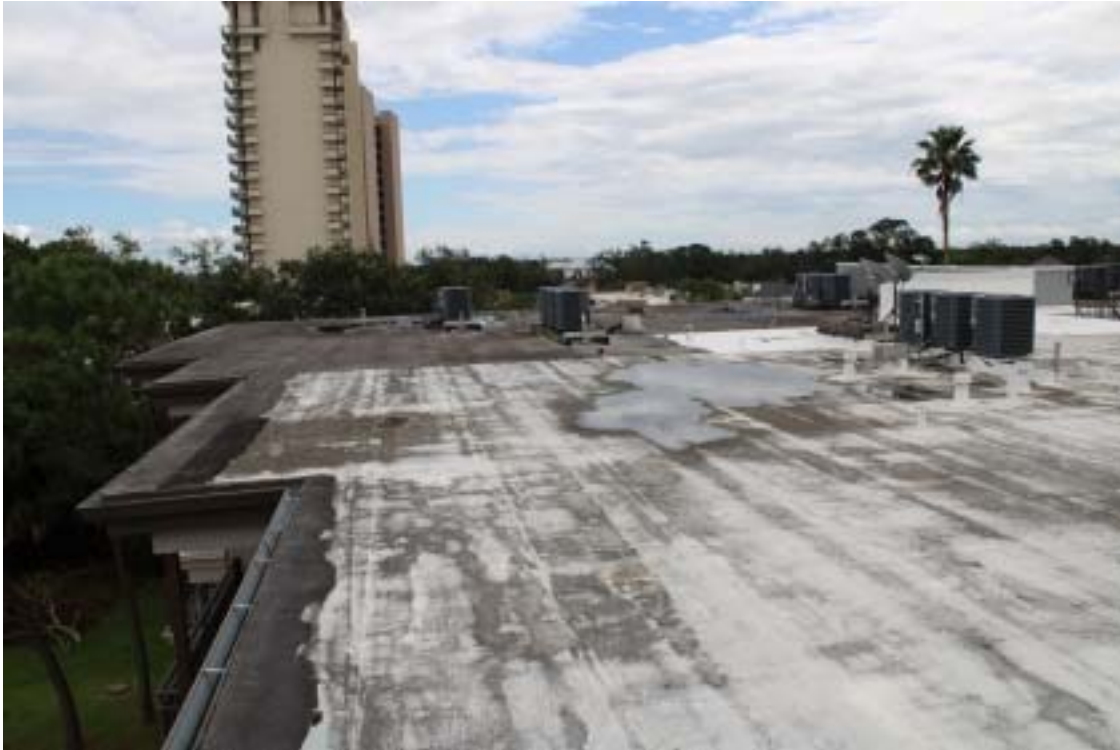
Photograph 17 - Rooftop from north edge – Note light-colored patched area

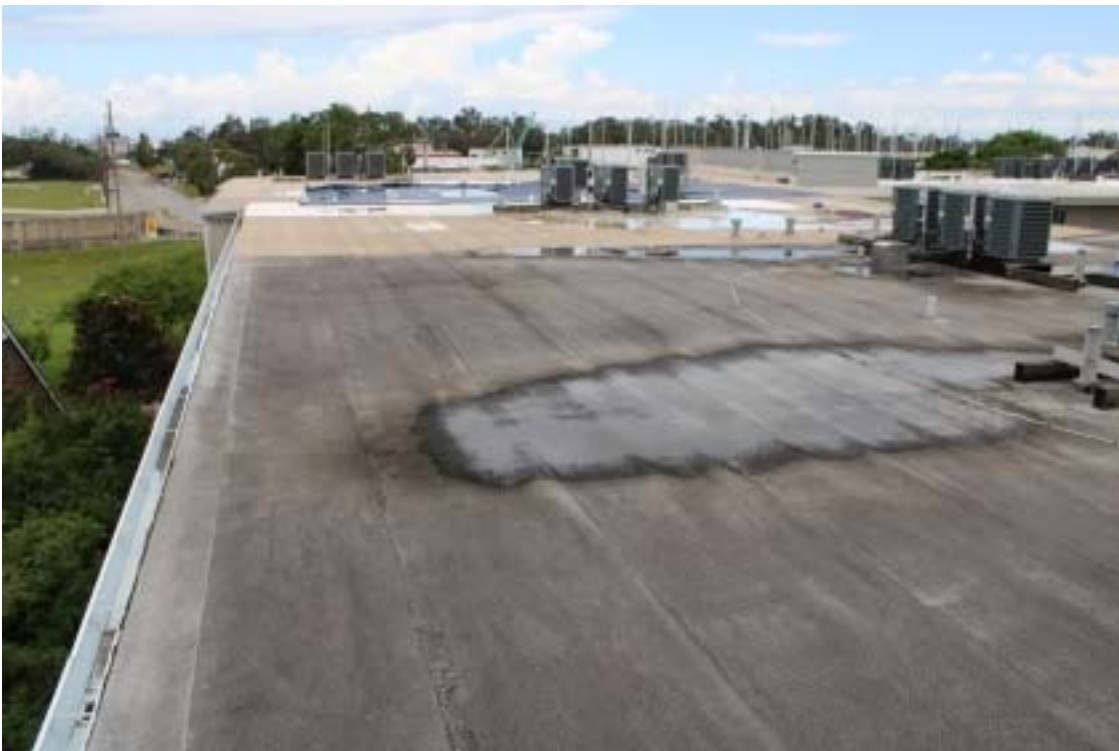
Photograph 20 - Rooftop from west edge – Looking north – Note roof colors and ponding

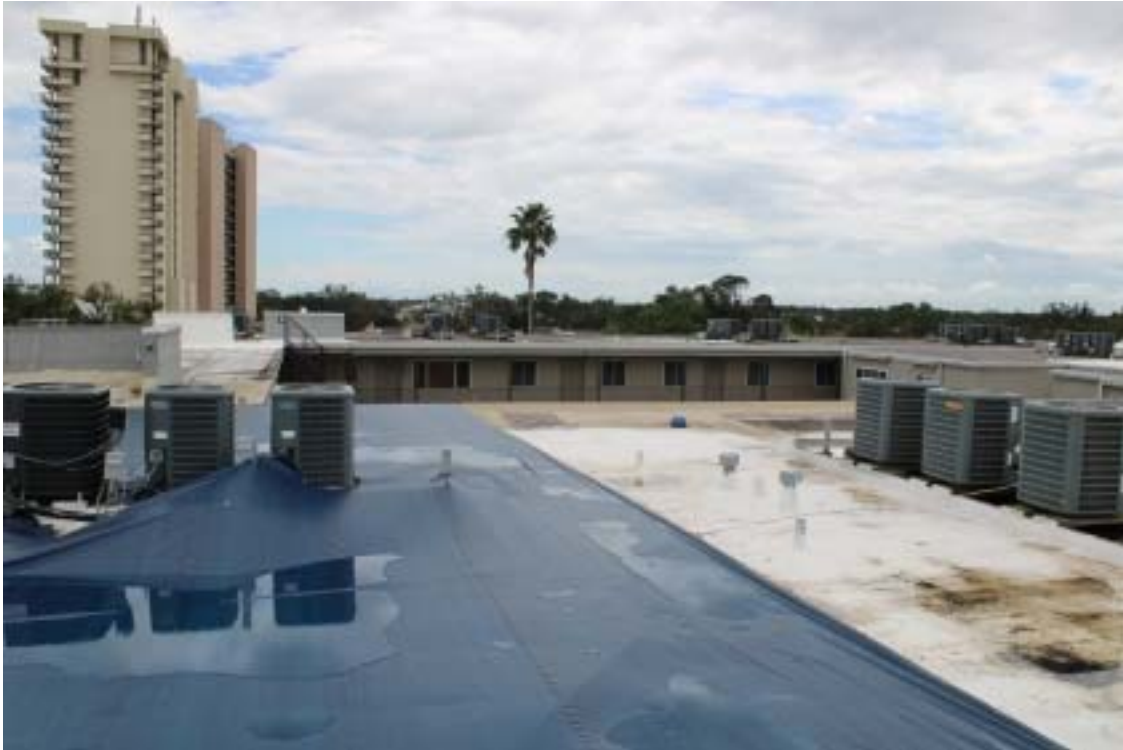
Photograph 21 - Rooftop from west edge – Looking east – Note blue tarp

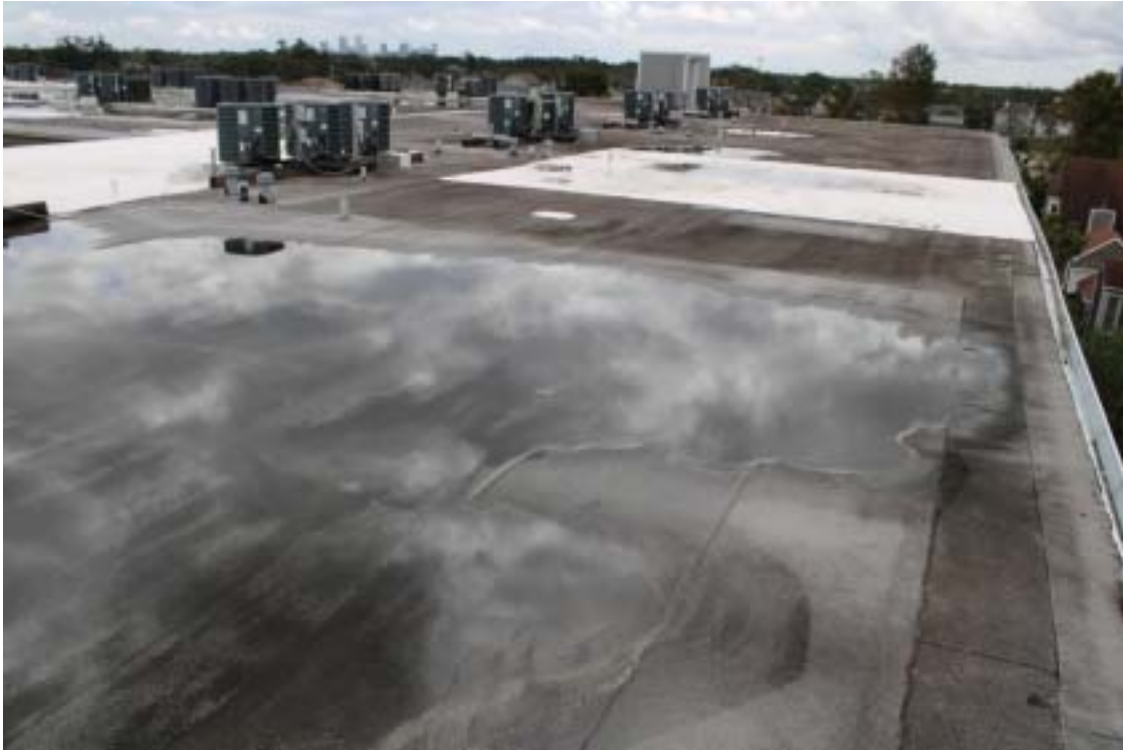
Photograph 23 - Rooftop from west edge – Looking south – Note varying roof colors and ponding

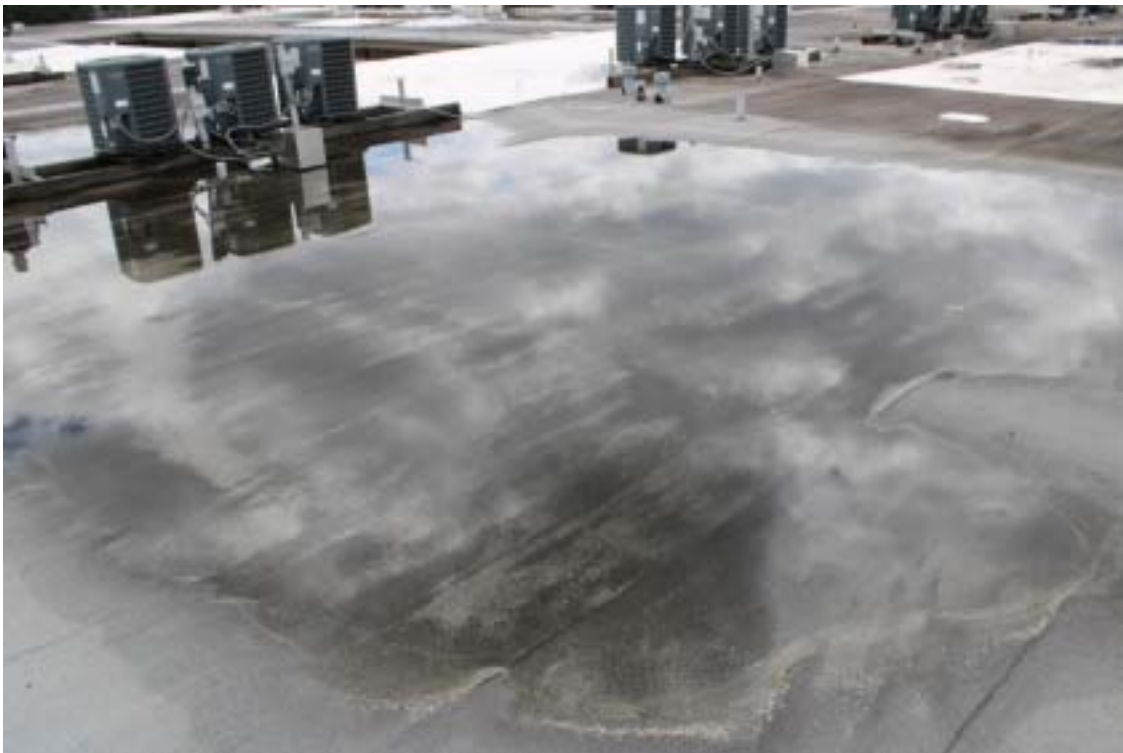
Photograph 24 - Rooftop from west edge – Looking southeast – Note ponding

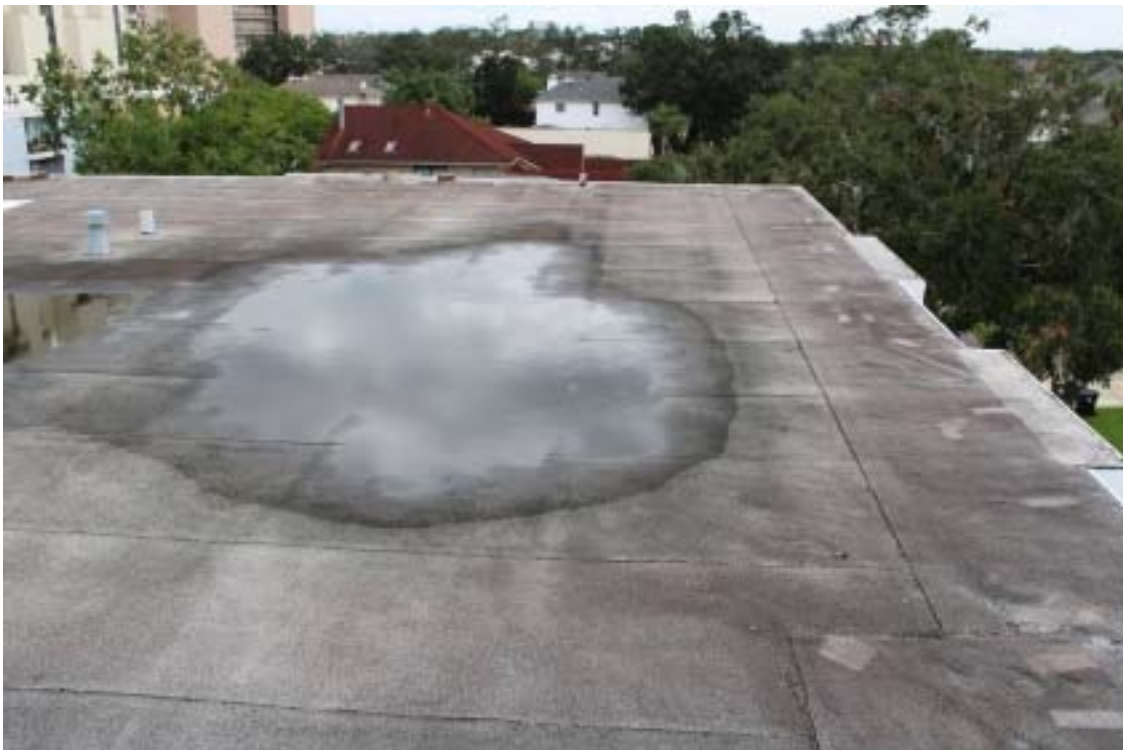
Photograph 28 - Rooftop from south edge – Looking east – Note ponding

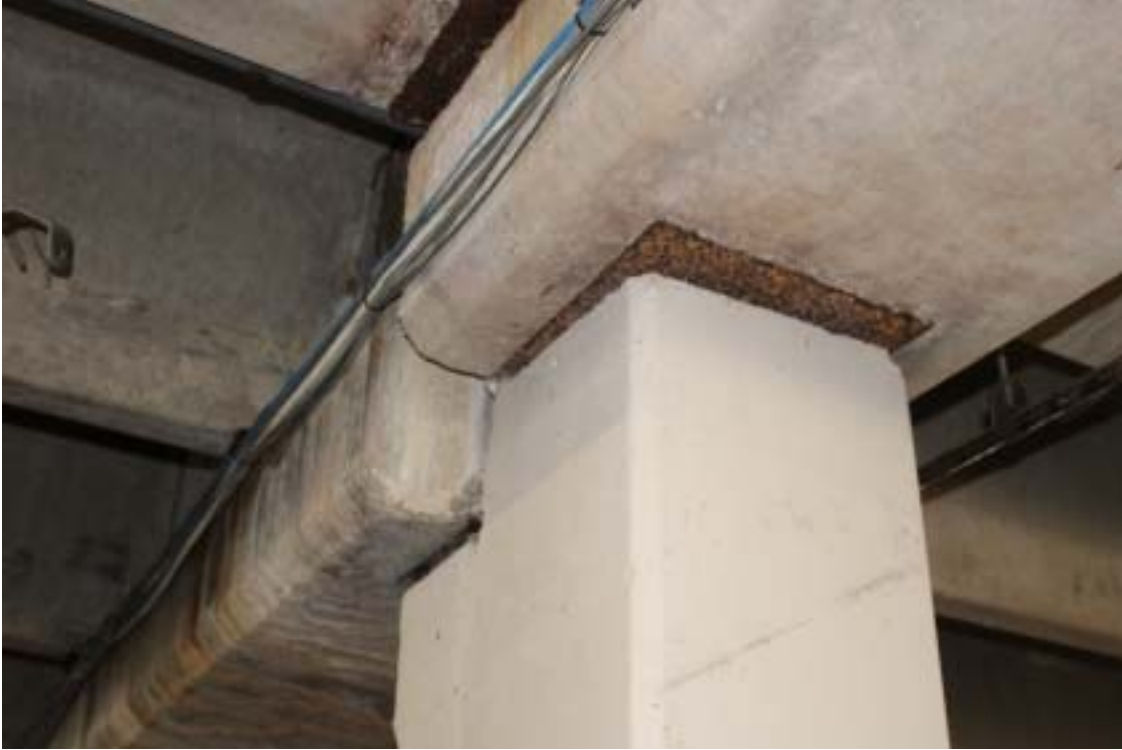
Photograph 37 - Concrete structure above parking level – Note some precast elements were not centered on the bearing plates.

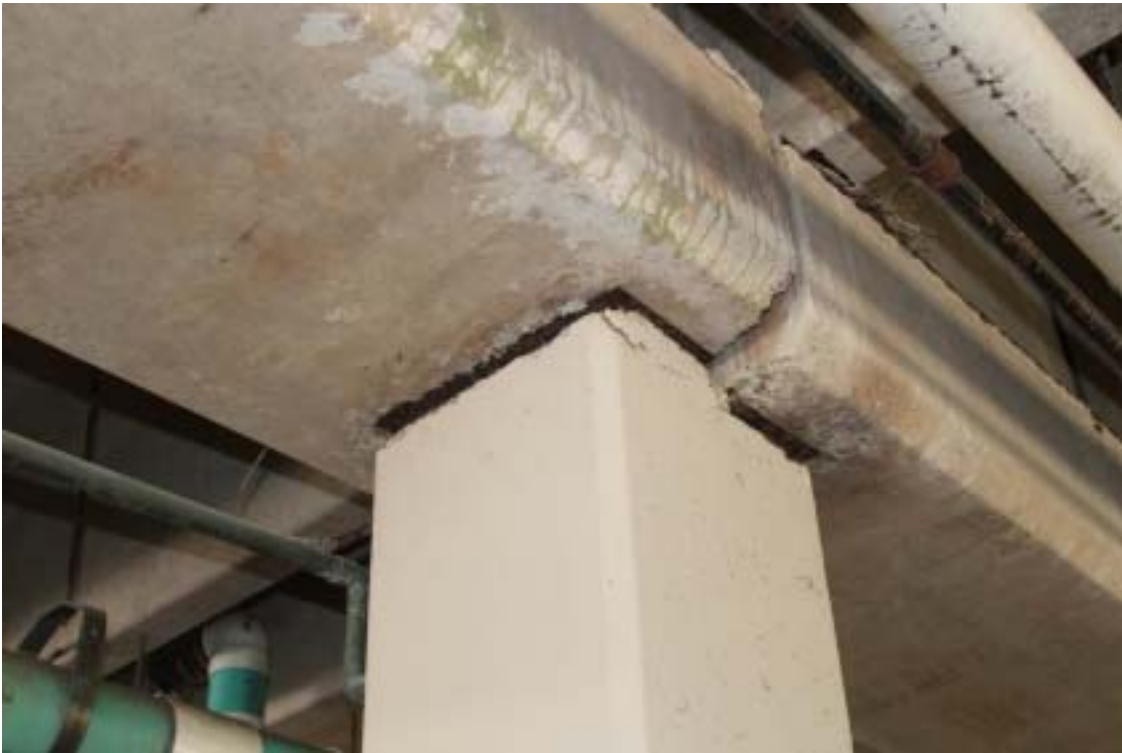
Photograph 38 - Concrete structure above parking level – Note off-center precast elements

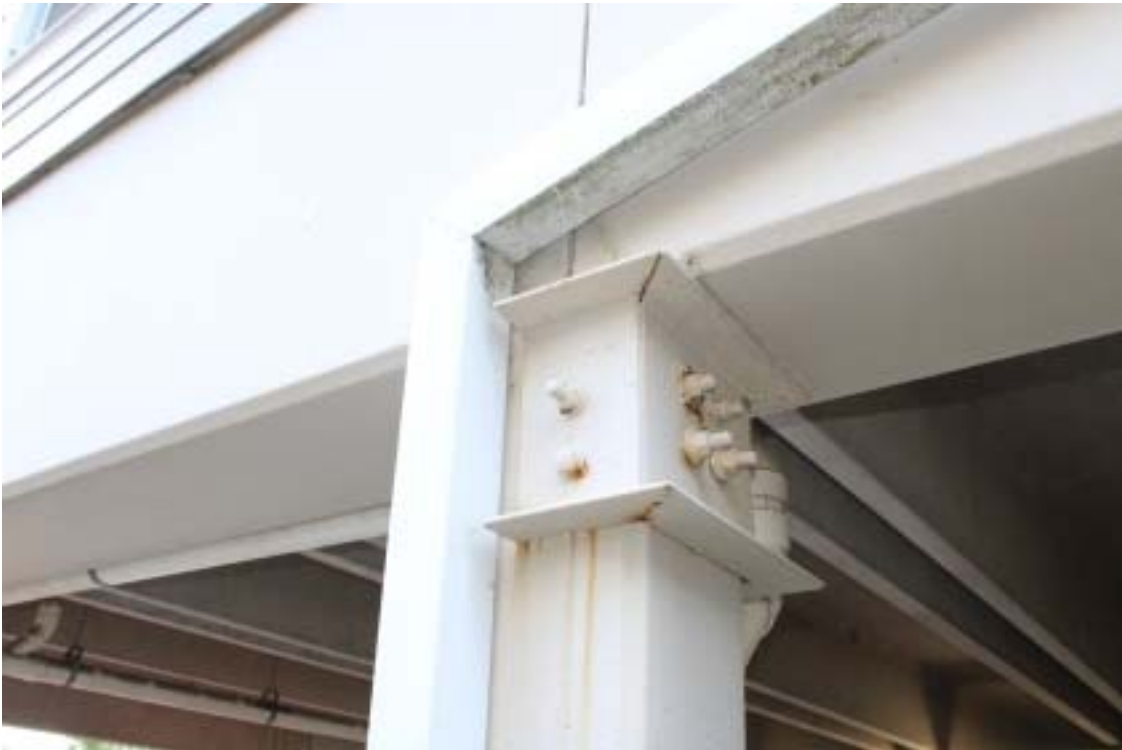
The concrete columns were almost all found to have spalled tops and some of the exposed surface irregularities and voids had been painted over. This spalling was the result of the embedded, uncoated steel baseplates, which were gradually corroding over the almost 50-year-life of this building and occurred before the last time the building was painted. This long-term deterioration of the concrete columns was not caused by the recent storm. There was no lateral shifting of the concrete structure observed.

Photograph 40 - Concrete column below precast elements – Note bolted repair and corrosion

- The loose and spalled concrete found at the tops of the concrete columns should be chipped away to expose the rusted steel. The steel should be abrasive blasted and quickly coated with a zinc-rich primer and a suitable topcoat finish. An engineer should be brought in to inspect all steel exposed during this repair project. A concrete bonding substance should be applied to the cracked concrete surface and a Portland cement mortar should be used to repair the tops of the columns. Any other exposed steel should be similarly cleaned and coated to prevent future corrosion.
- The original structural drawing of the concrete portion of the structure were not available and any demolition to the tops of the columns should be accomplished under the

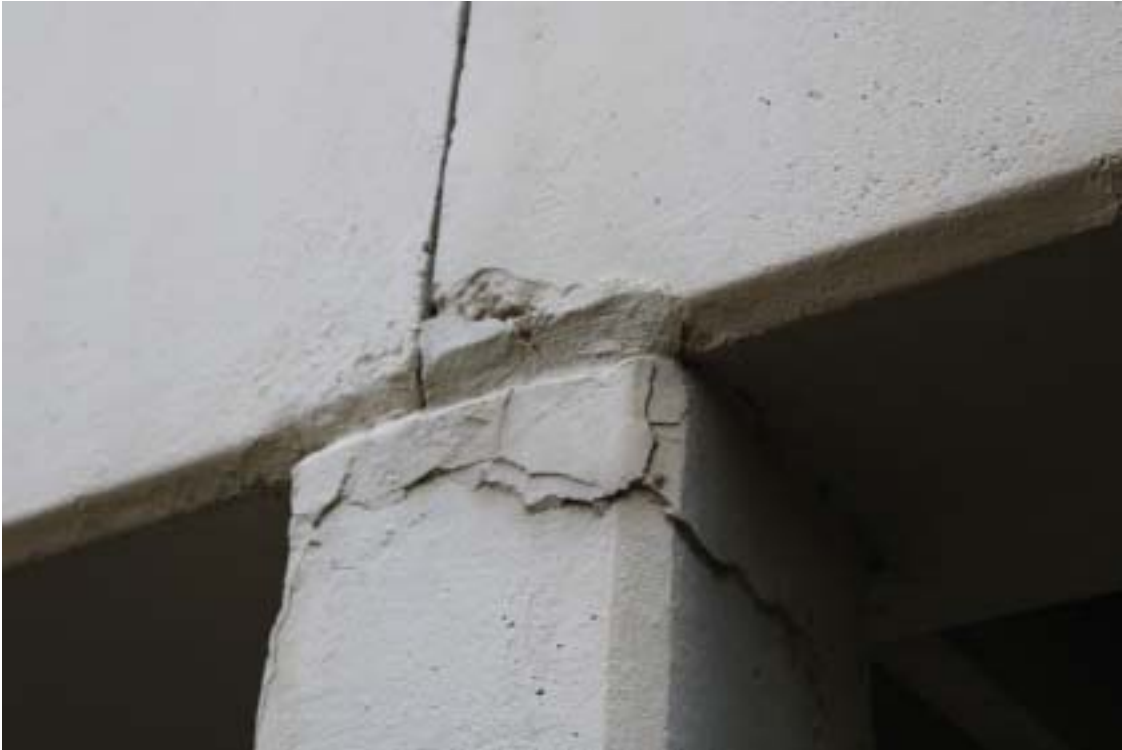
Photograph 41 - Concrete column below precast elements – Note spalling at top

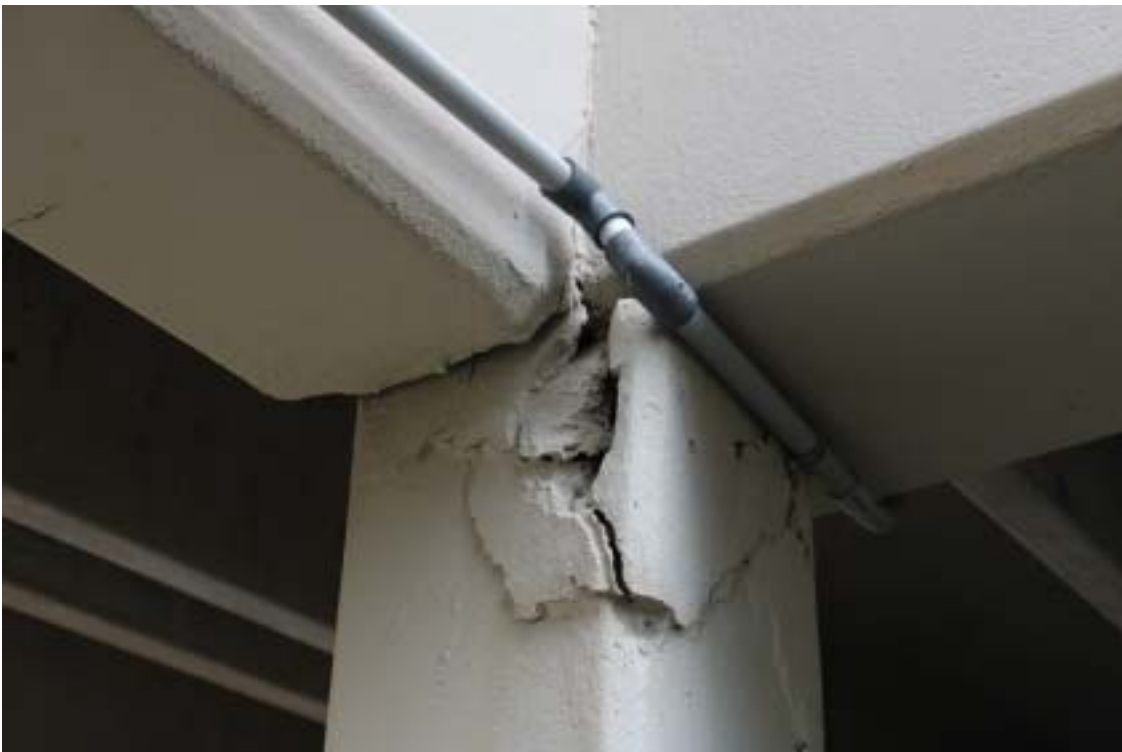
Photograph 42 - Concrete column below precast elements – Note spalling at top and coating over the spalled pieces

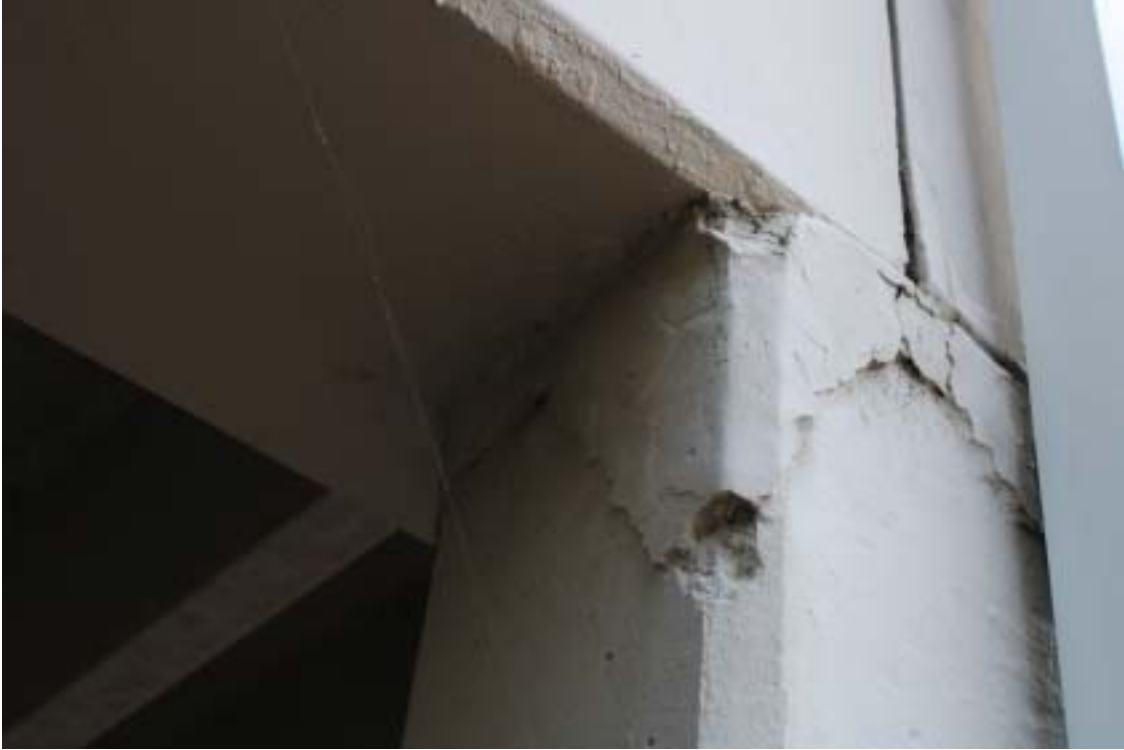
Photograph 43 - Concrete column below precast elements – Note spalling at top and coating over the spalled pieces

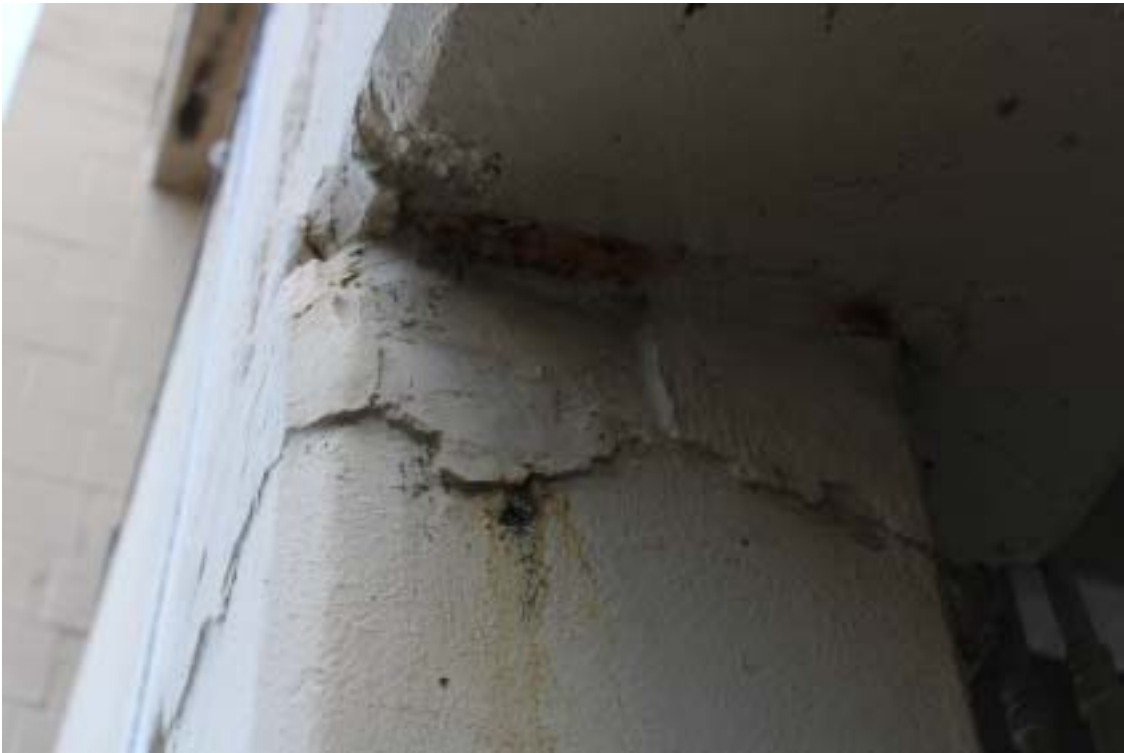
Photograph 44 - Concrete column below precast elements – Note spalling at top

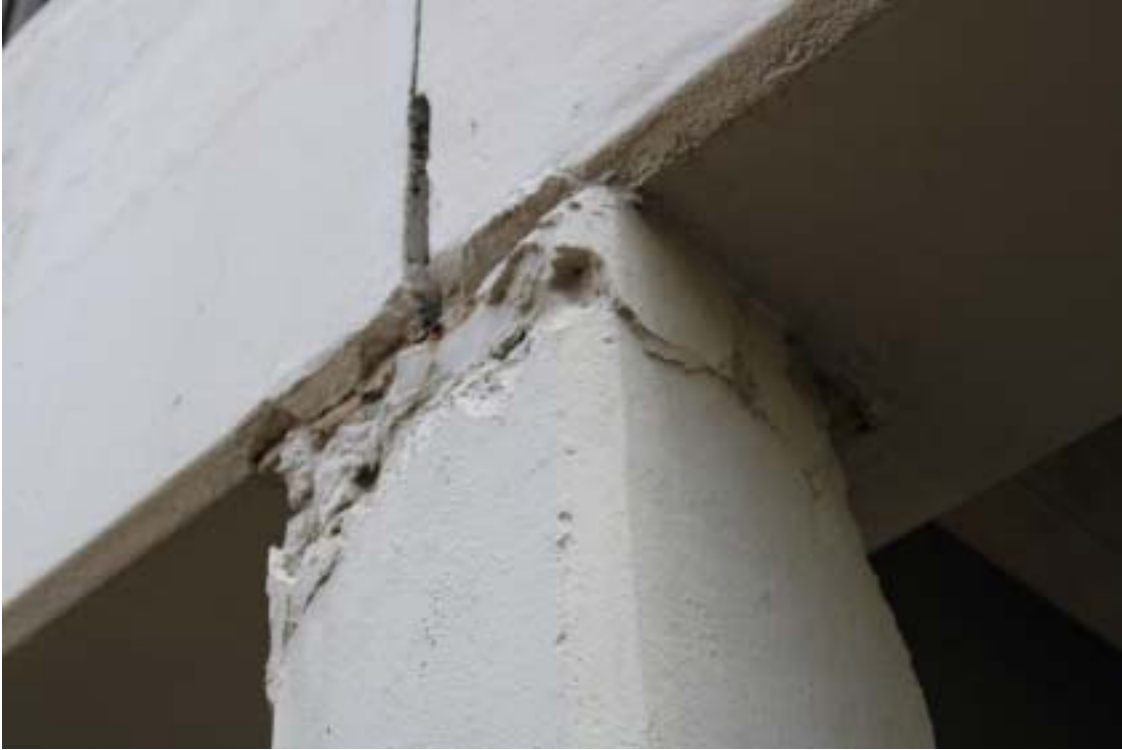
Photograph 45 - Concrete column below precast elements – Note spalling at top

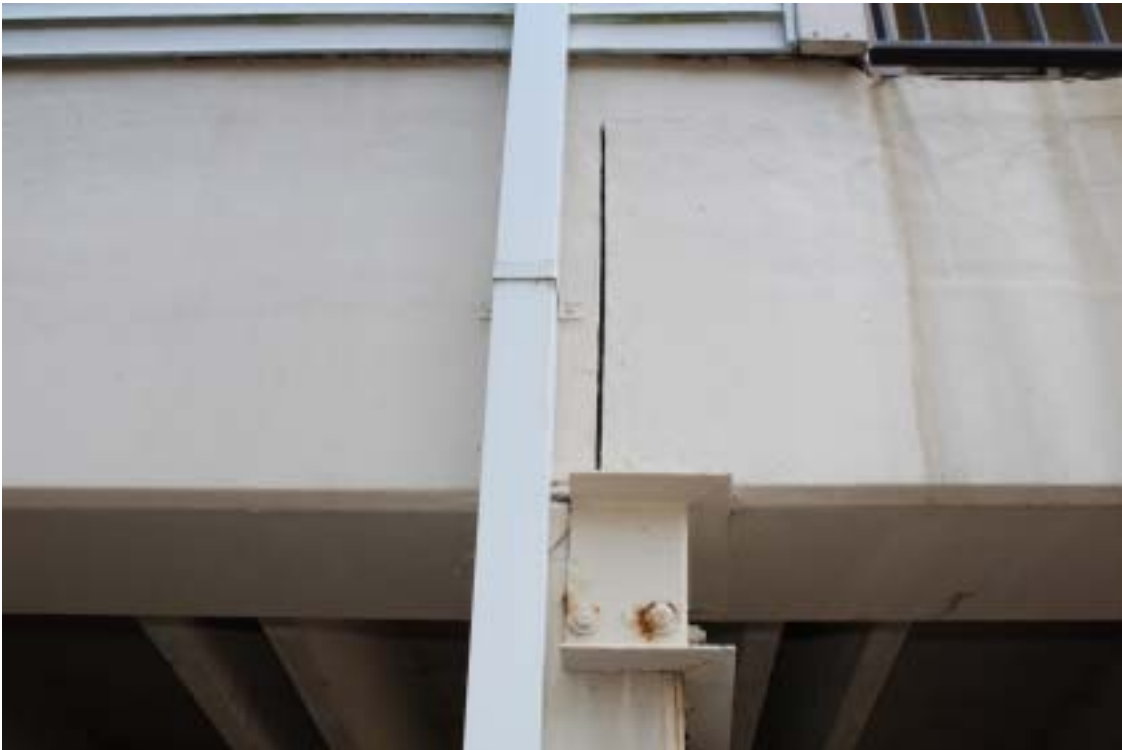
Photograph 46 - Concrete column below precast elements – Note bolted repair

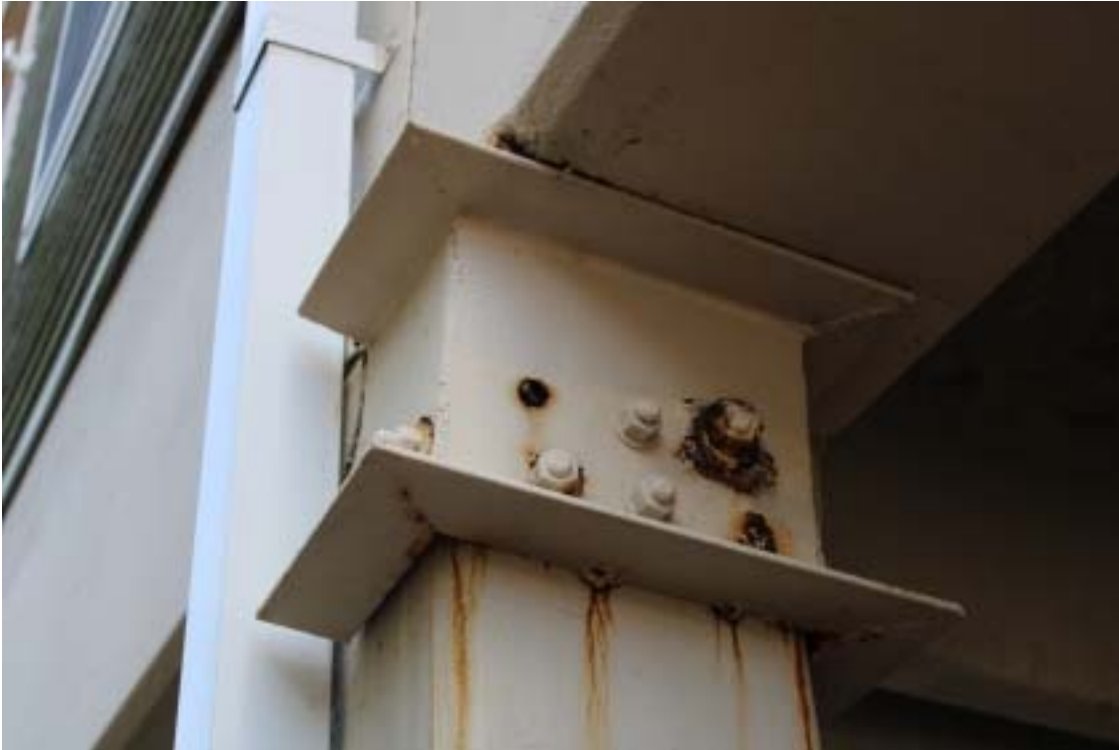
Photograph 47 - Concrete column below precast elements – Note corroded bolted repair

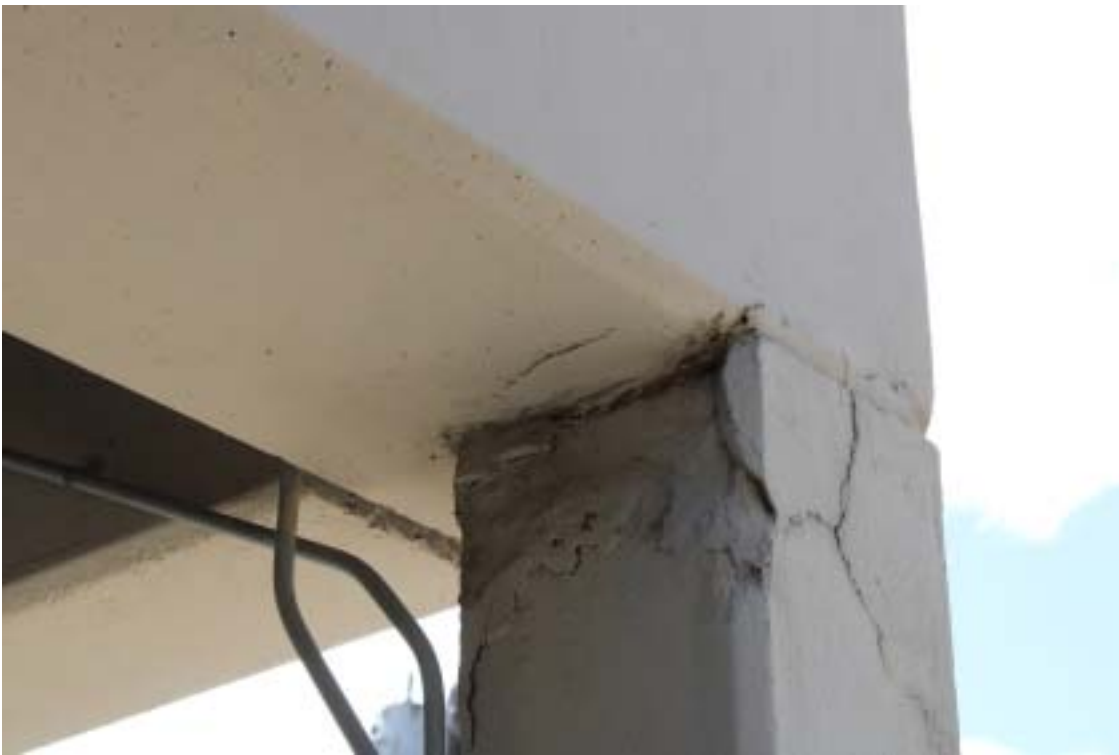
Photograph 48 - Concrete column below precast elements – Note spalling at top and coating over the spalled pieces

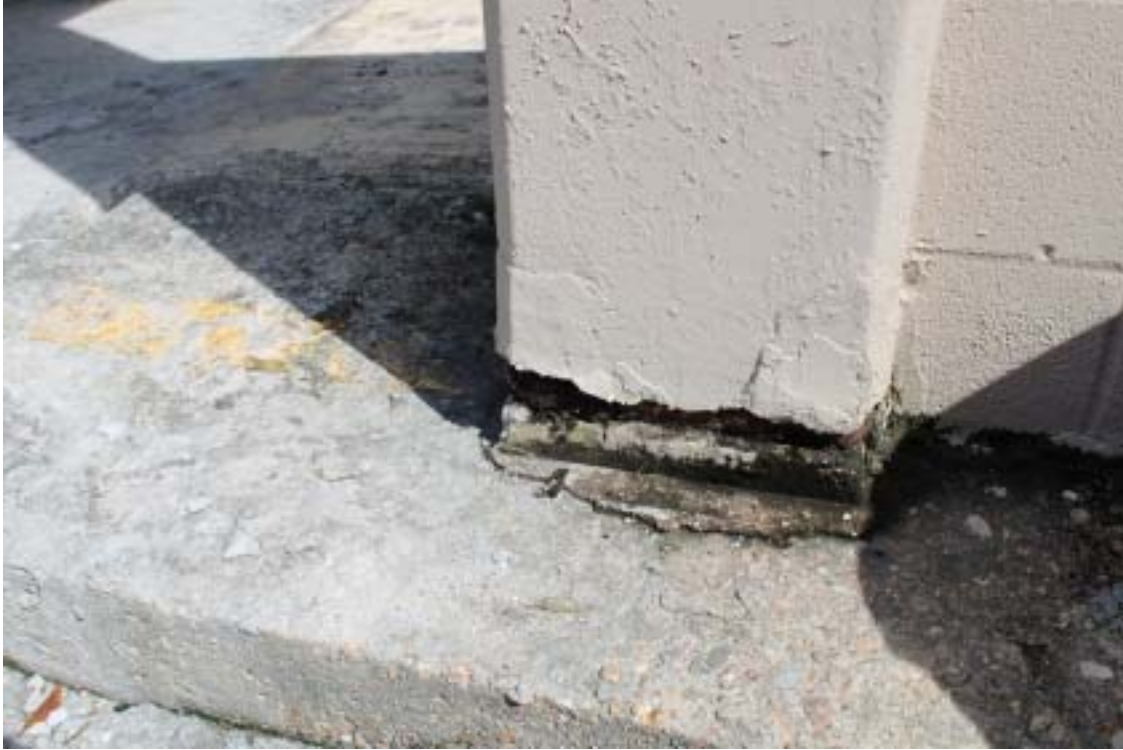
Photograph 49 - Concrete column below precast elements – Note section loss at base

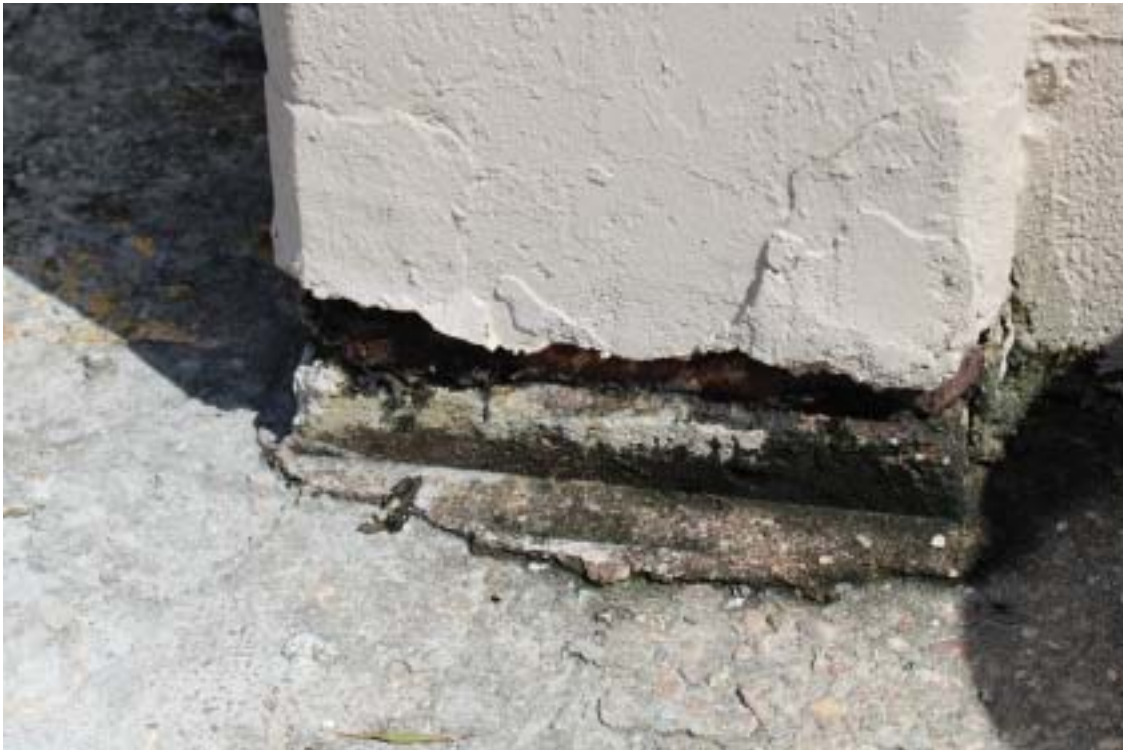
Photograph 50 - Concrete column below precast elements – Note section loss cracking at base

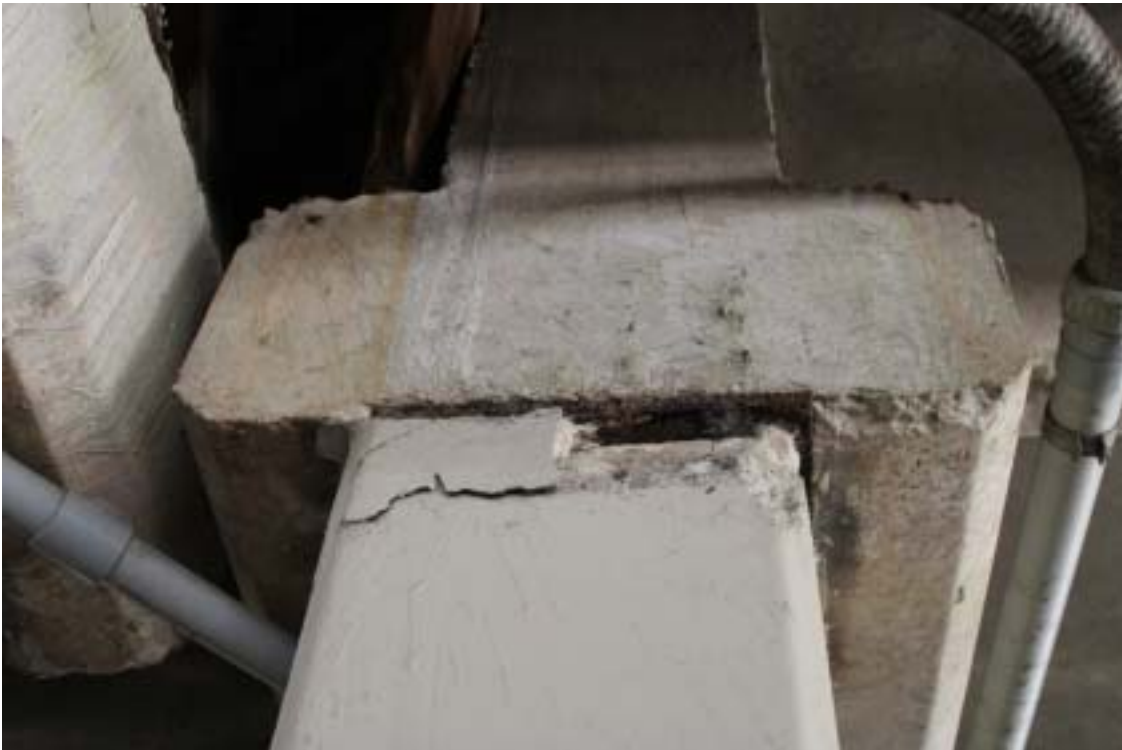
Photograph 52 - Concrete column below precast elements – Note spalling at top

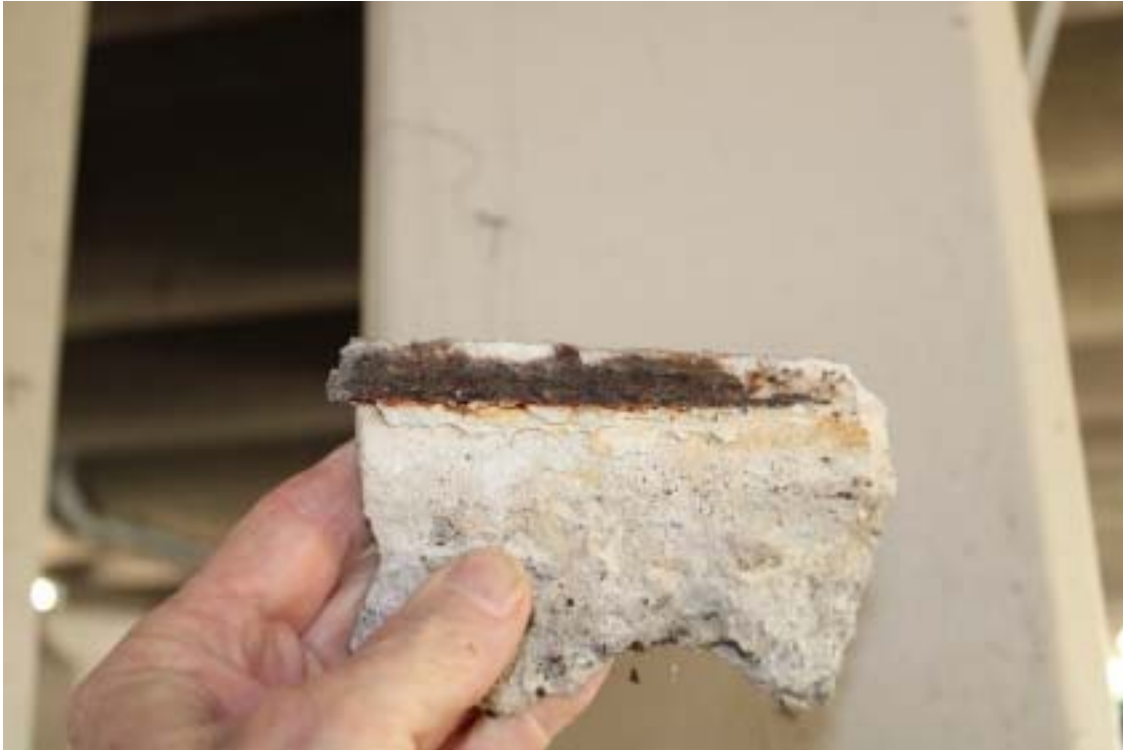
Photograph 53 - Concrete column below precast elements – Note spalled piece from top

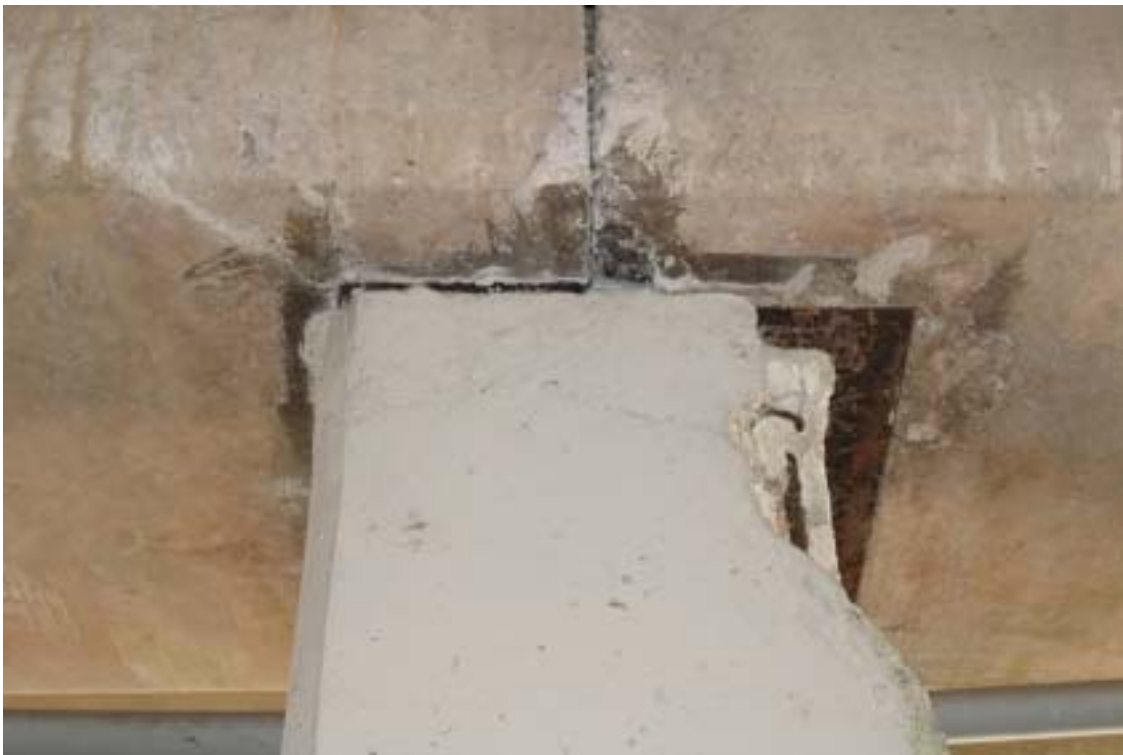
Photograph 54 - Concrete column below precast elements – Note spalled top and steel plate
