October 26, 2021

**Re: Storm Damage Assessment
Harborview Homeowner's Association Property – New Orleans, Louisiana
Claim No.: 4186938
Date of Loss: August 29, 2021
SDII Project No.: 8125715**

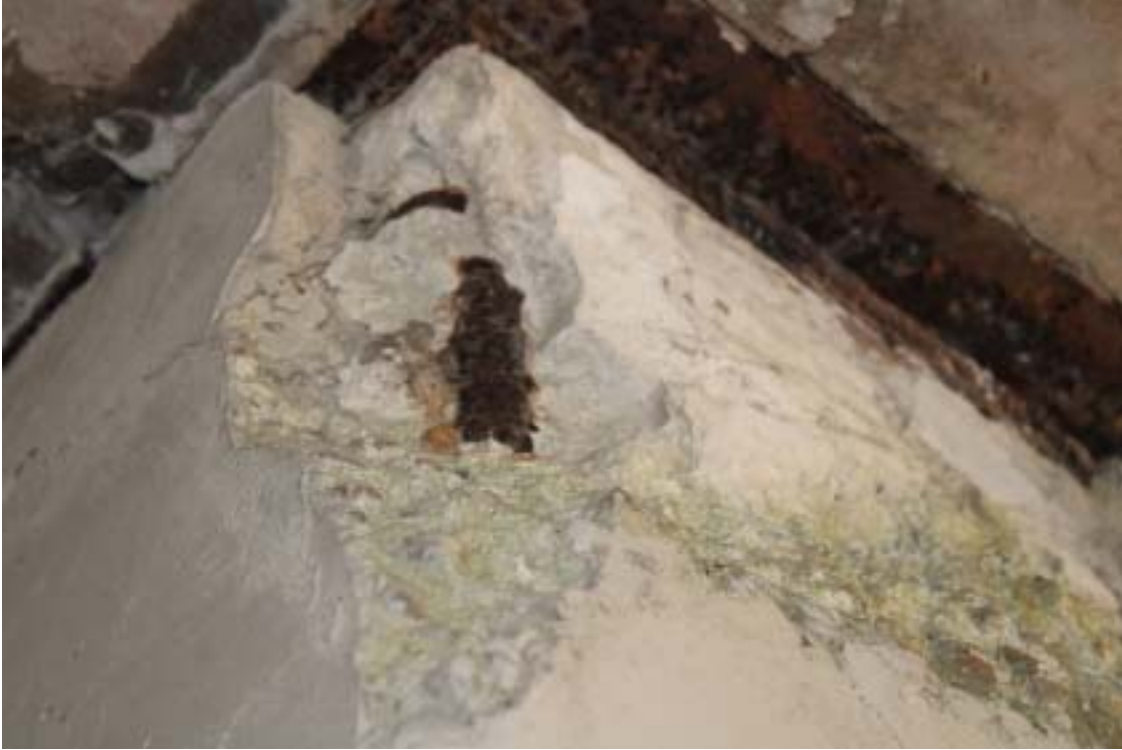
Photograph 55 - Concrete column below precast elements – Note spalled top and steel plate

- The loose and spalled concrete found at the tops of the concrete columns should be chipped away to expose the rusted steel. The steel should be abrasive blasted and quickly coated with a zinc-rich primer and a suitable topcoat finish. An engineer should be brought in to inspect all steel exposed during this repair project. A concrete bonding substance should be applied to the cracked concrete surface and a Portland cement mortar should be used to repair the tops of the columns. Any other exposed steel should be similarly cleaned and coated to prevent future corrosion.
- The original structural drawing of the concrete portion of the structure were not available and any demolition to the tops of the columns should be accomplished under the

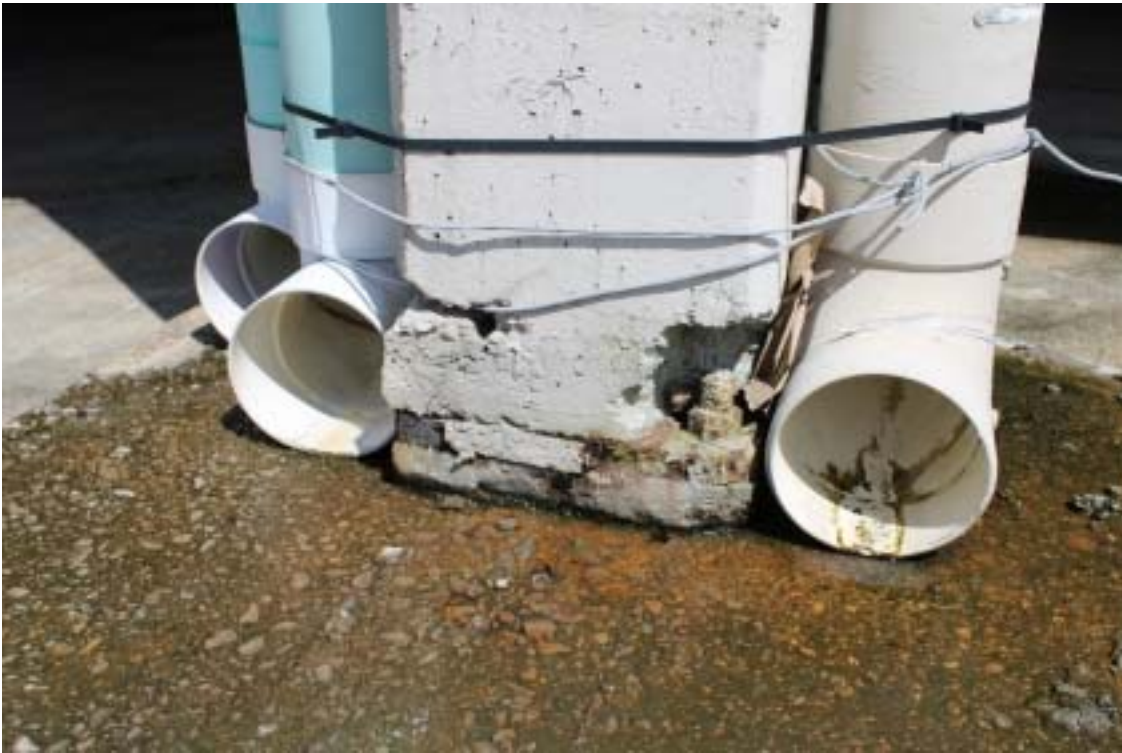
One column along the south wall of the building, found to have steel base plates and anchor bolts, did not match most of the other columns and was likely a repaired or replaced column. Another column along the east edge of the structure was also of dissimilar construction and was likely a steel column encased in concrete. All other concrete columns are assumed to be conventionally reinforced concrete with embedded plates on top. No original structural drawings of the concrete portion of this building were available.

Photograph 56 - Concrete column below precast elements – Note spalled base, anchor bolt, and steel plate

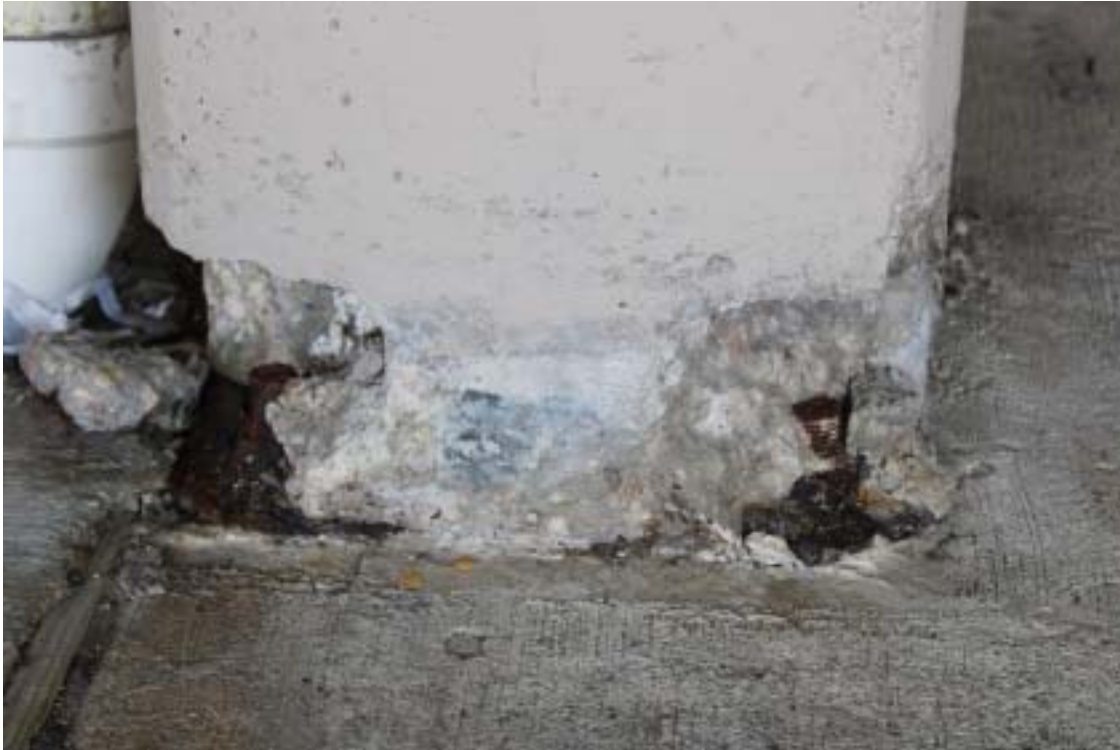
Photograph 57 - Concrete column below precast elements – Note spalled base, anchor bolts, and steel plate

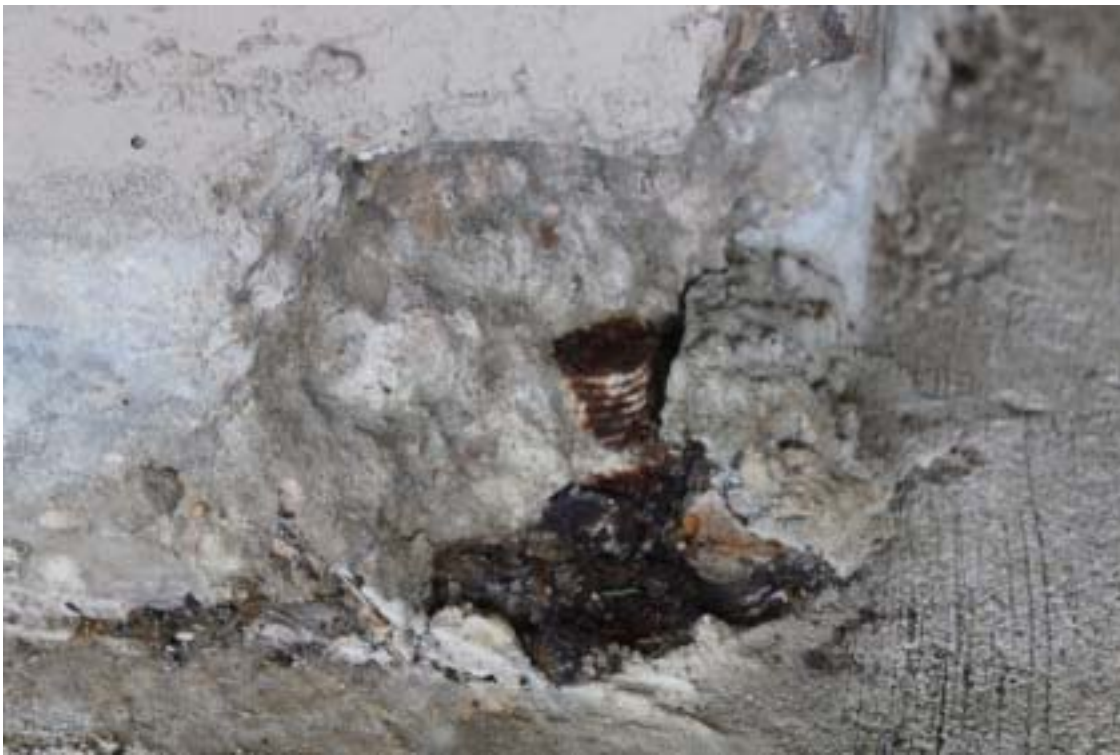
Photograph 58 - Concrete column below precast elements – Note spalled base, anchor bolt, and steel plate

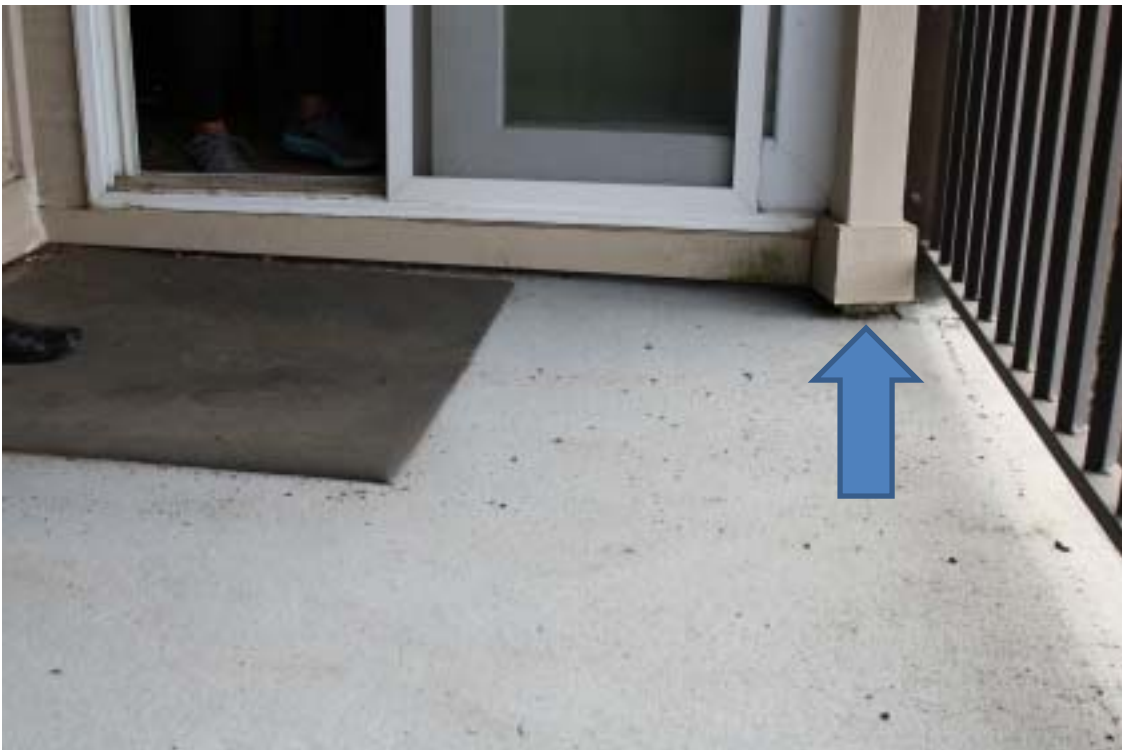
Photograph 68 - West side gallery floor – Note gap between surface and plinth

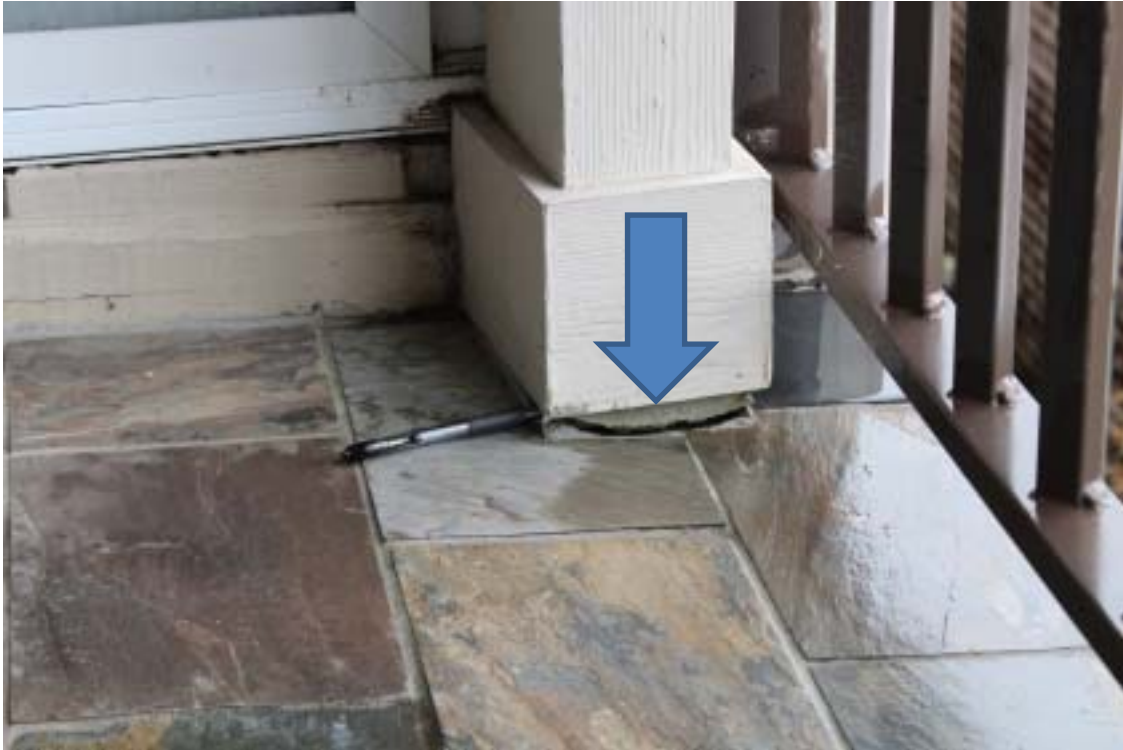
Photograph 69 - West side gallery floor – Note gap between surface and plinth

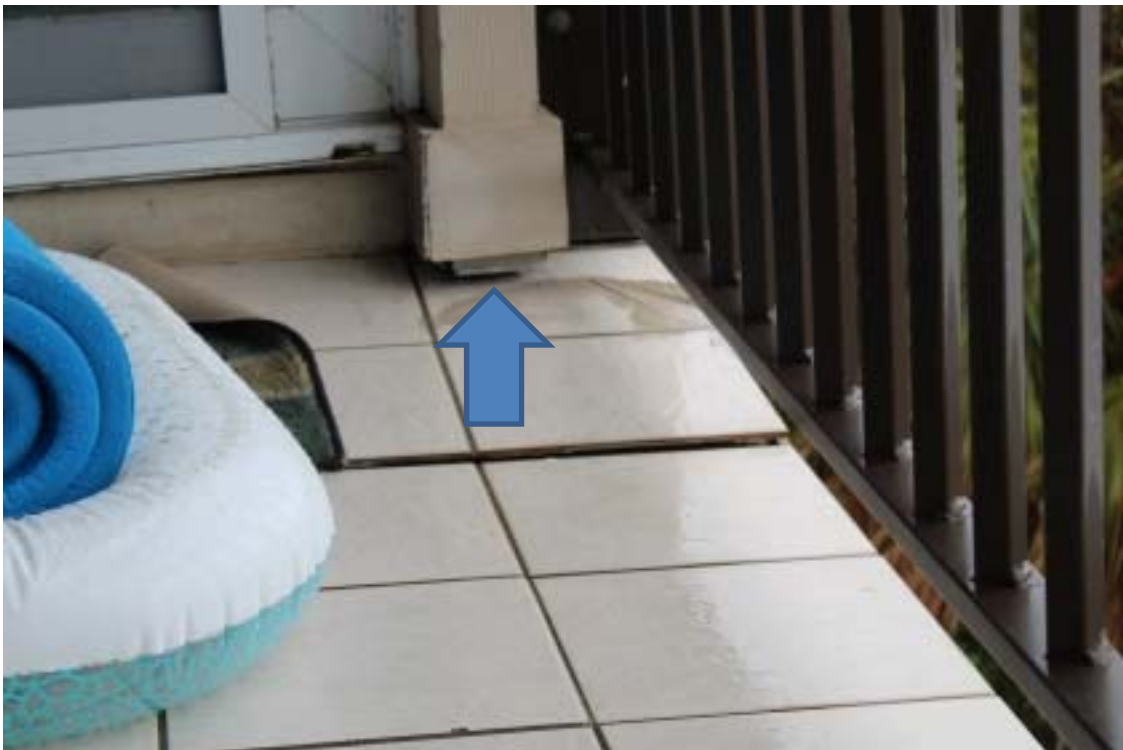
Photograph 70 - West side gallery floor – Note gap between surface and plinth

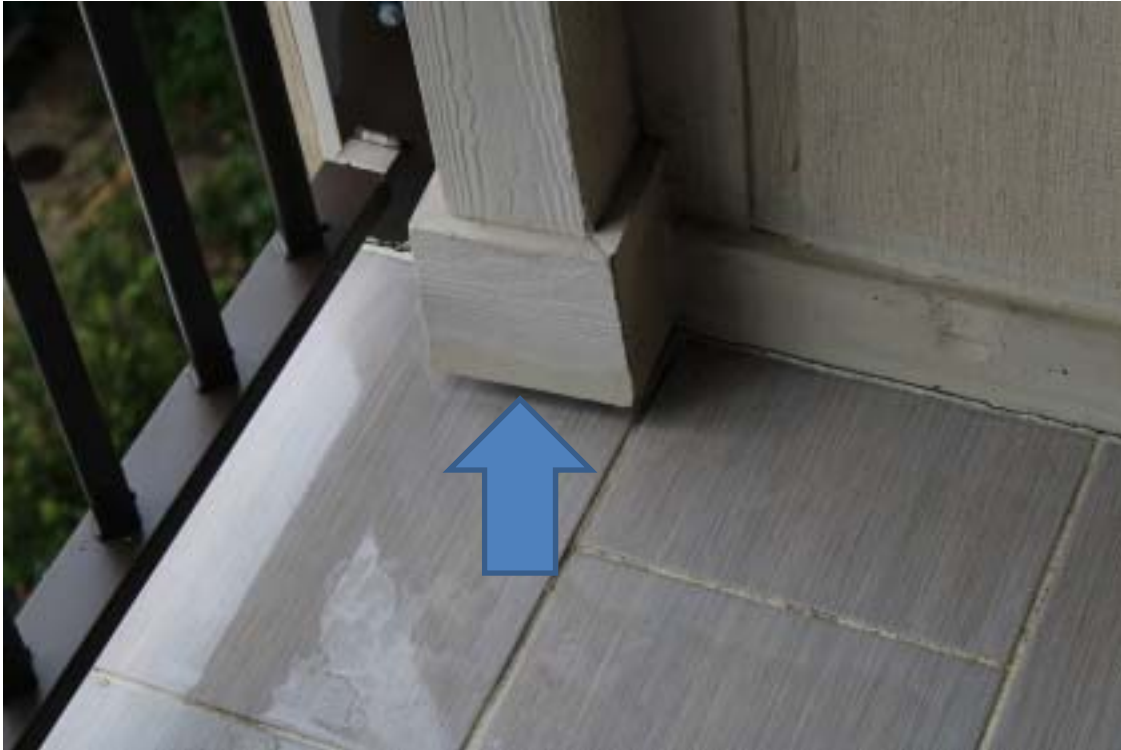
Photograph 71 - West side gallery floor – Note gap between surface and plinth

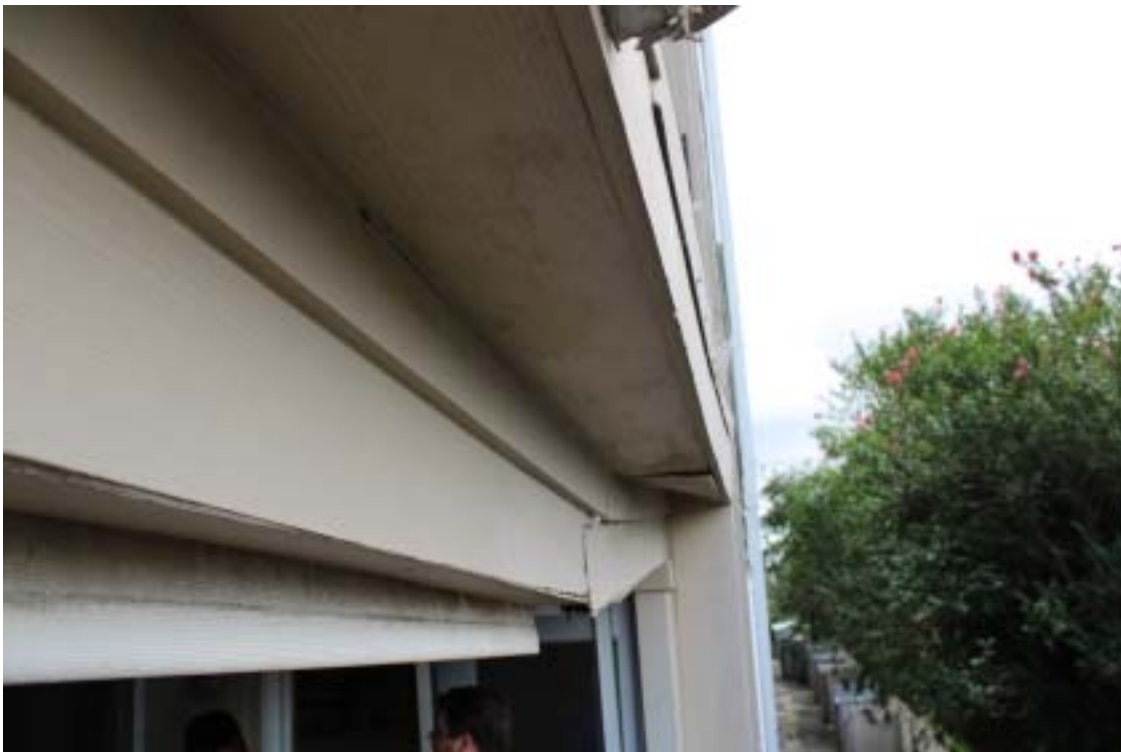
Several of the west side galleries on floors number three and four were found to have failing support framing and should not be used until they are repaired. Not all of the units with these galleries were accessible during SDII's inspection so fewer than half of the 18 galleries with the failing structures were documented. The original design detail called for wood framing and a plywood deck covered with a membrane and exterior carpet. The membrane had failed, and the framing had deteriorated due to exposure to moisture over the approximate 50 years since they

3. The deteriorated structural timber framing of the galleries was the result of failed waterproofing membranes used in the original construction and was not caused by this recent storm.

Photograph 72 - West side gallery floor support – Note deflected shape

- The gallery floors, support framing, and lower wall sheathing and siding should be removed and the floor should be reframed with pressure-treated framing and pressure-treated plywood. A suitable waterproof membrane should be installed and flashed under the wall sheathing. The floor and wall finishes should be restored in kind.

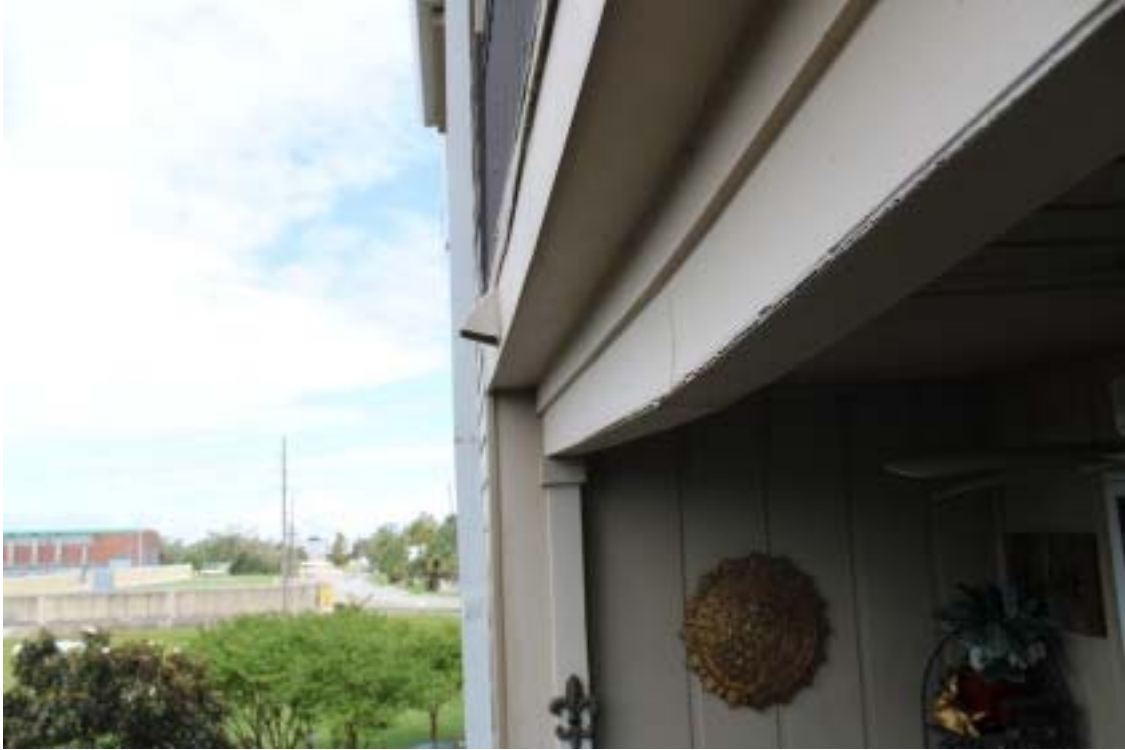
Photograph 73 - West side gallery floor support – Note deflected shape

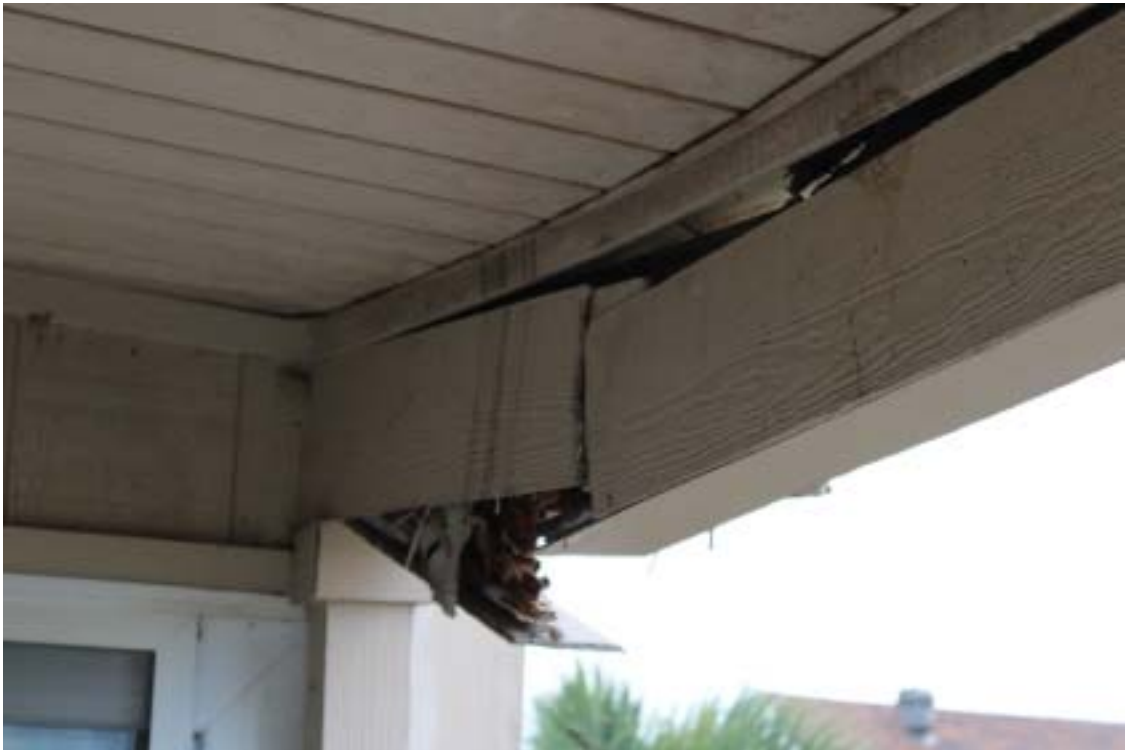
Photograph 74 - West side gallery floor support – Note deflected shape and damaged support beam

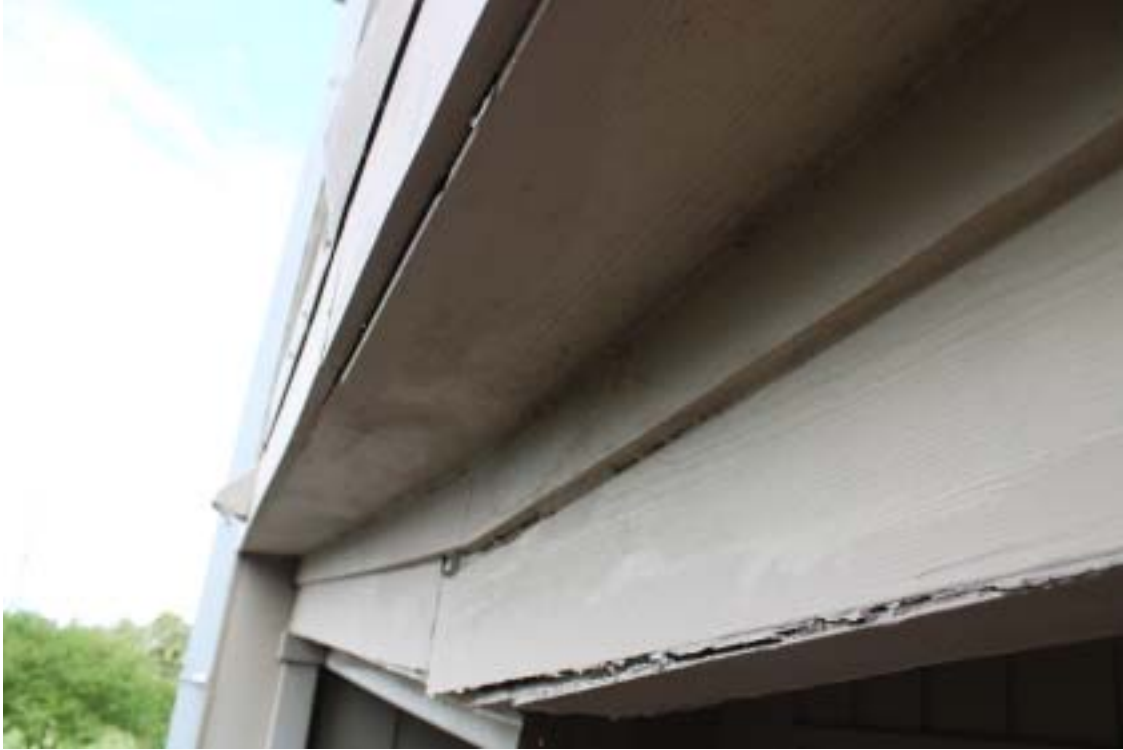
Photograph 75 - West side gallery floor support – Note deflected shape

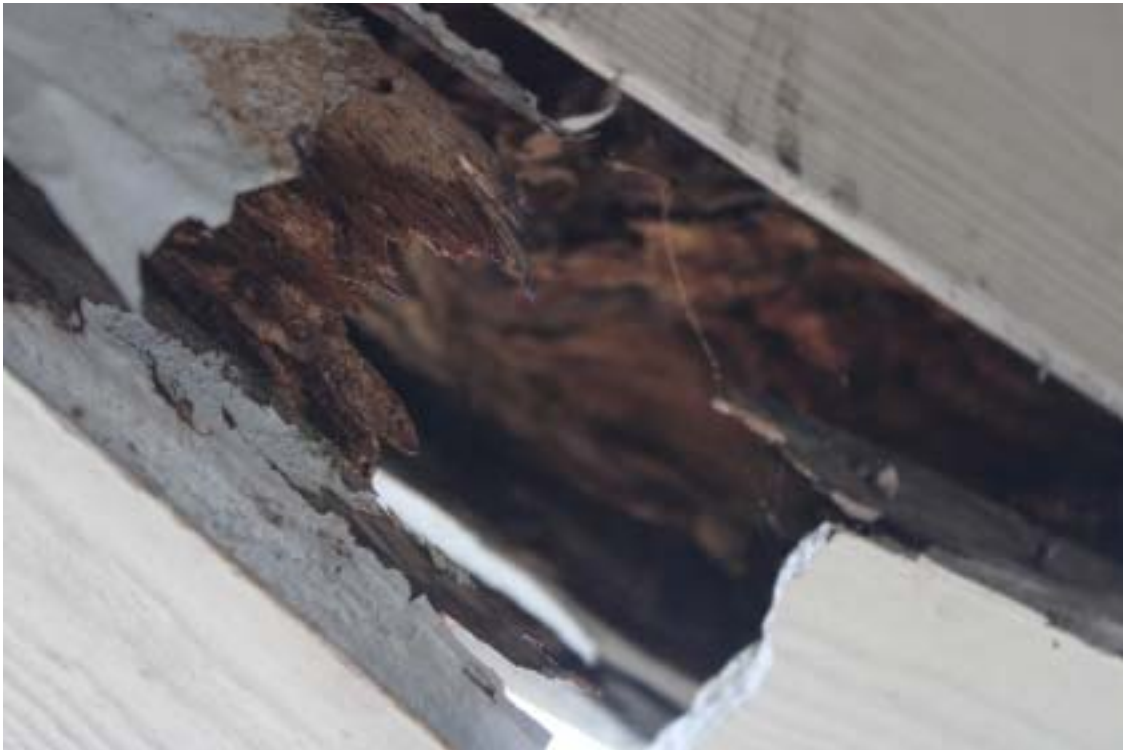
Photograph 76 - West side gallery floor support – Note decayed wood beam

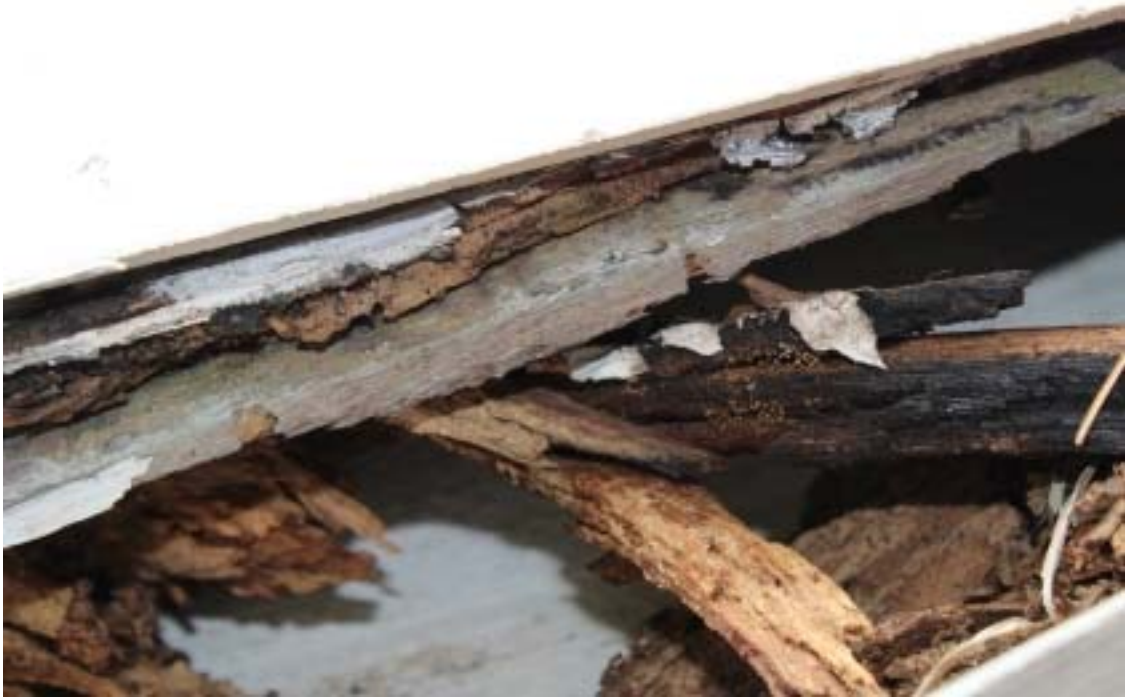
Photograph 77 - West side gallery floor support – Note decayed wood beam
