APPENDIX

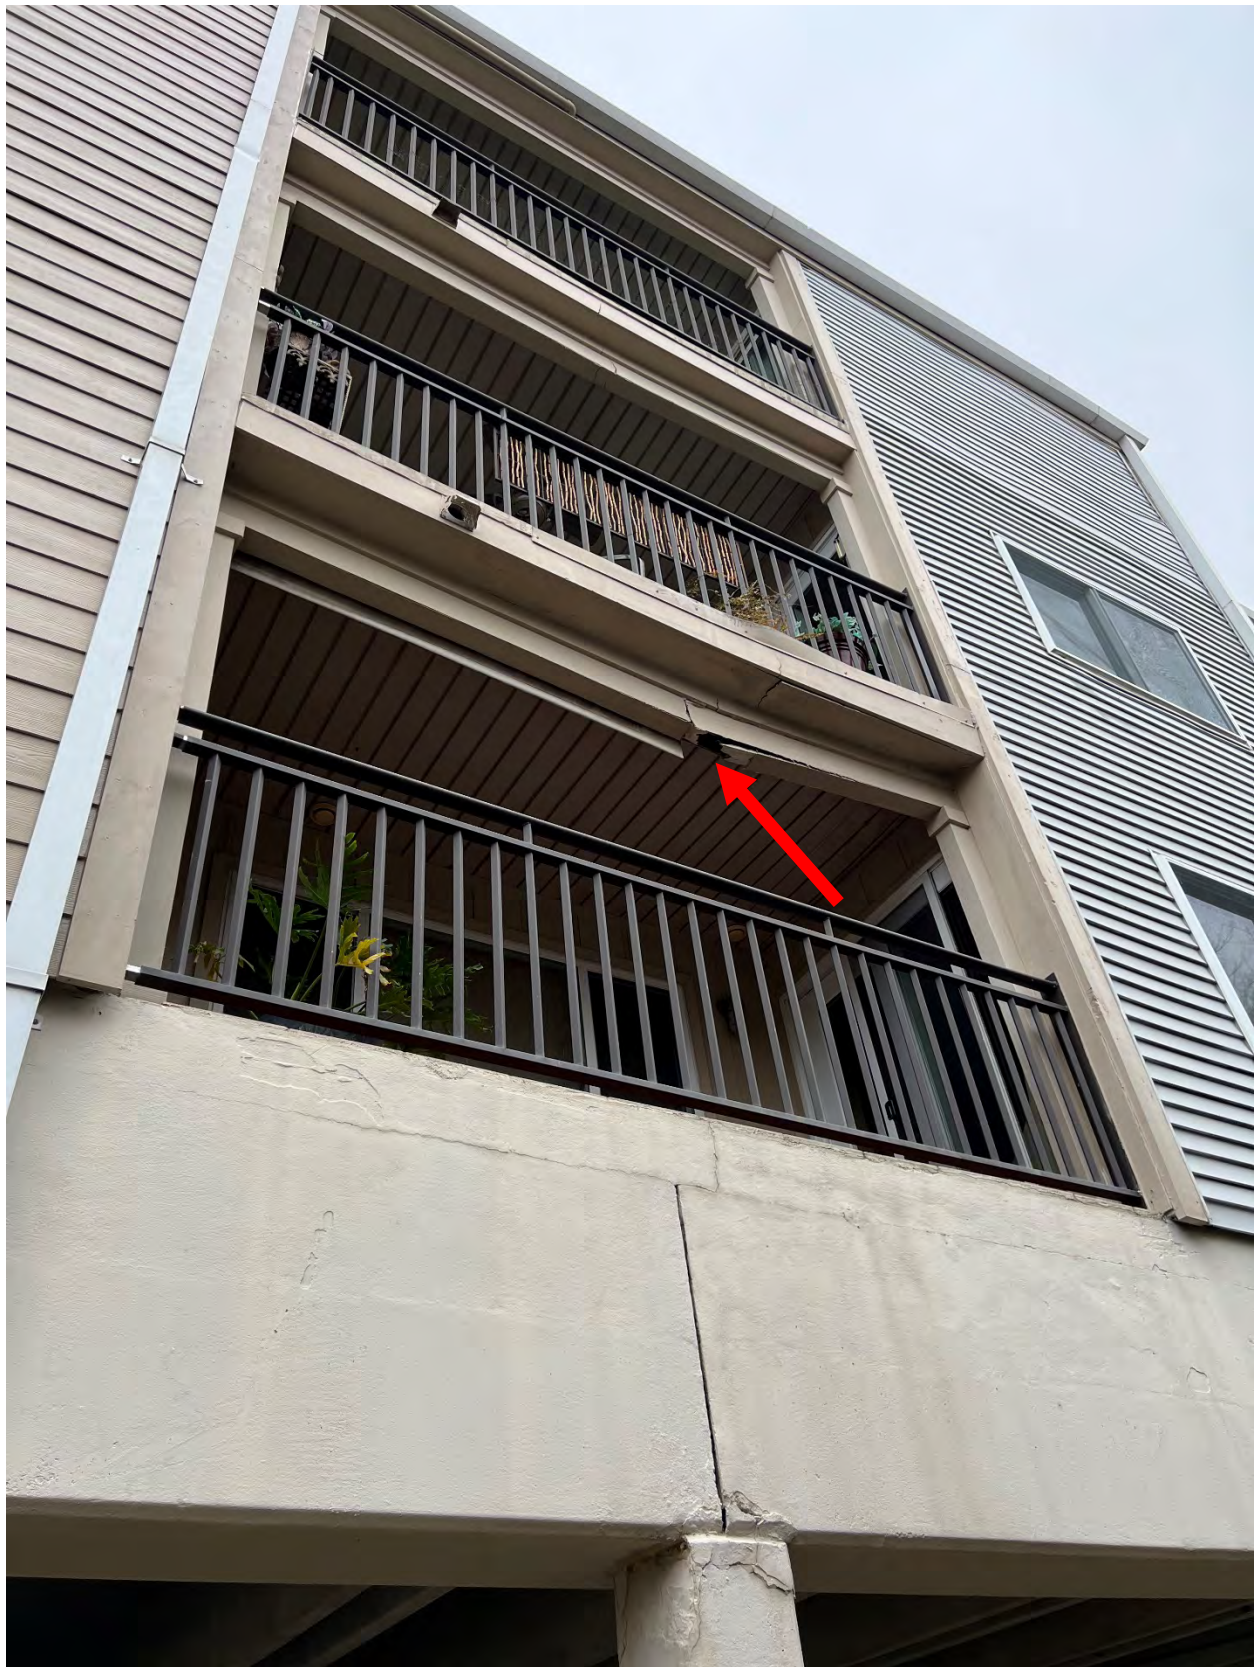
Photo #1 – View of partial balcony failure exhibiting noticeable deflection and water damage.

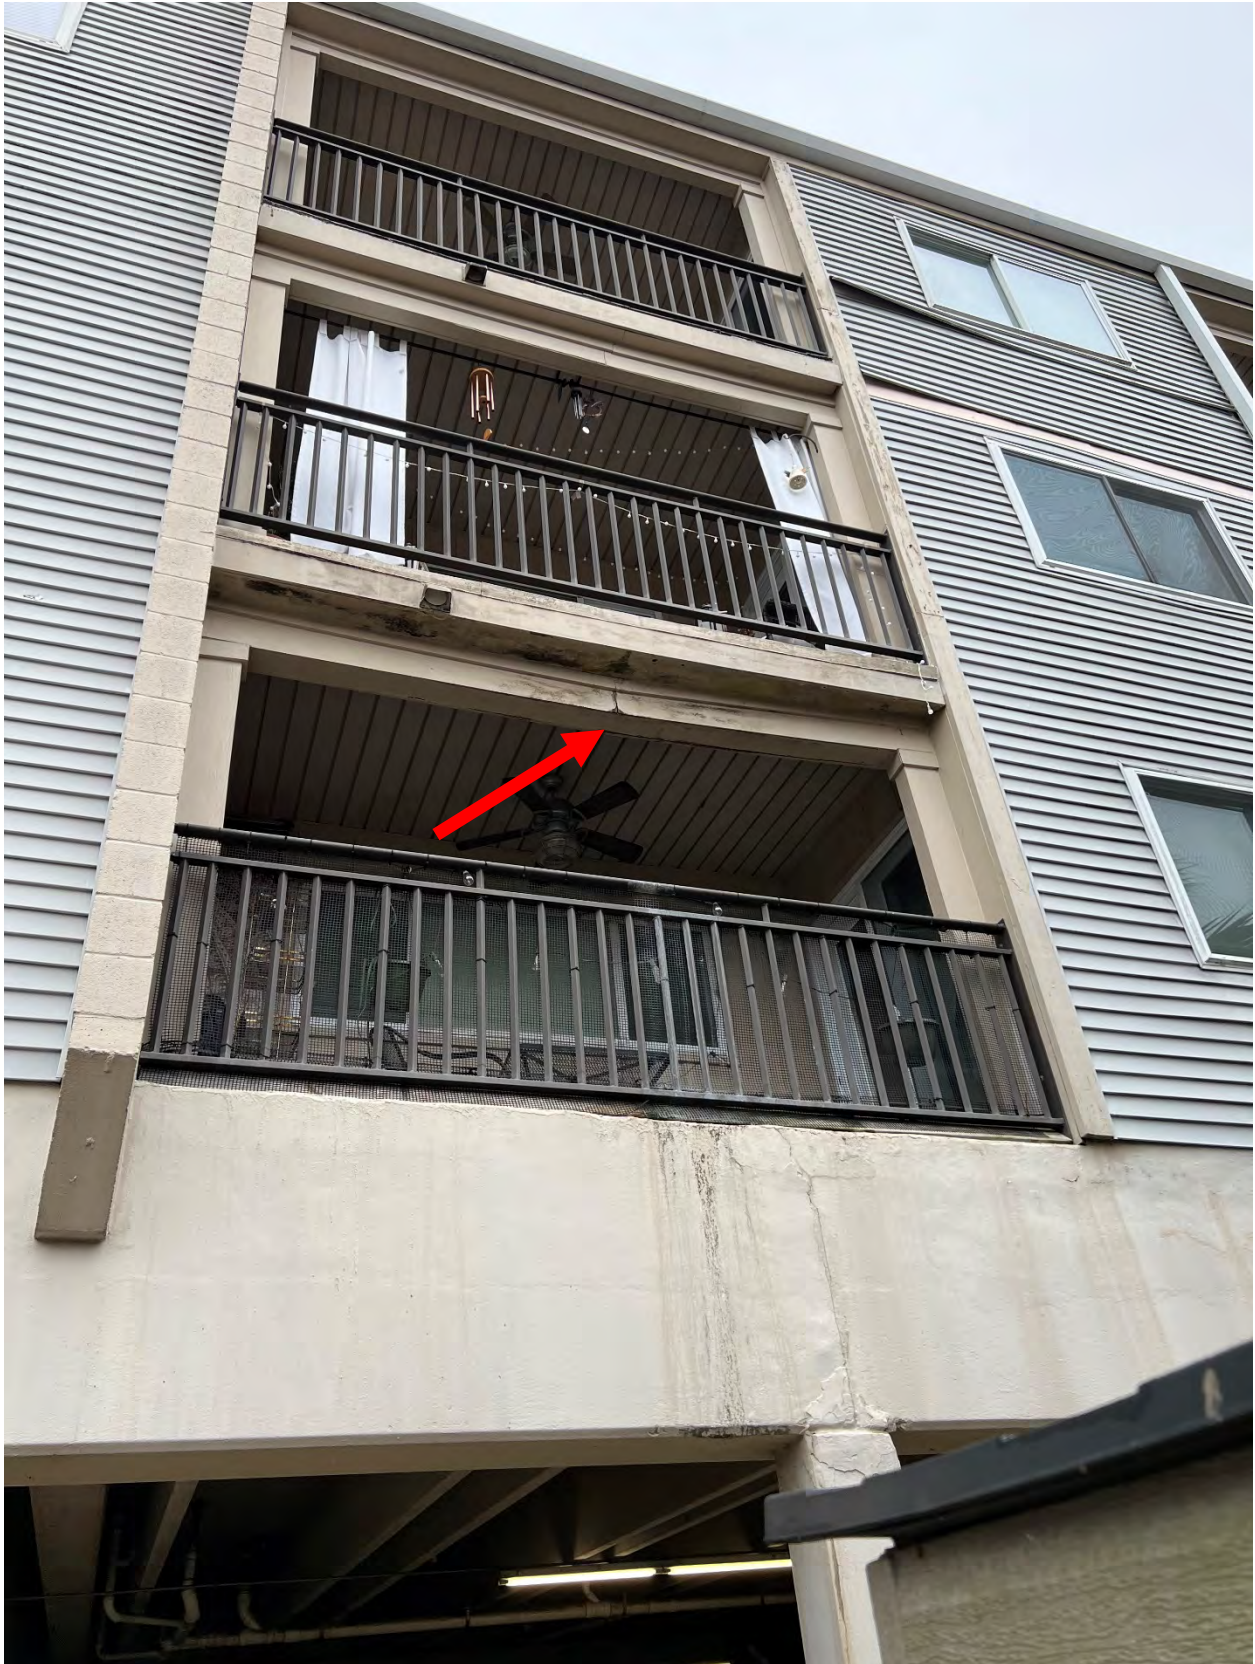
Photo #2 – View of partial balcony failure exhibiting noticeable deflection and water damage.

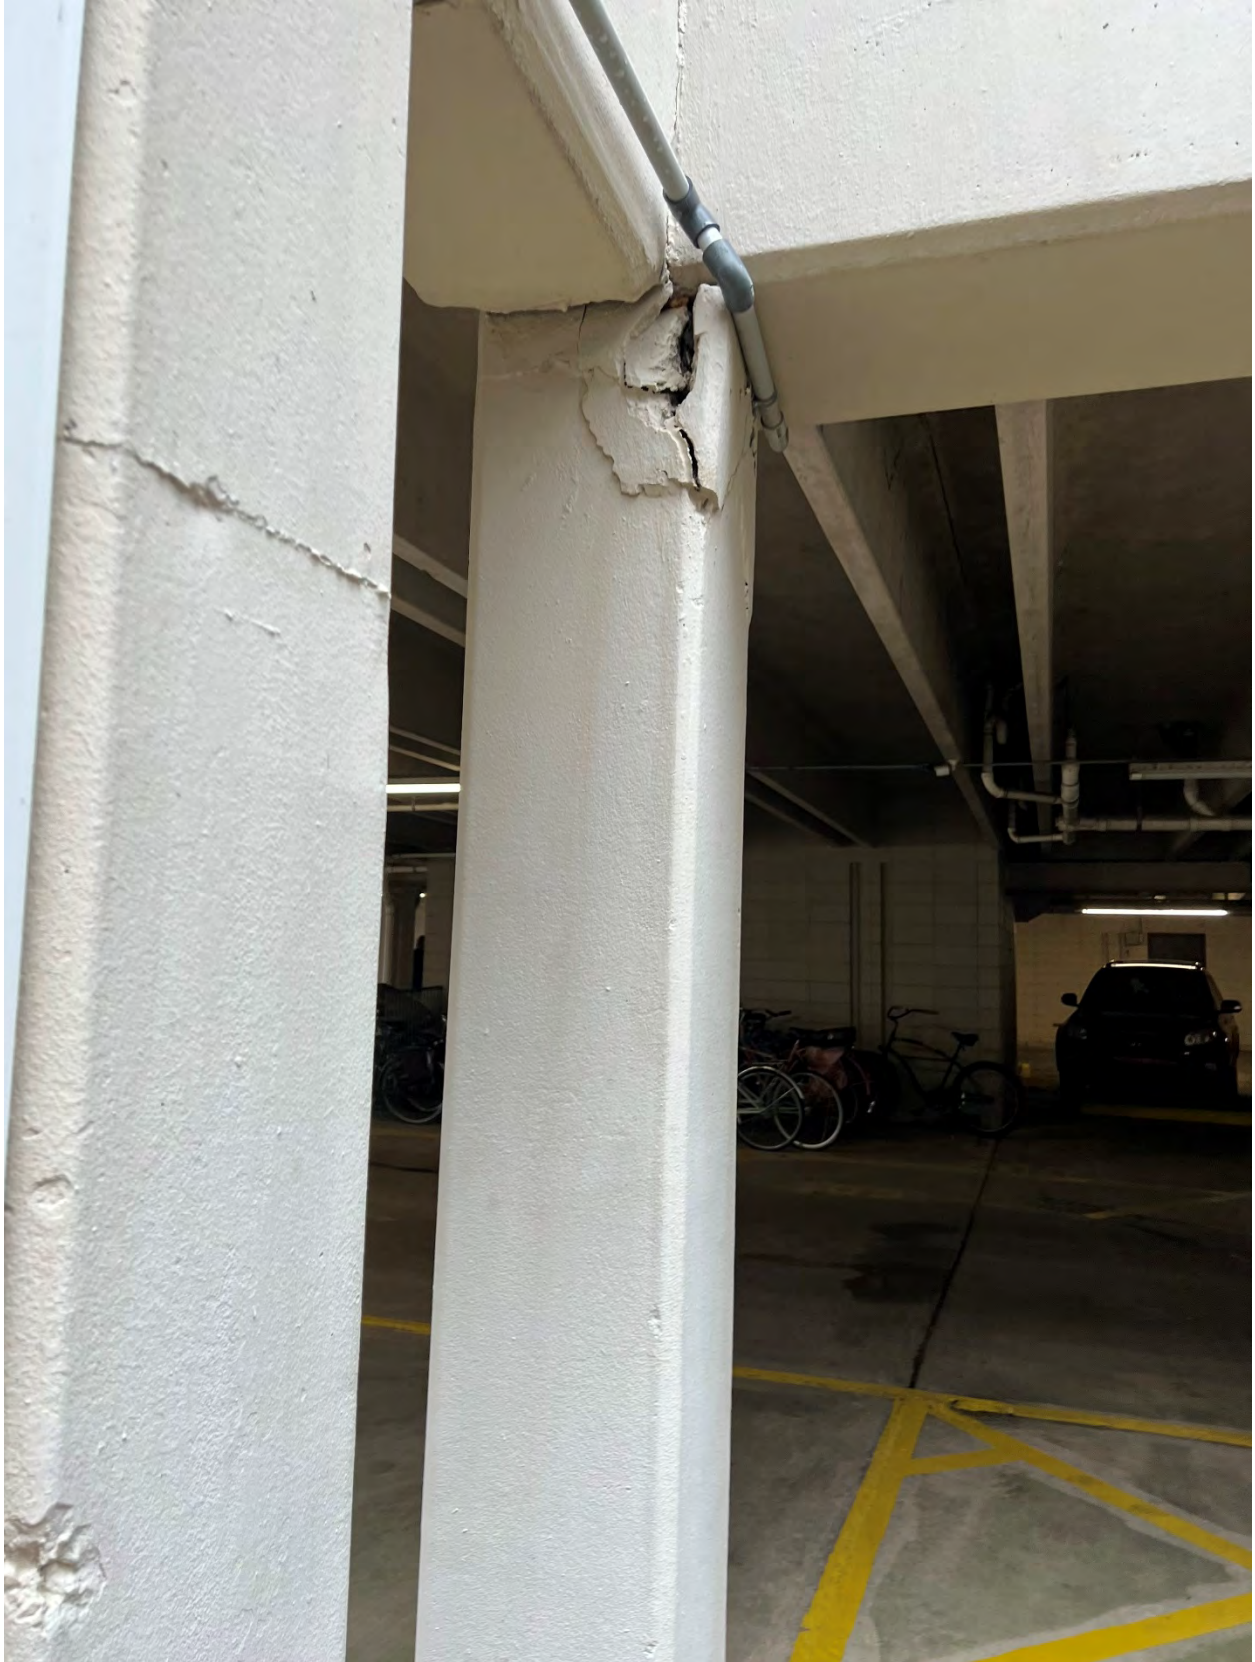
Photo #3 – View of typical top of column concrete spalling.

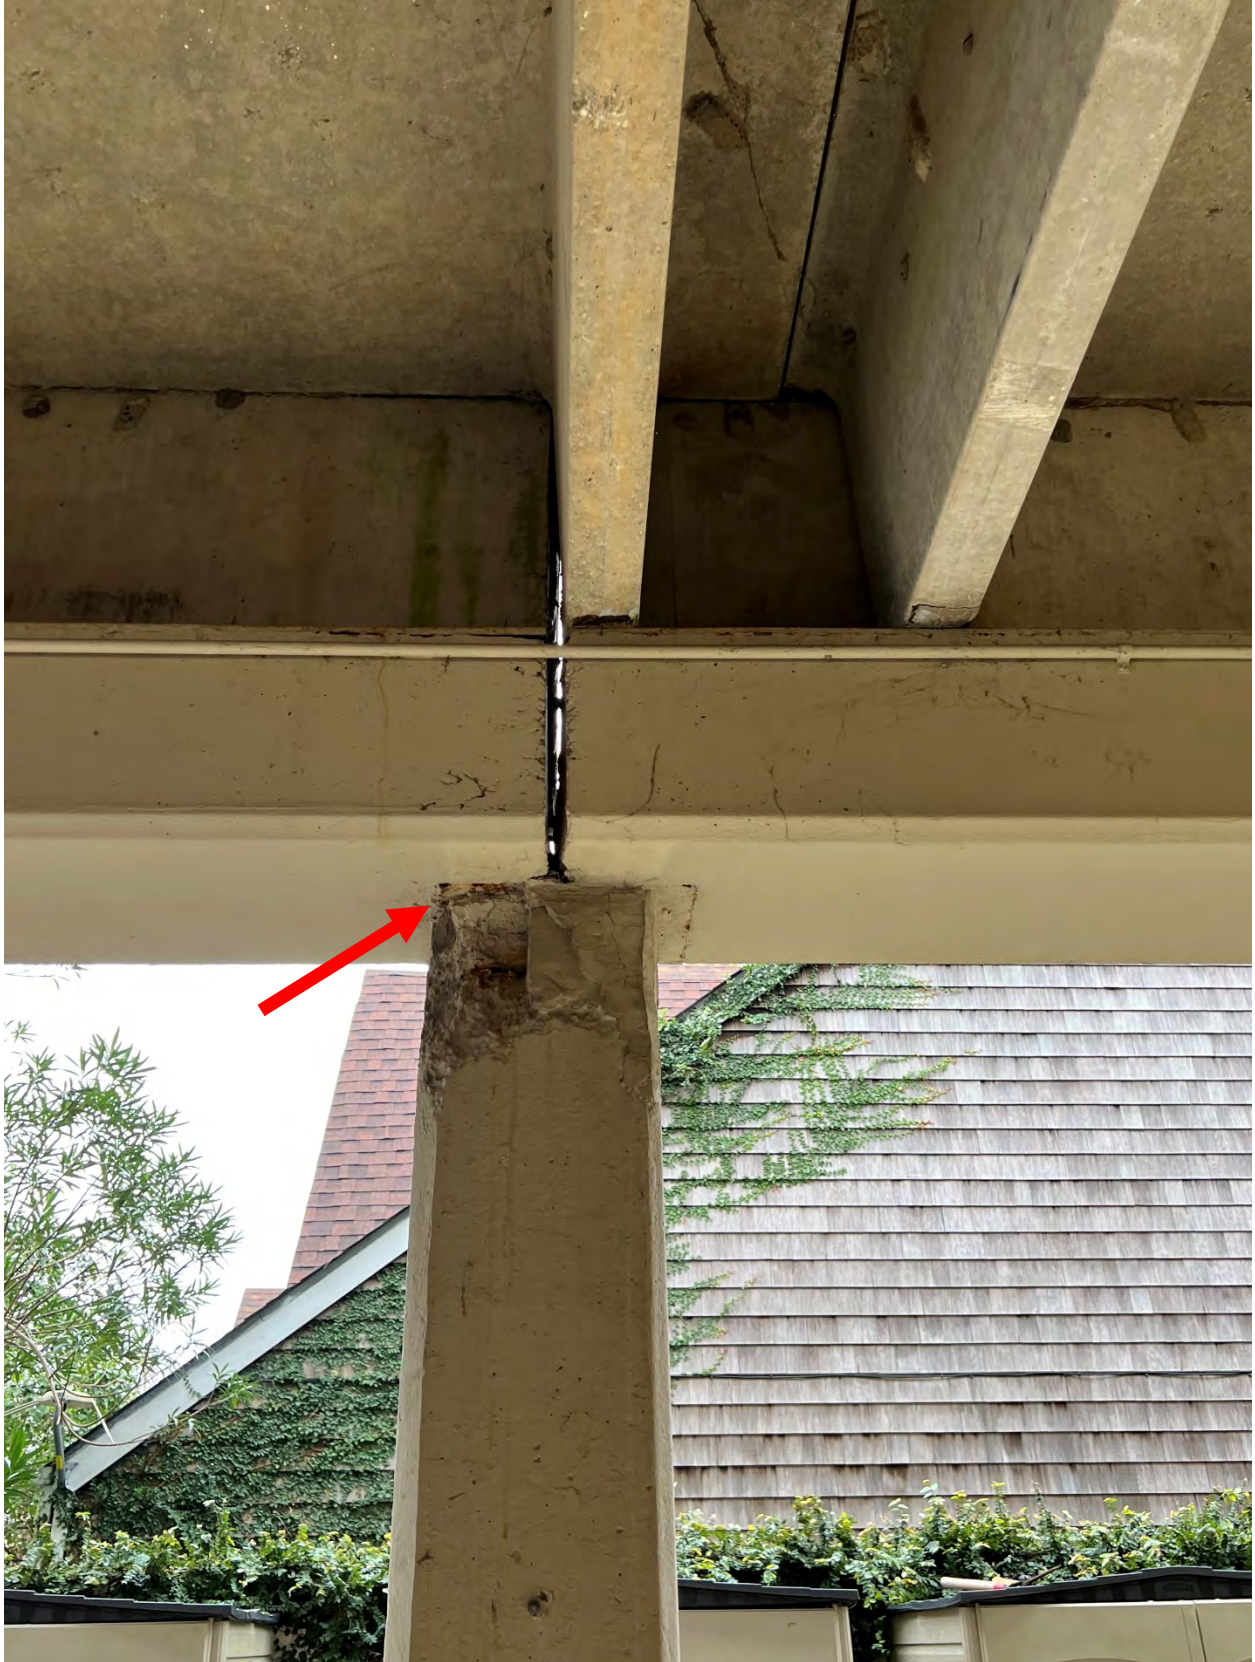
Photo #4 – View of typical top of column concrete spalling. Rusting of embed plate is visible.

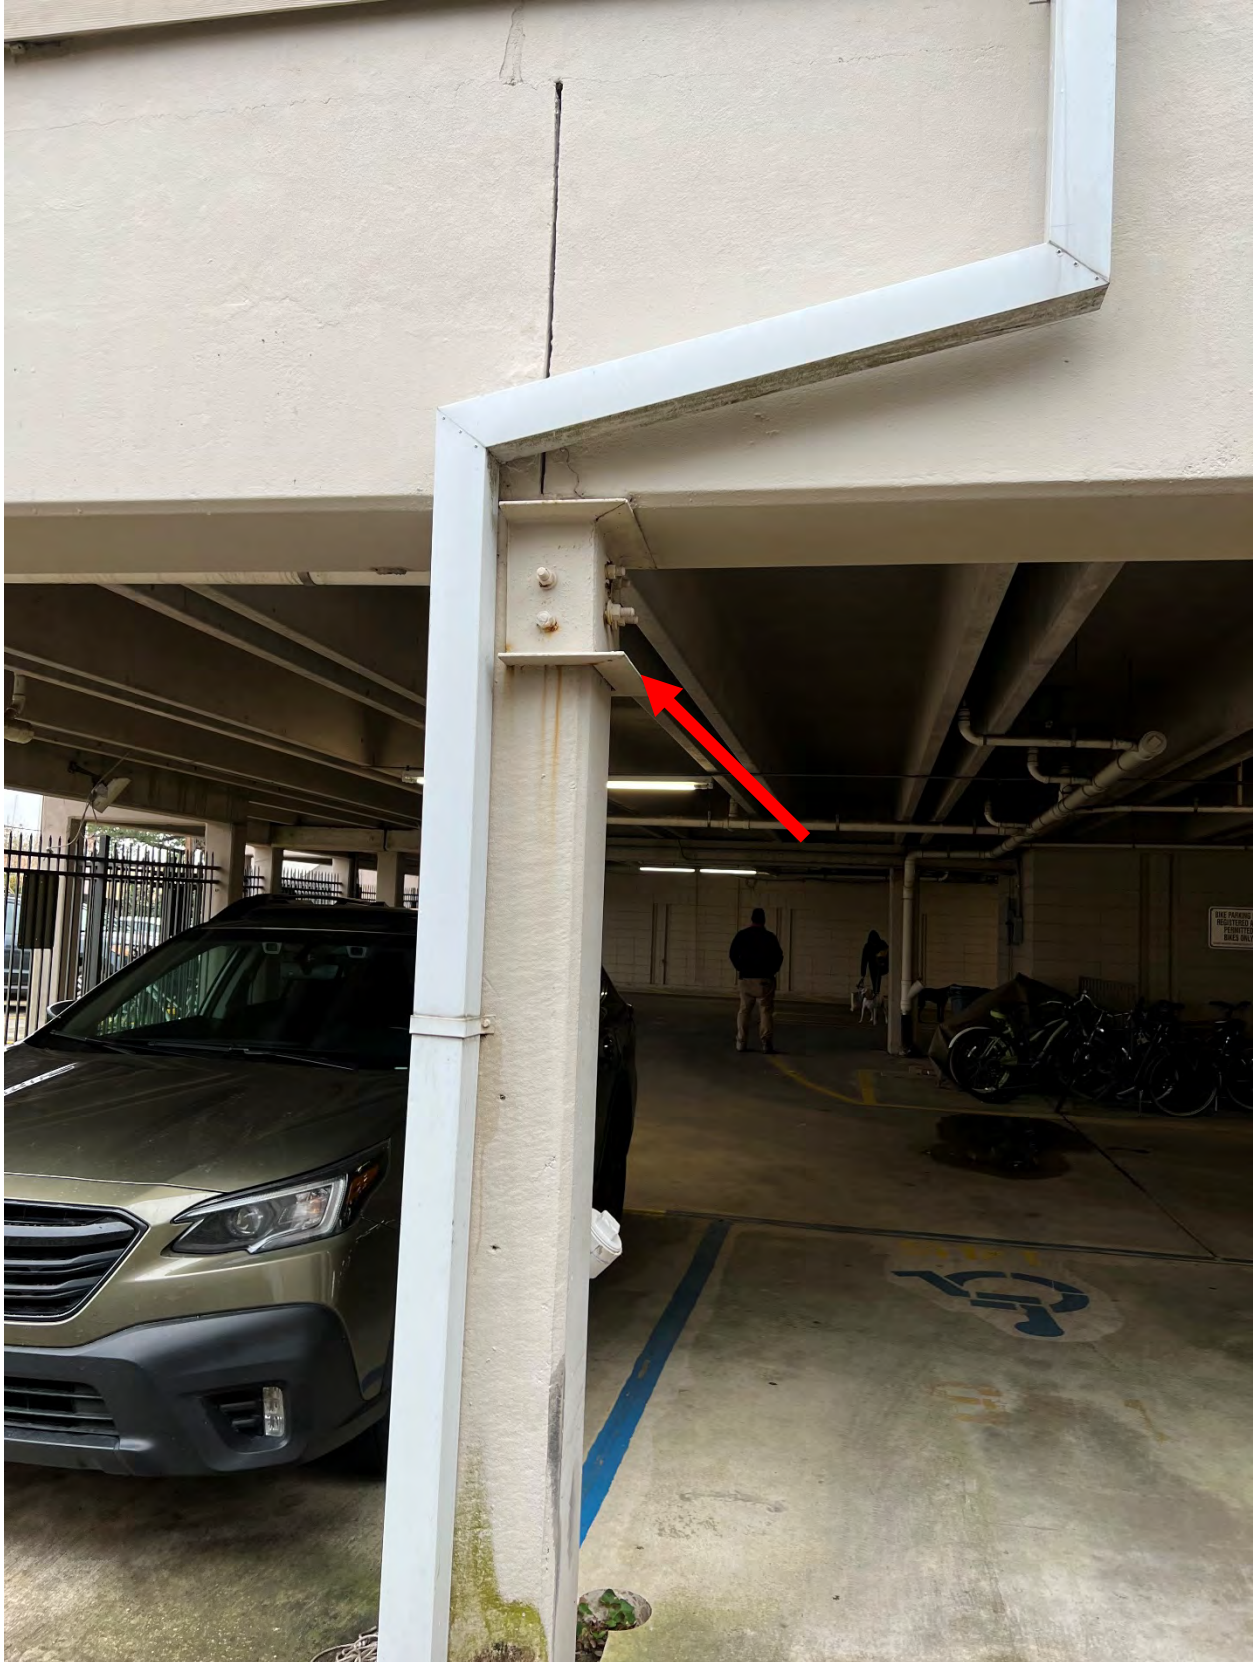
Photo #5 – Steel collar reinforcing at column.

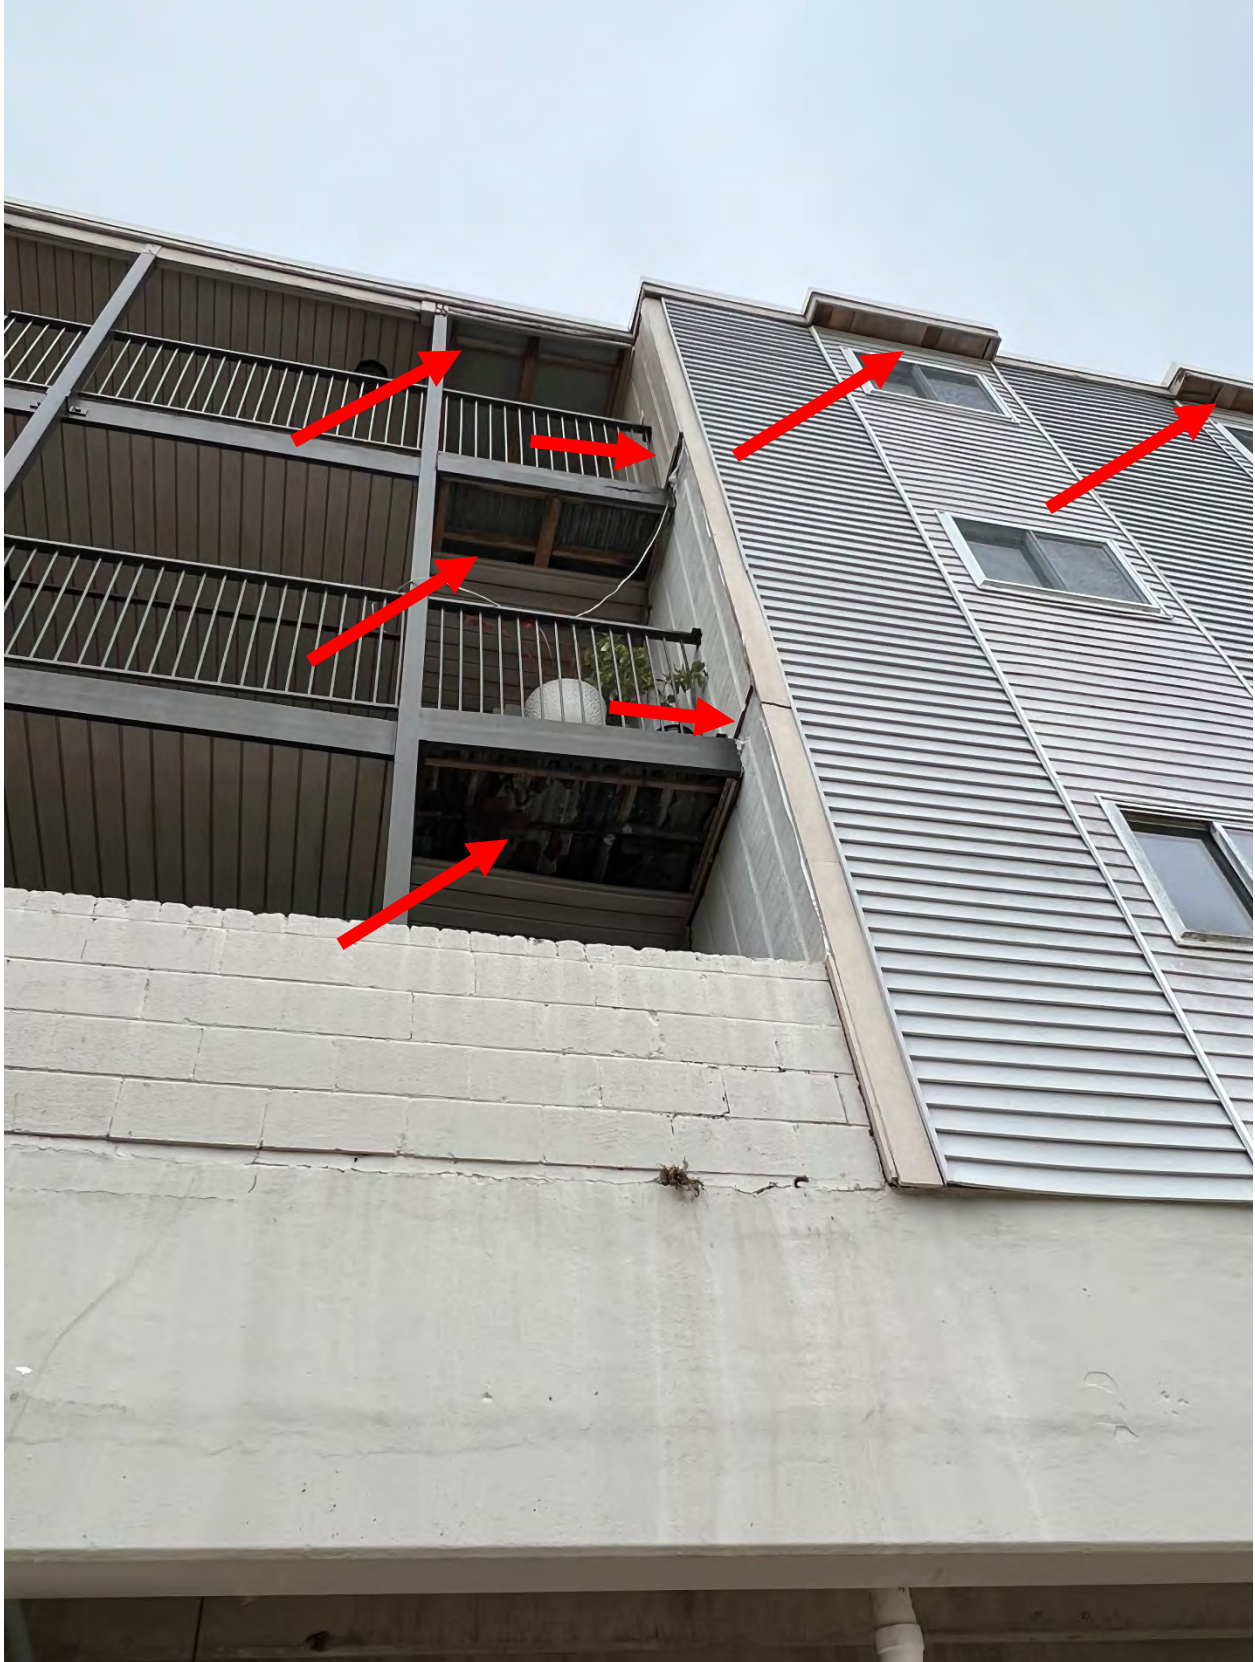
Photo #6 – View of wind related damages to corridor and roof soffits and exterior siding.

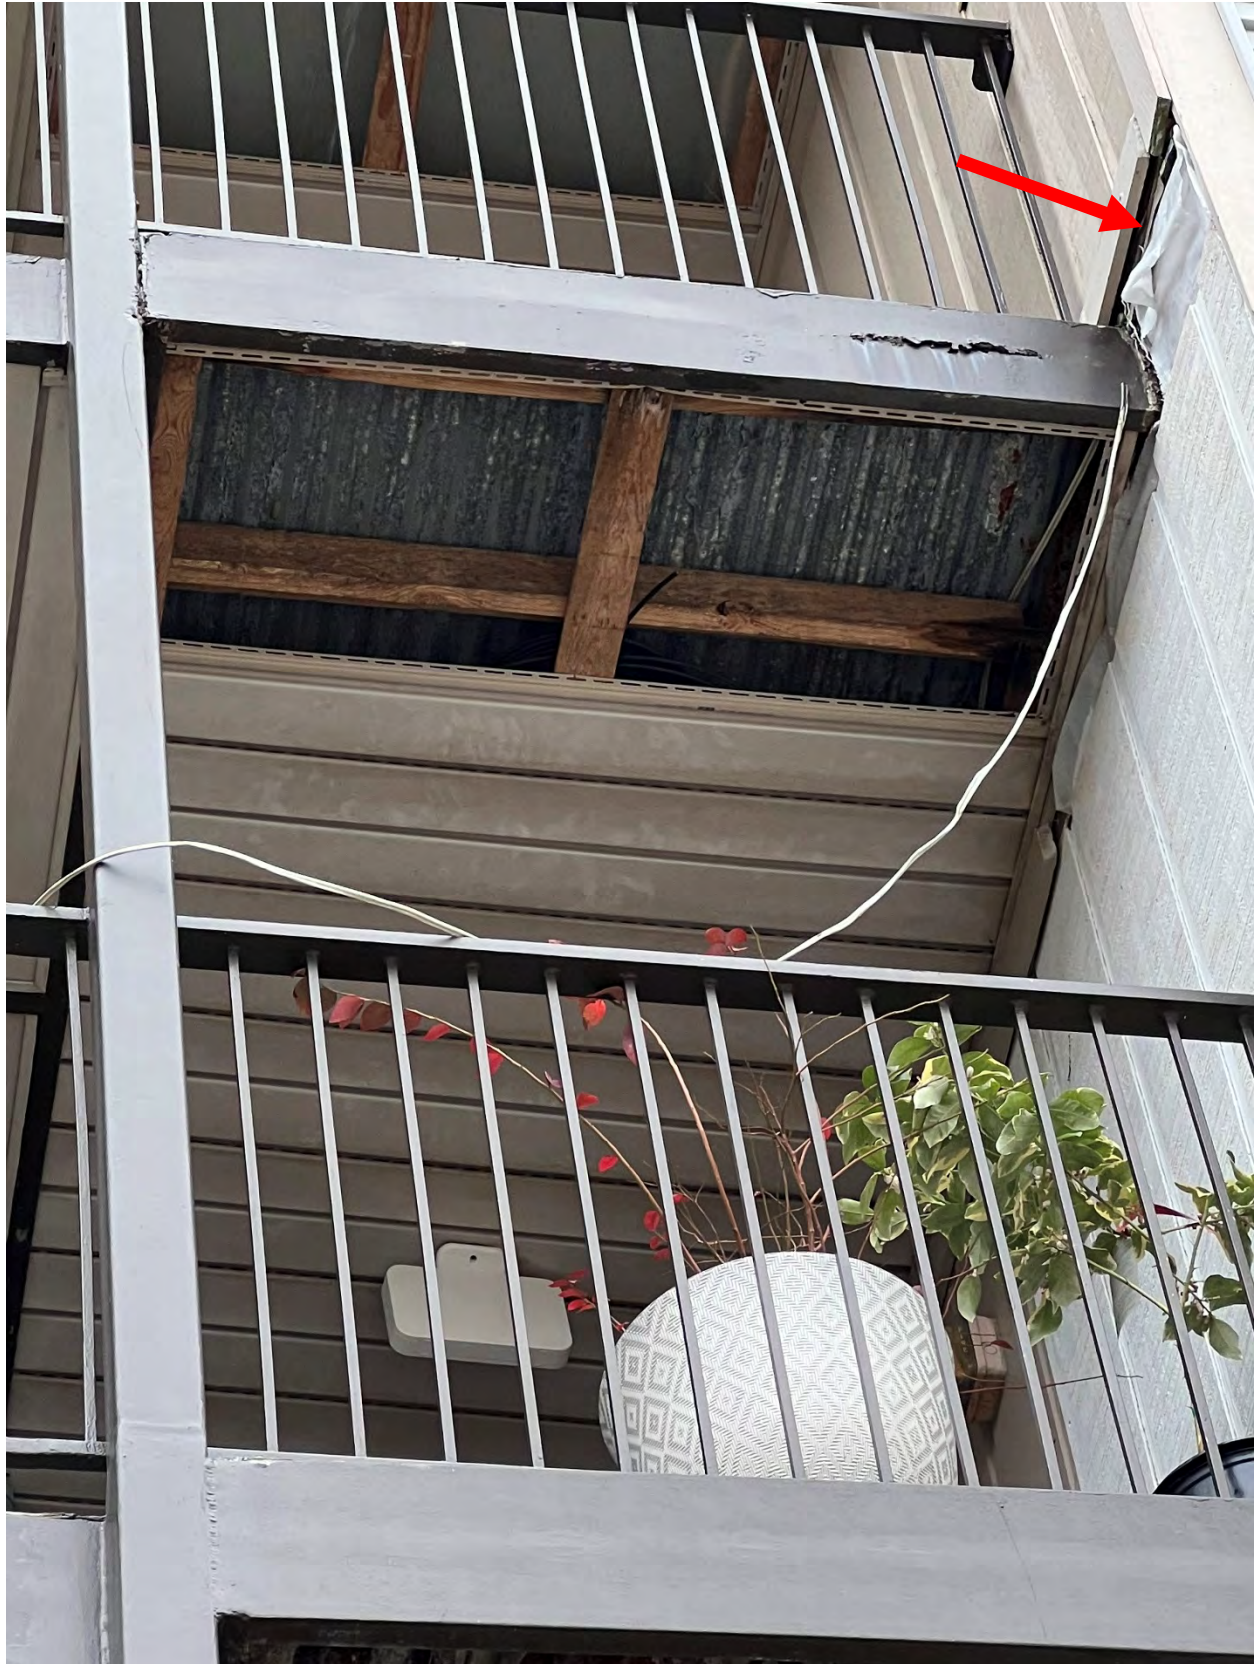
Photo #7 – Close up view of soffit and siding damage.

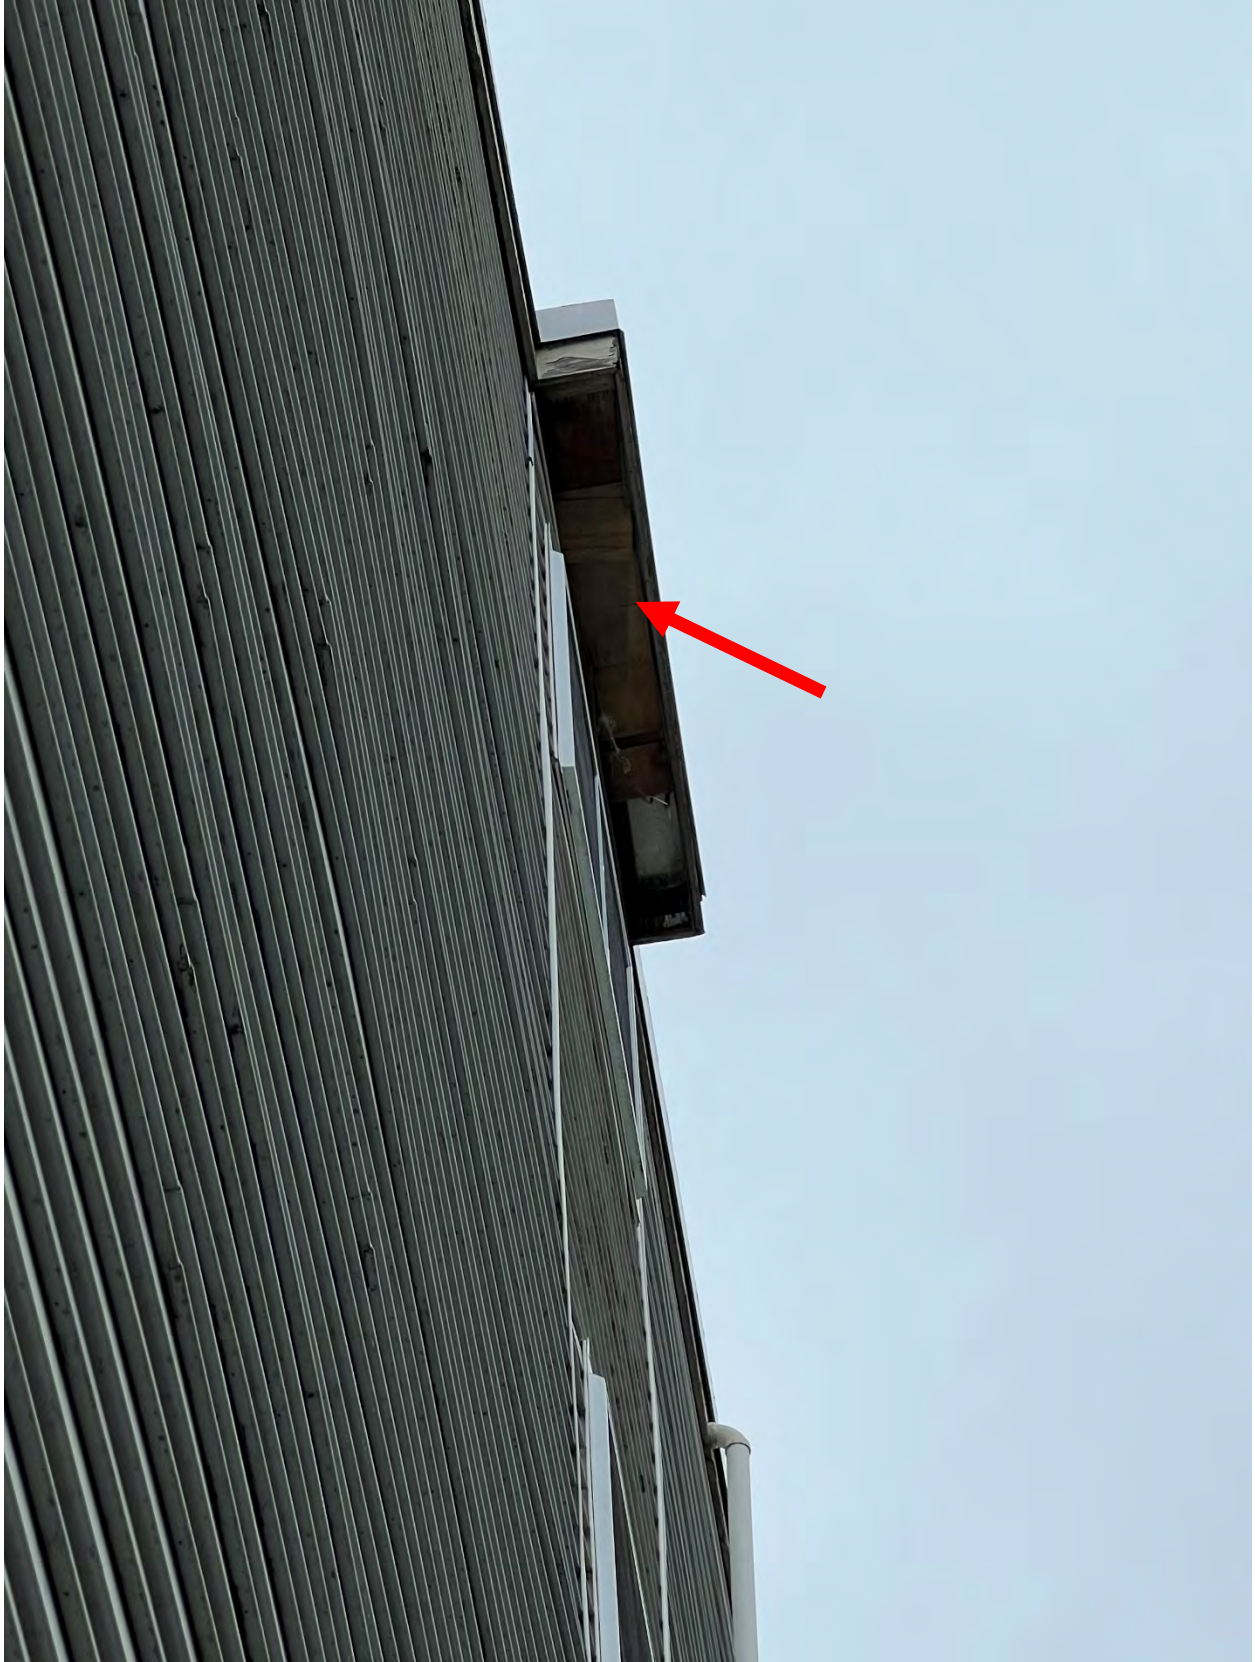
Photo #8 – View of wind related damage to roof soffits at east wall.

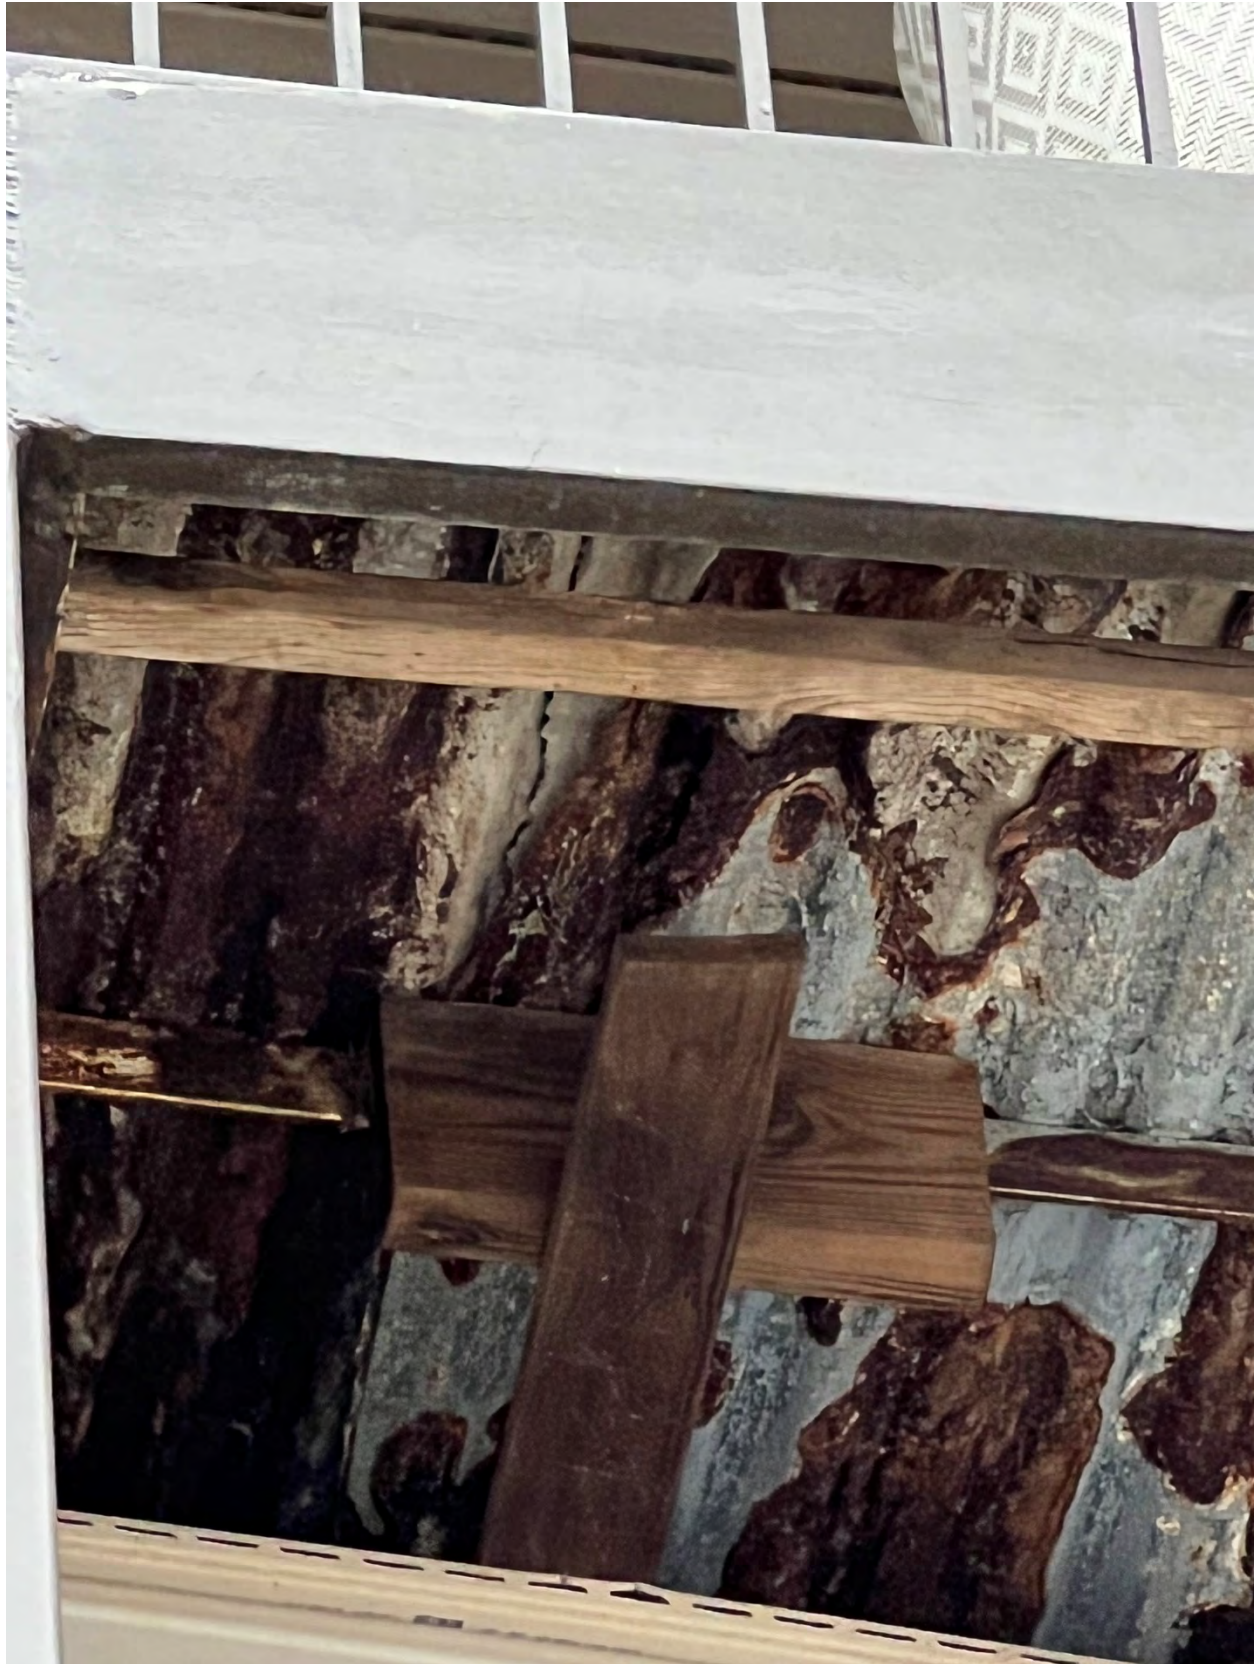
Photo #9 – Close up view of corrosion at underside of corridor slab.

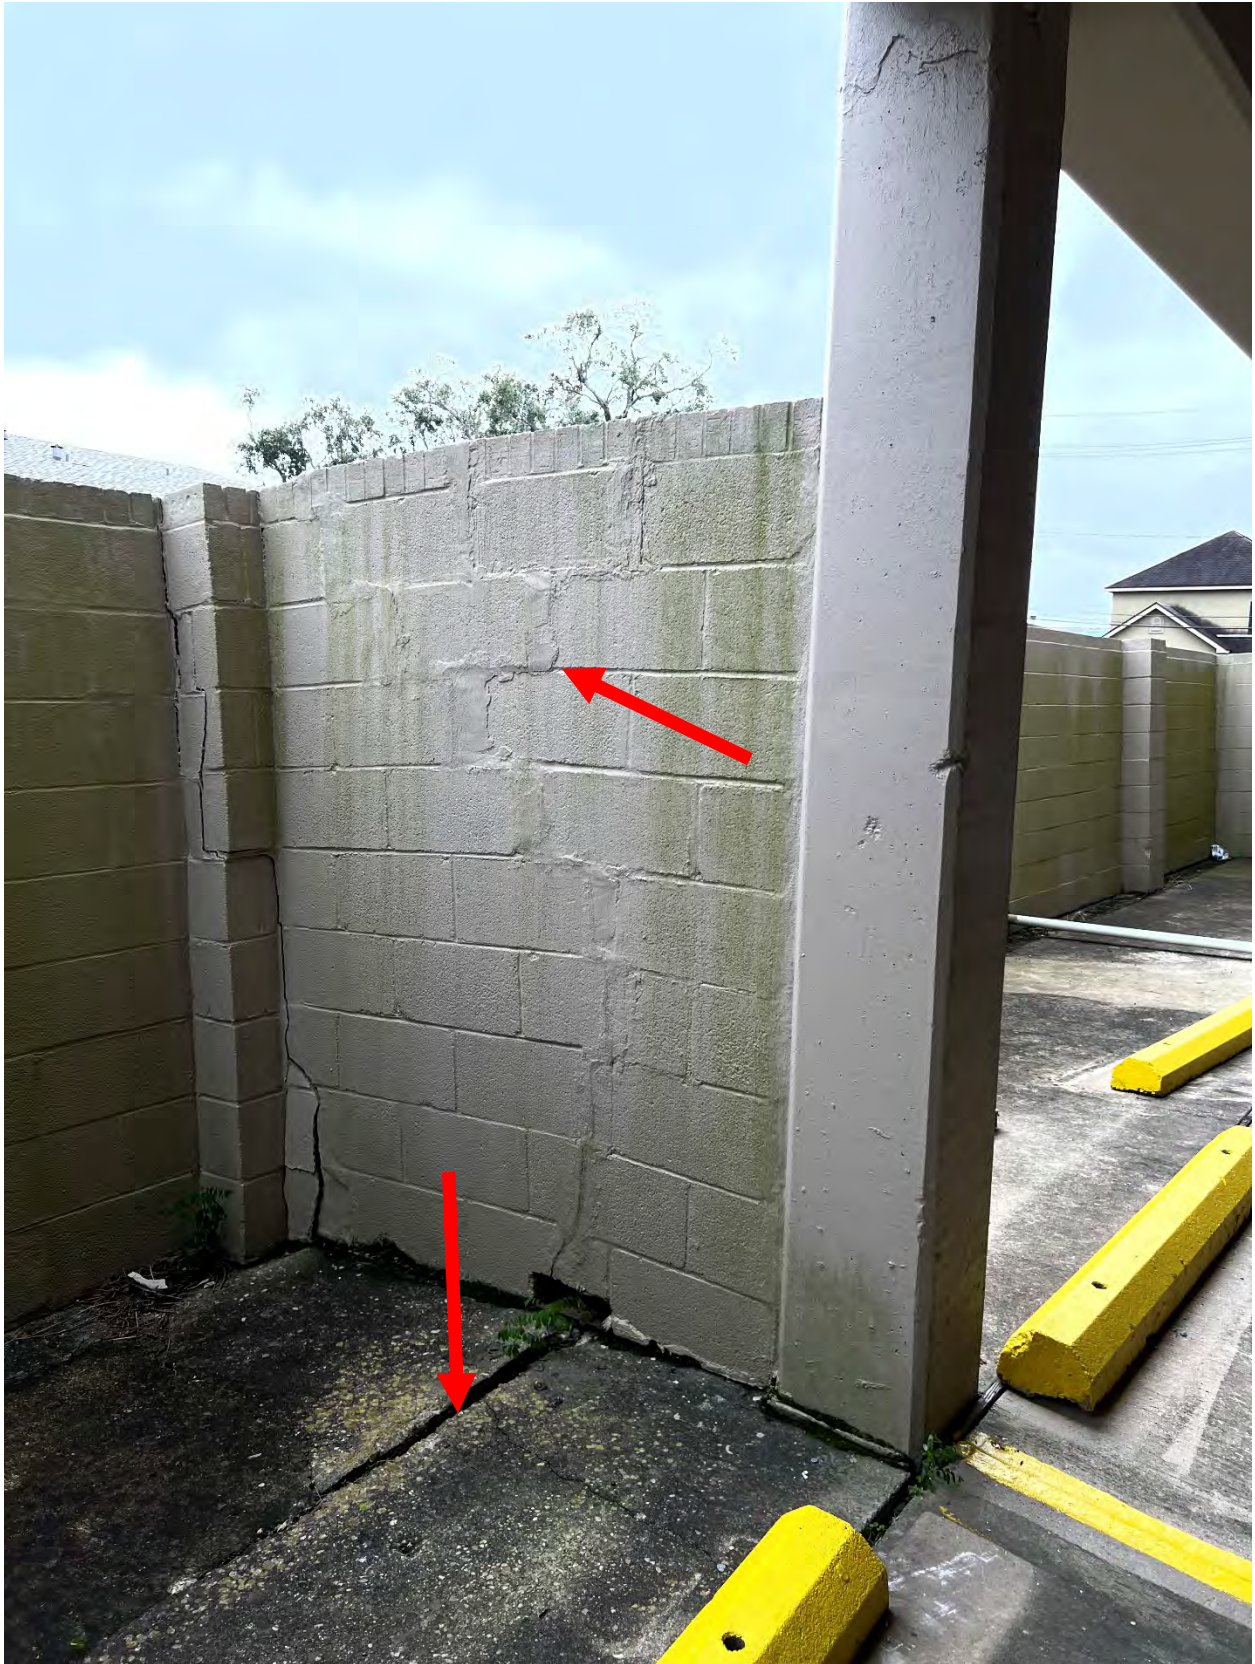
Photo #10 – View of CMU enclosure wall exhibiting settlement issues.

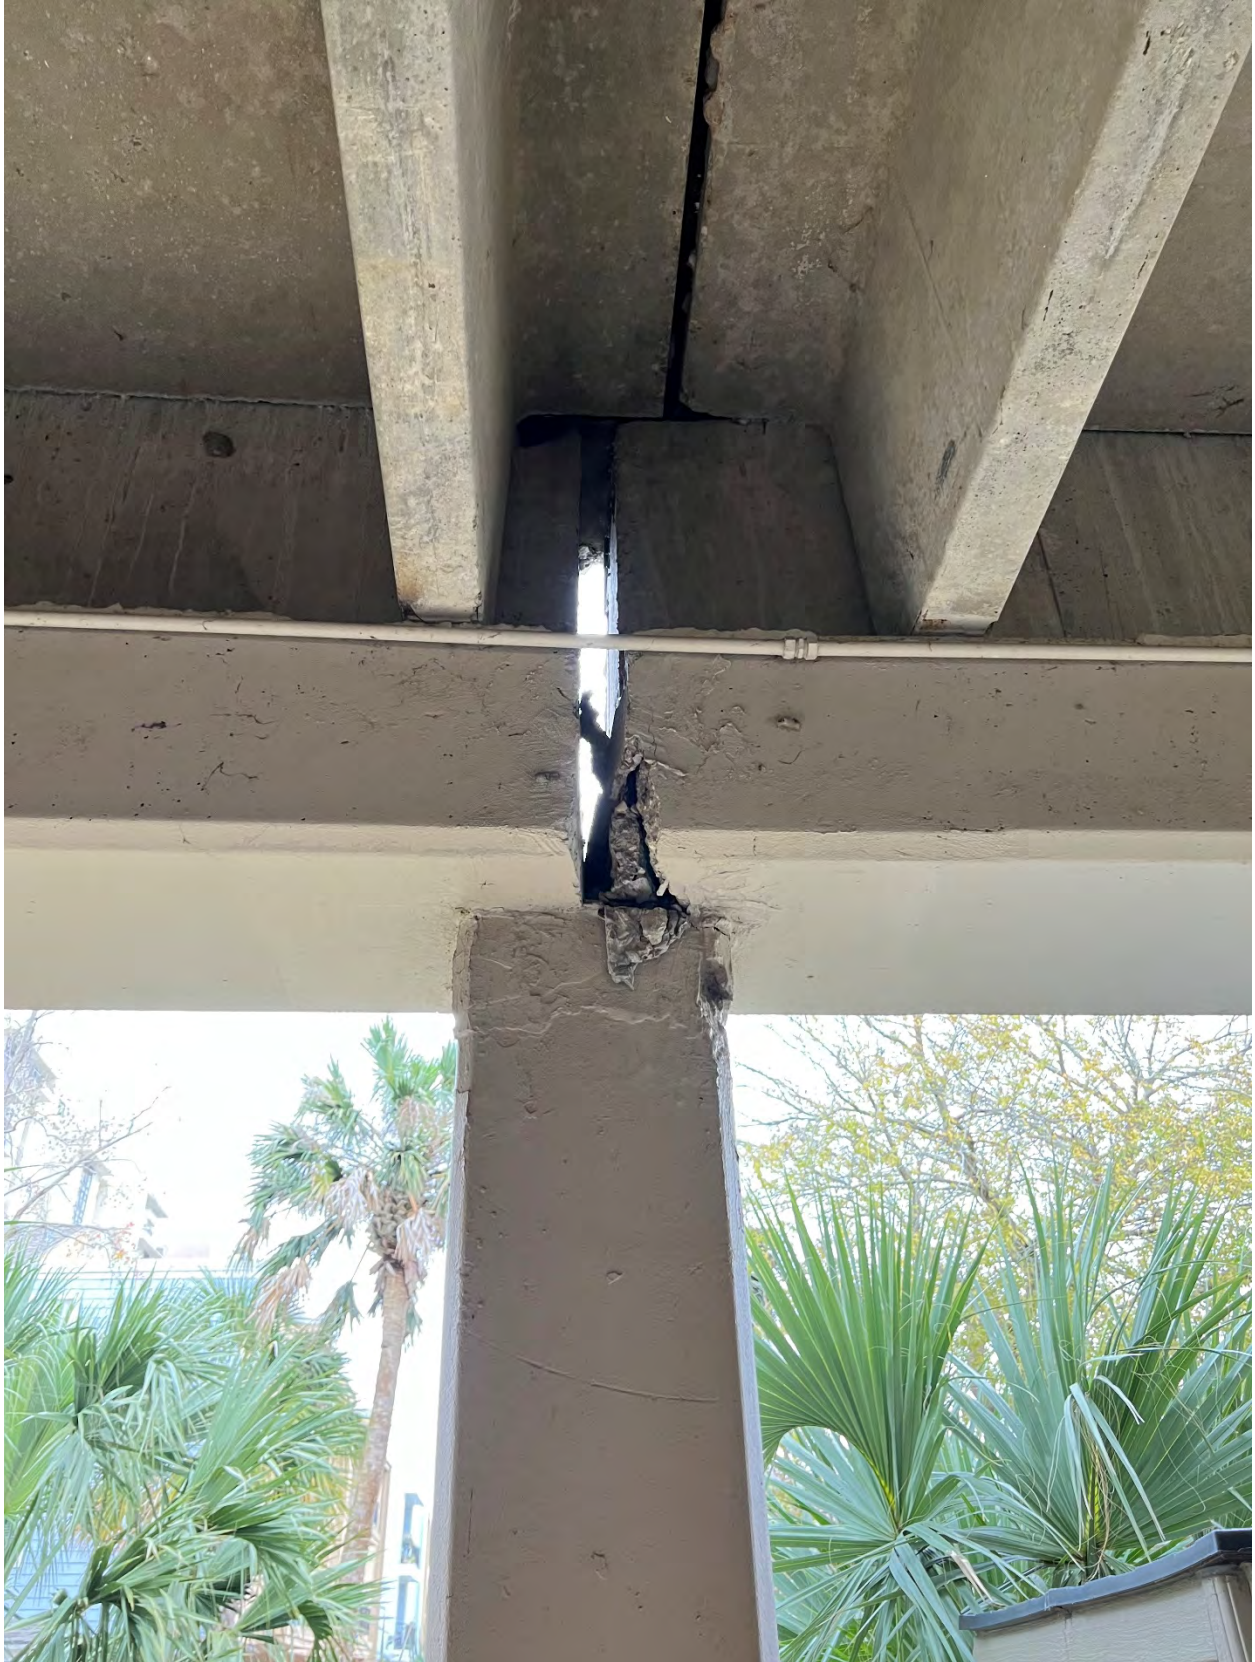
Photo #11 – Column 1 of 2 where shoring is required. 10th column from N-E corner.
