APPENDIX

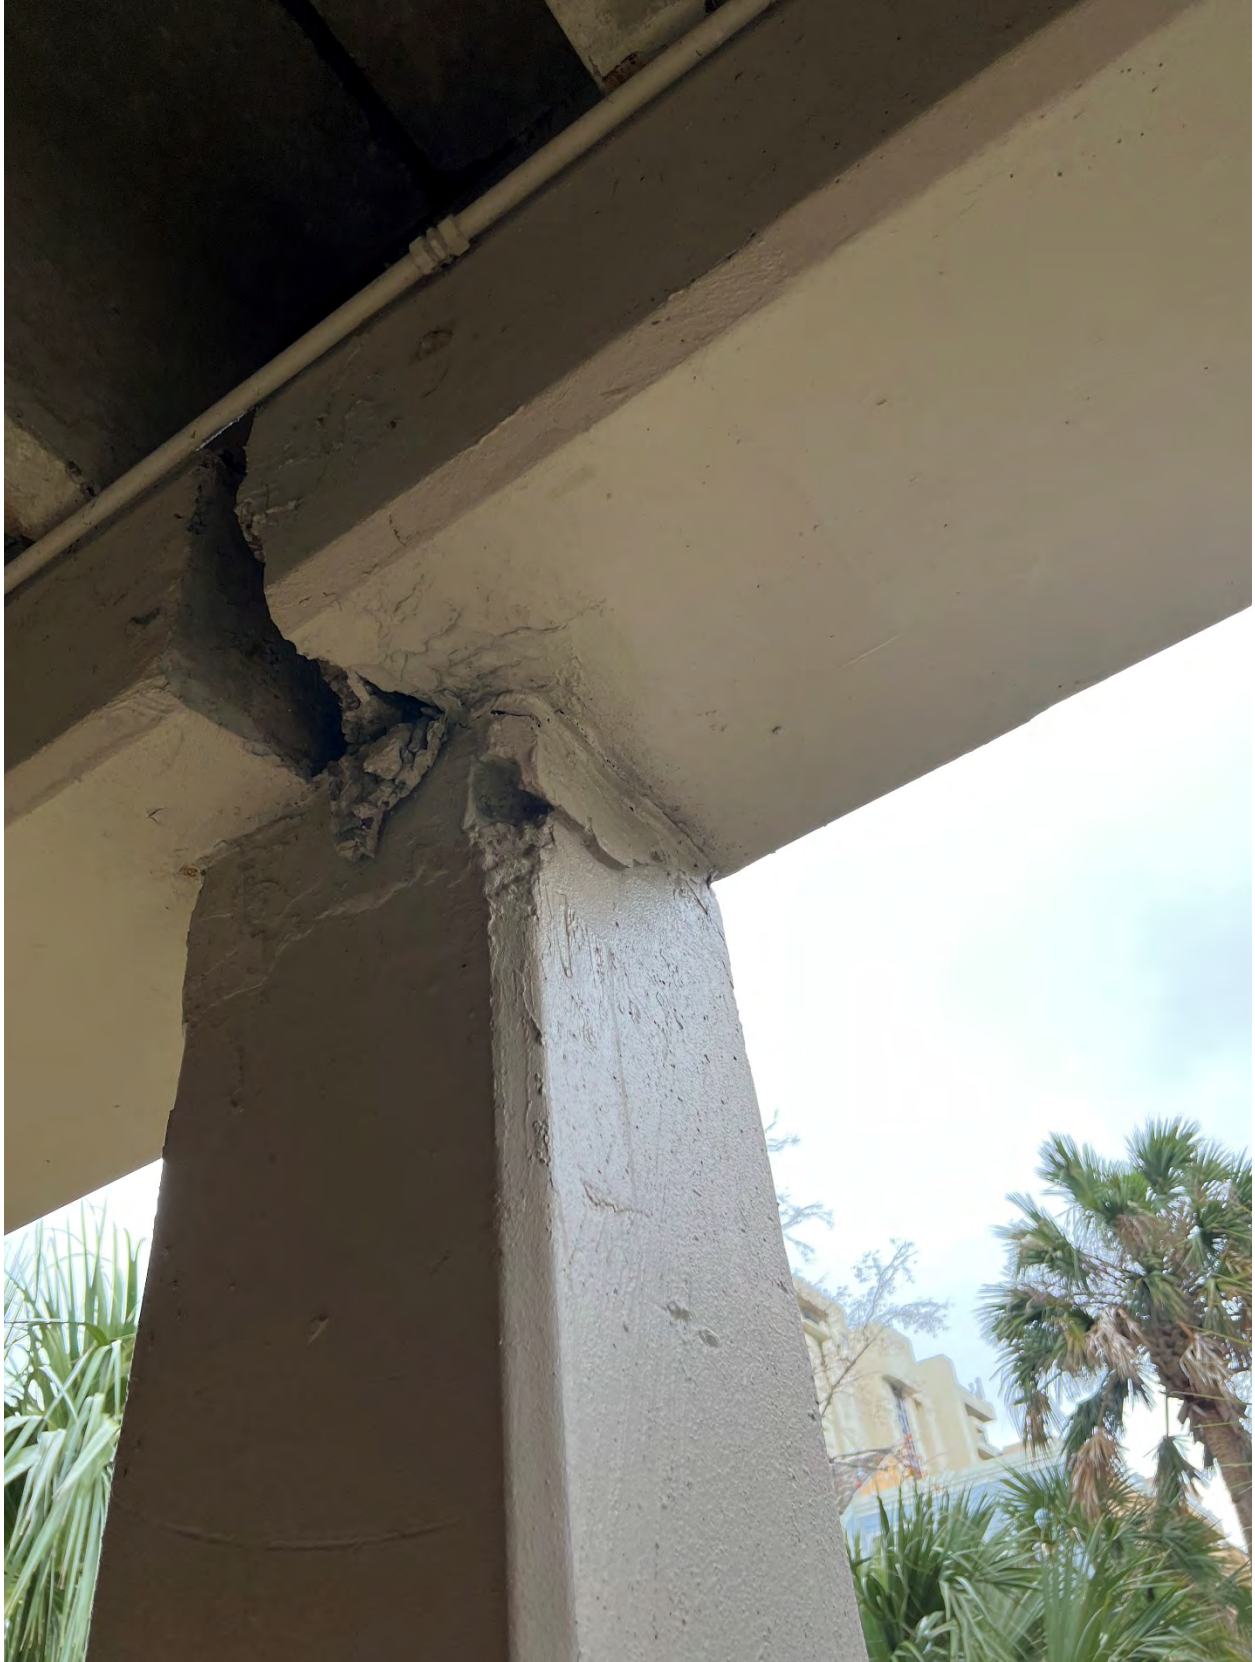
Photo #12 – Close up view of column in photo #11 showing minimal beam support.

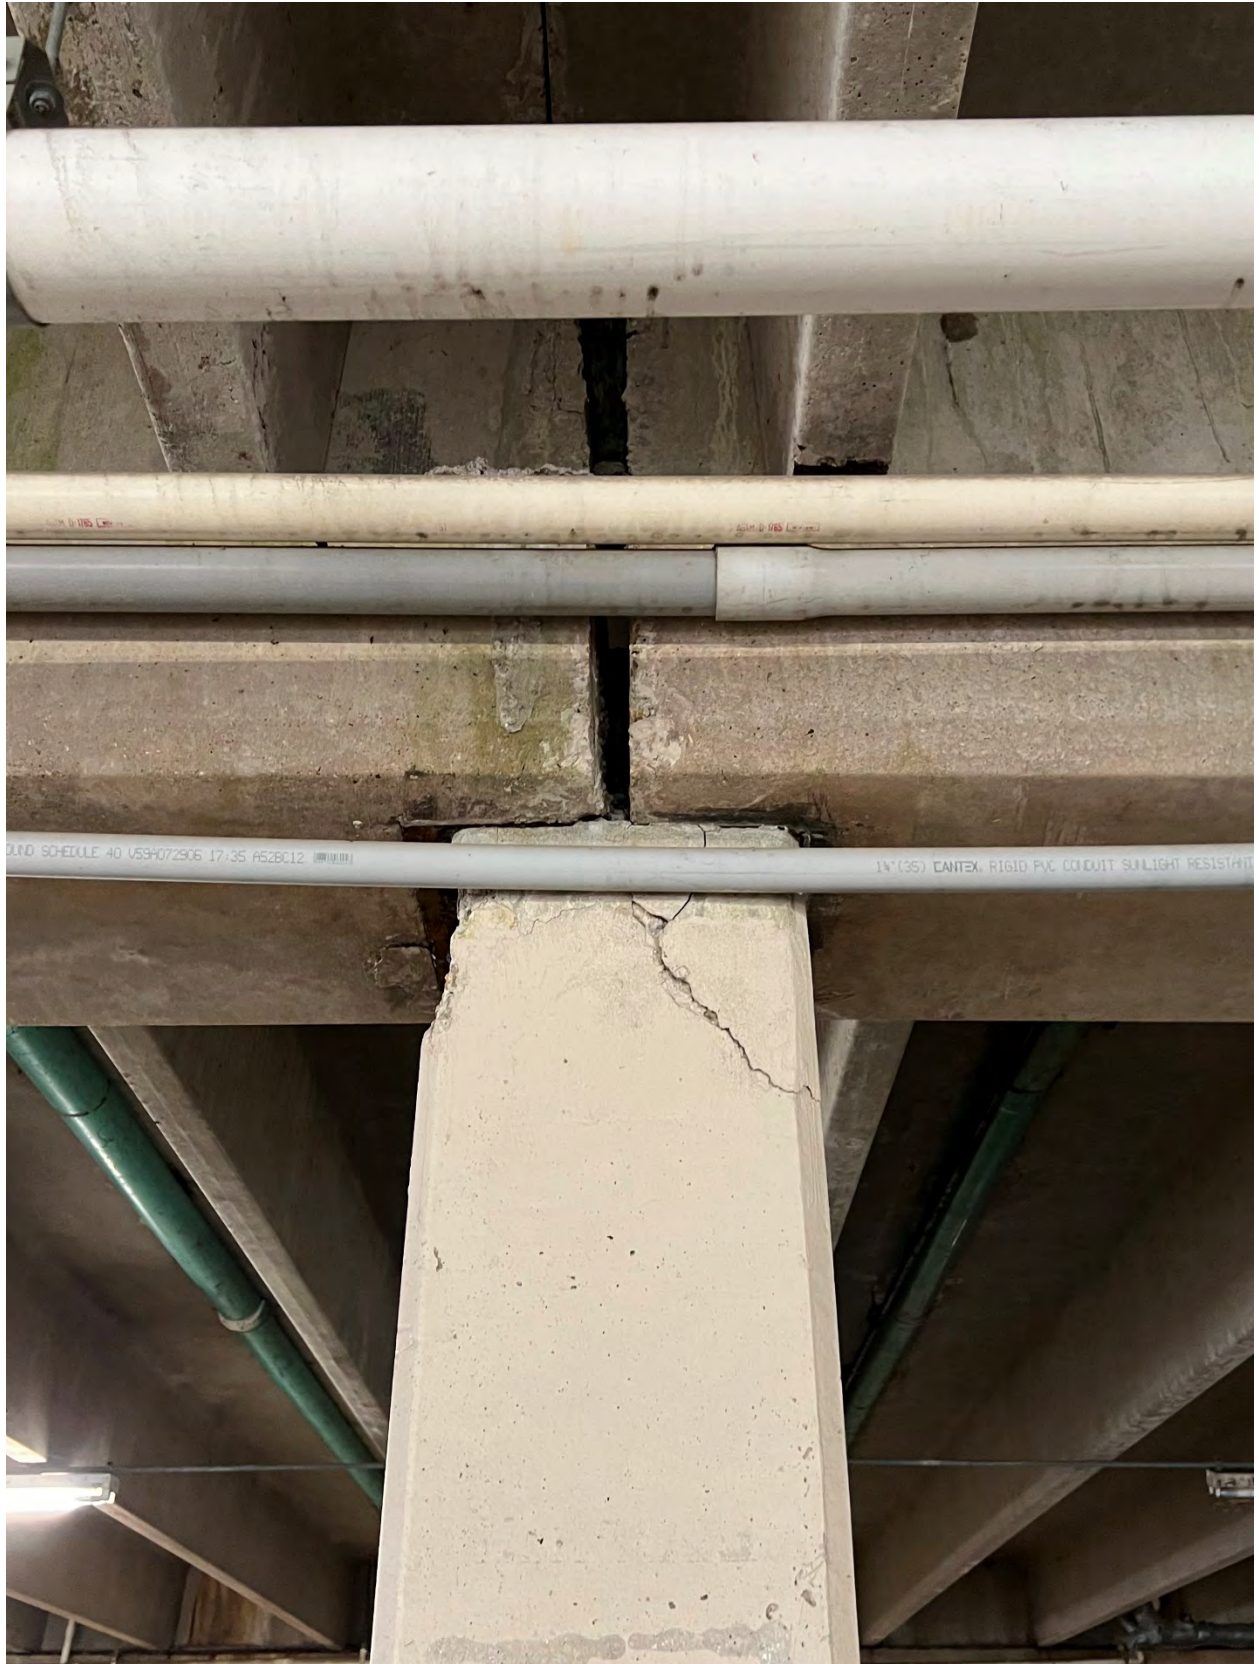
Photo #13 – Column 2 of 2 where shoring is required. 12th column from N-E corner at 1st interior bay.

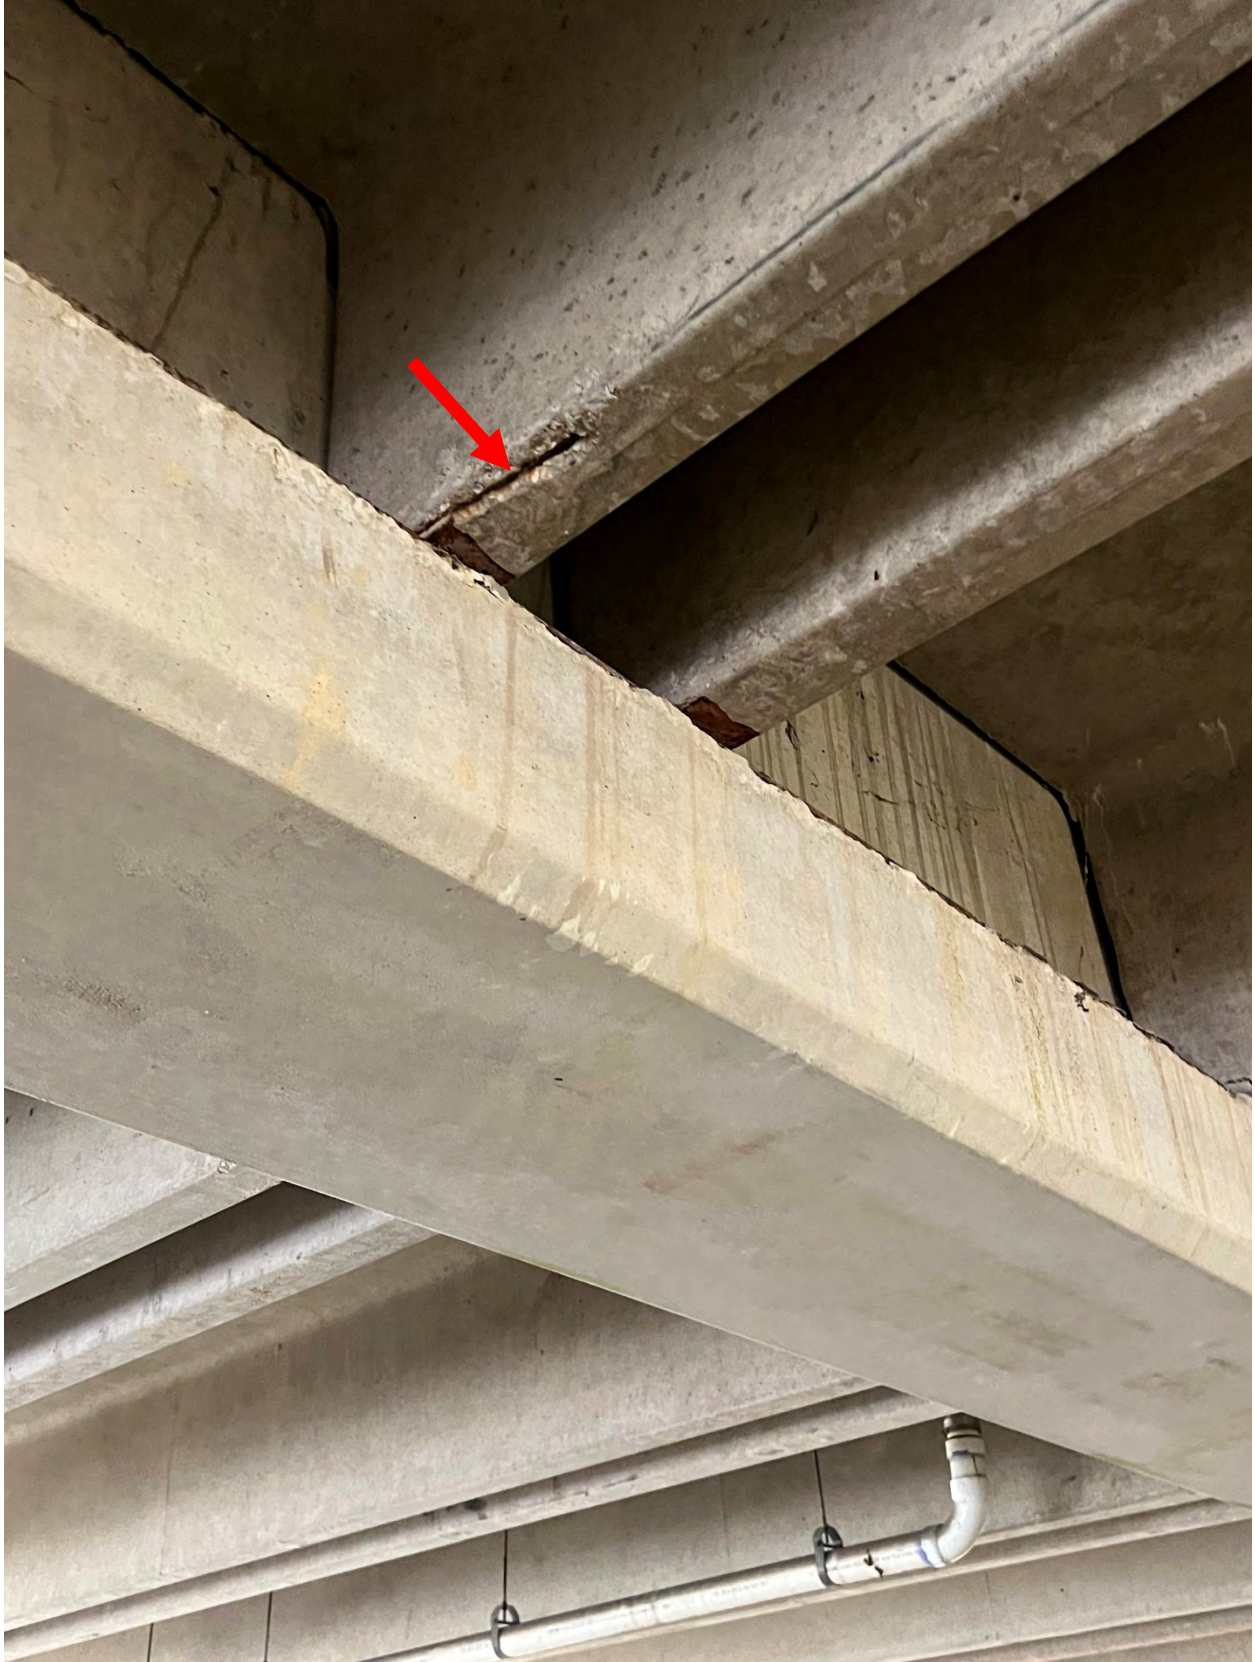
Photo #14 – View of typical corrosion at precast double Tee ends.

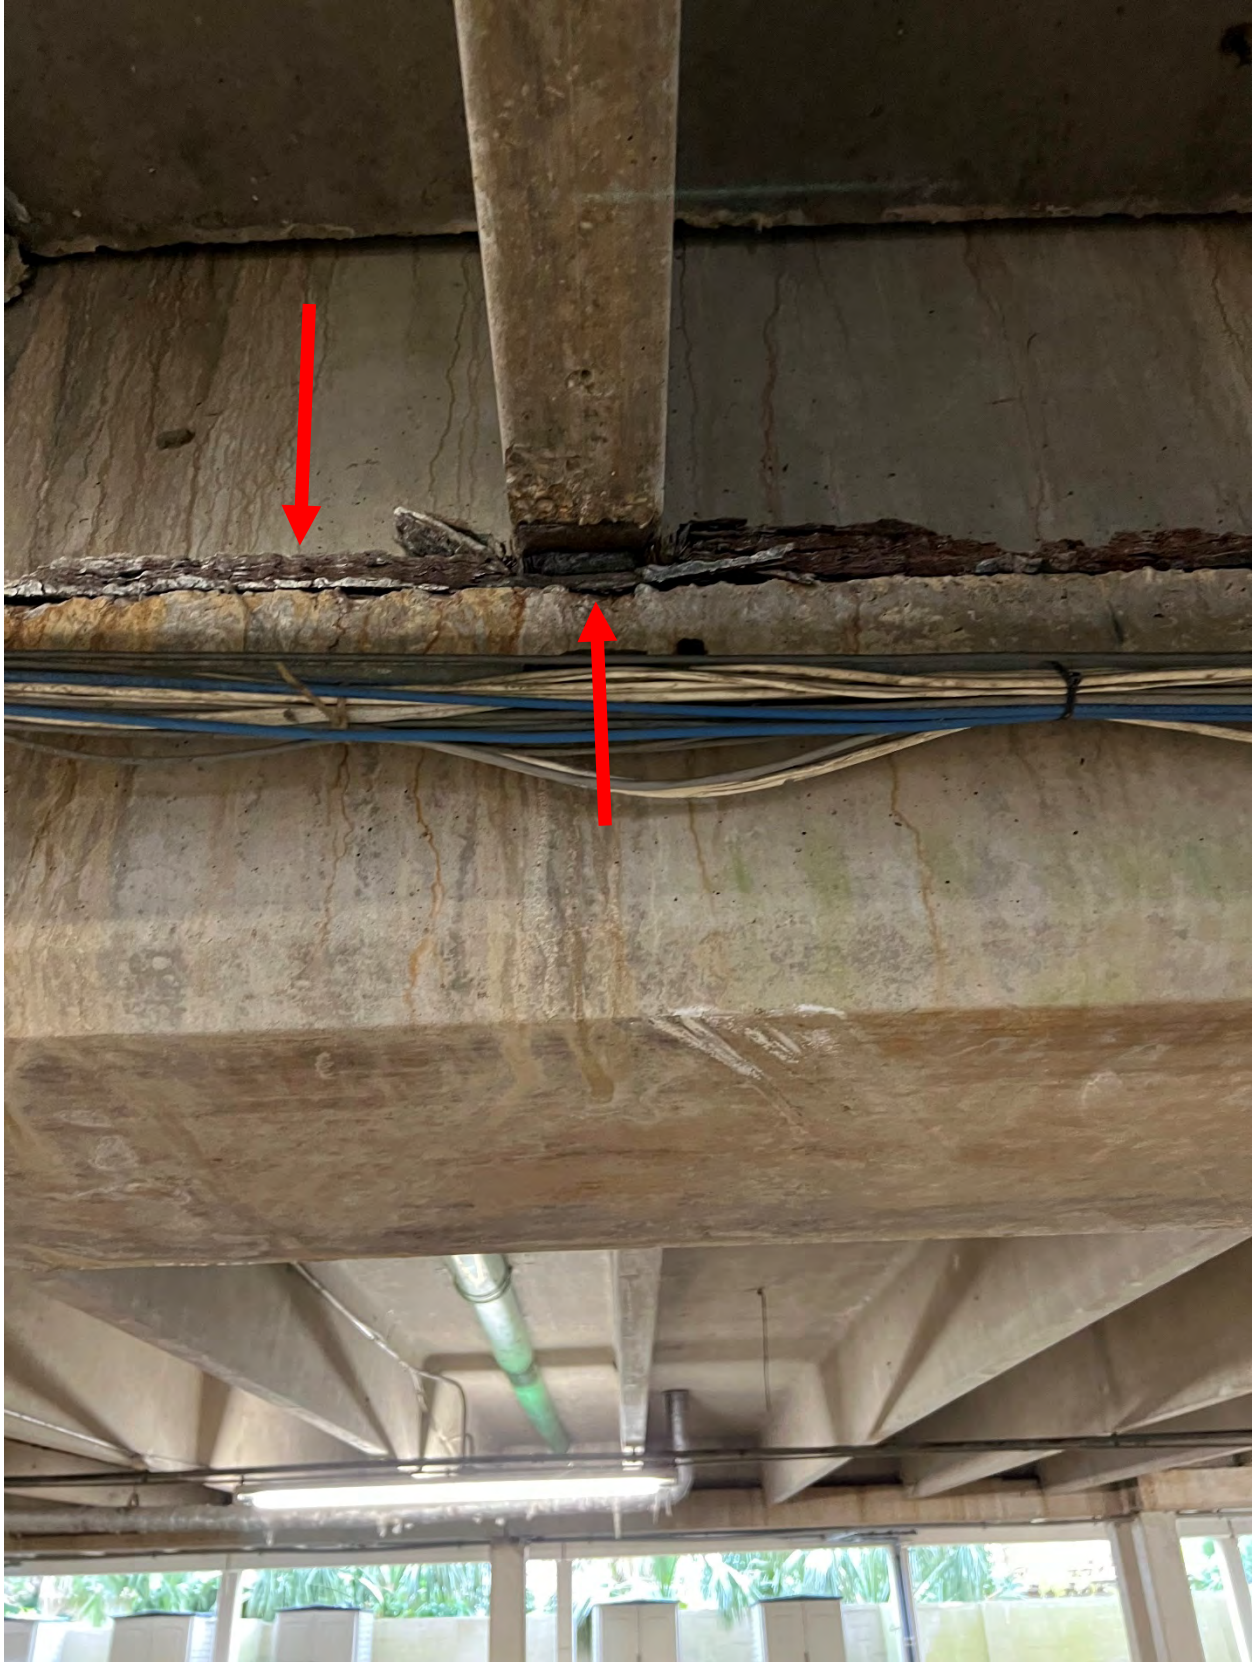
Photo #15 – View of extreme corrosion at double Tee steel bearing angle.

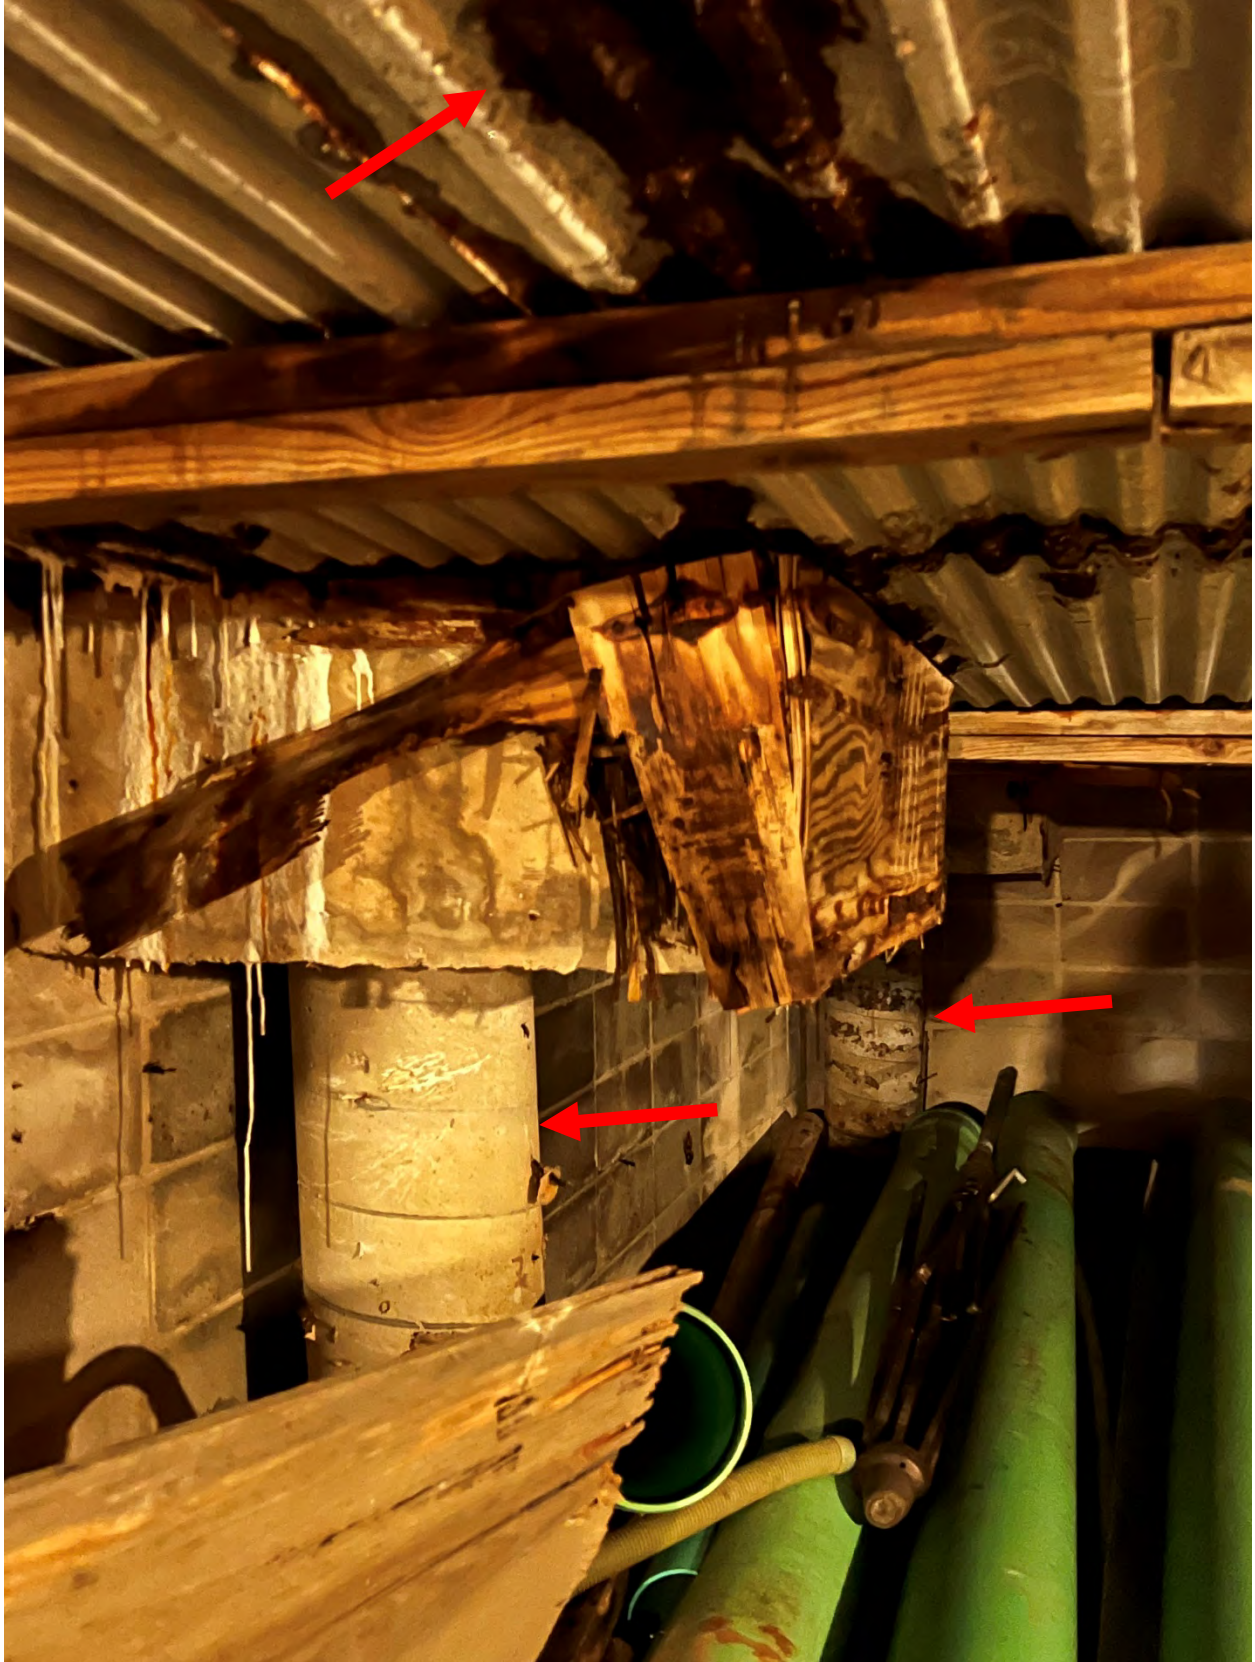
Photo #16 – View of typical deck corrosion at pool support structure. Piles visible in photo.

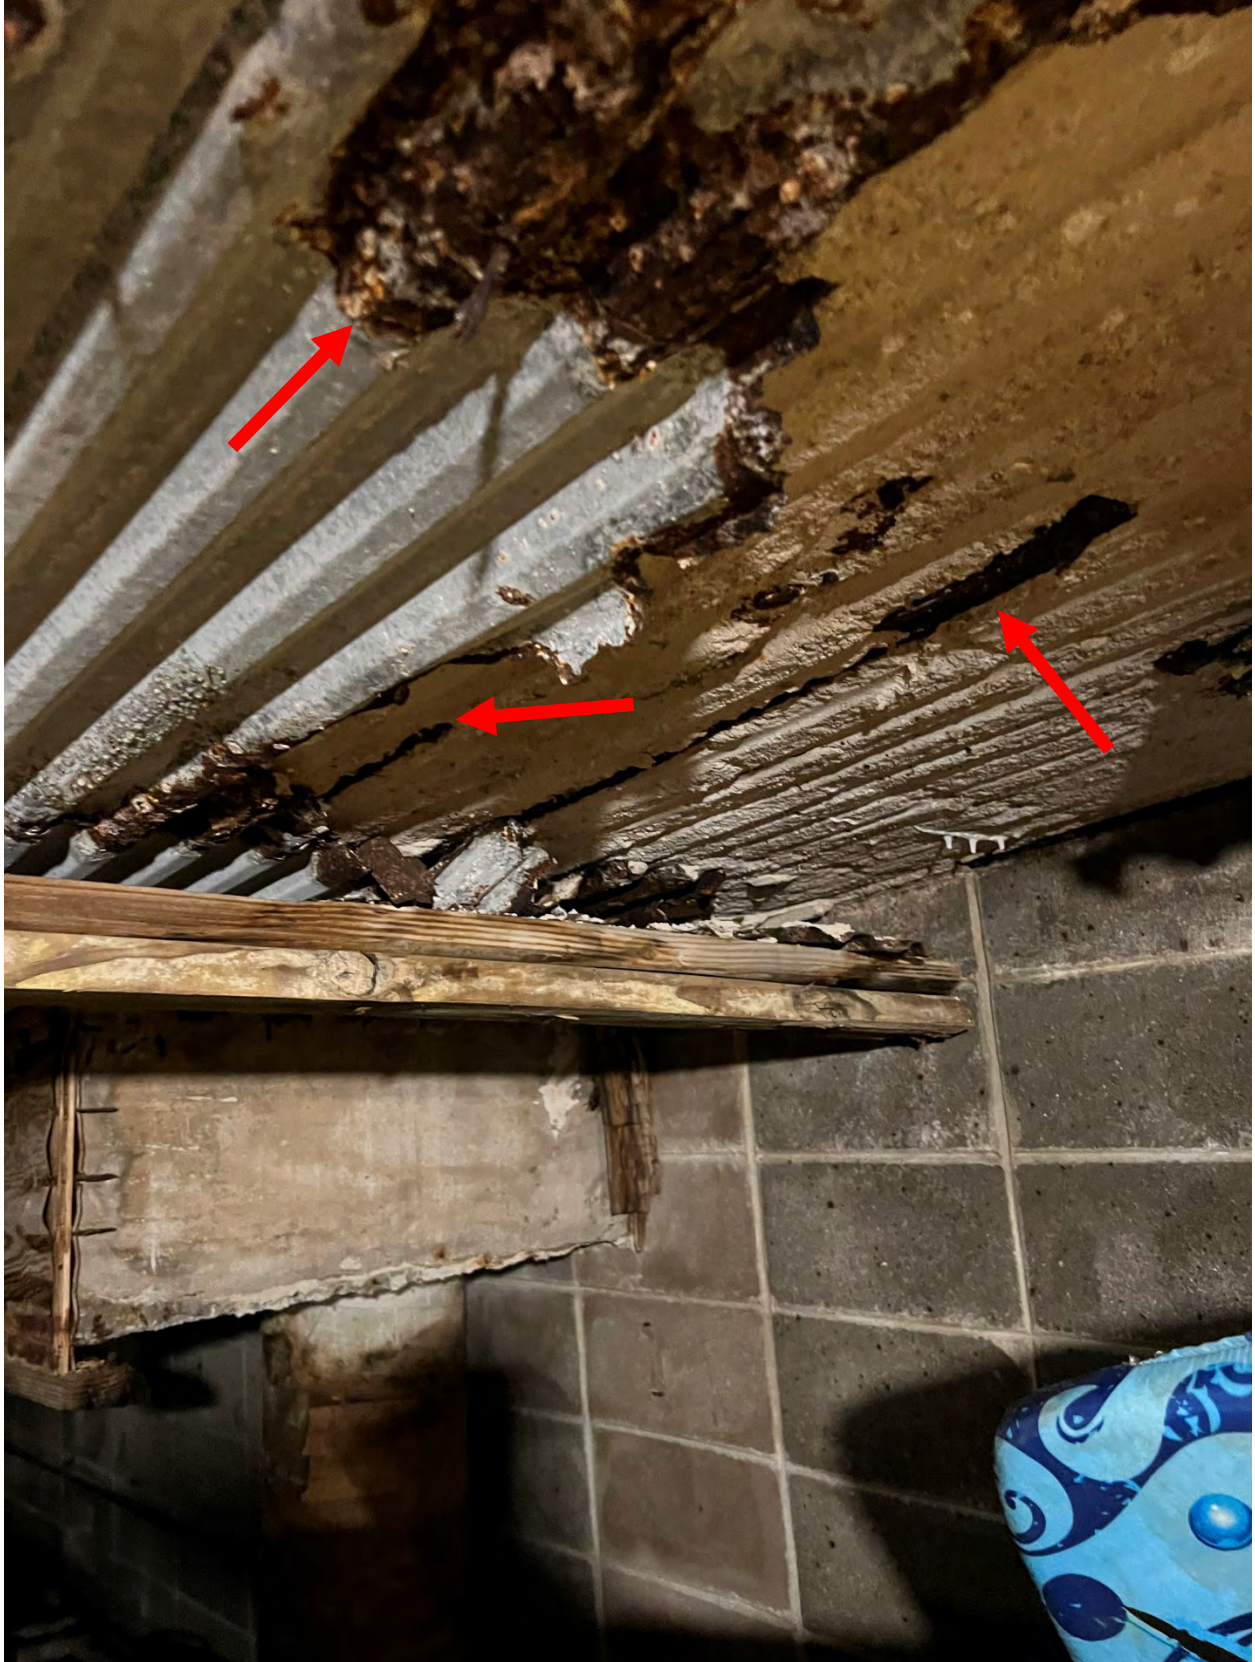
Photo #17 – View of exposed slab reinforcing and metal decking exhibiting severe corrosion.

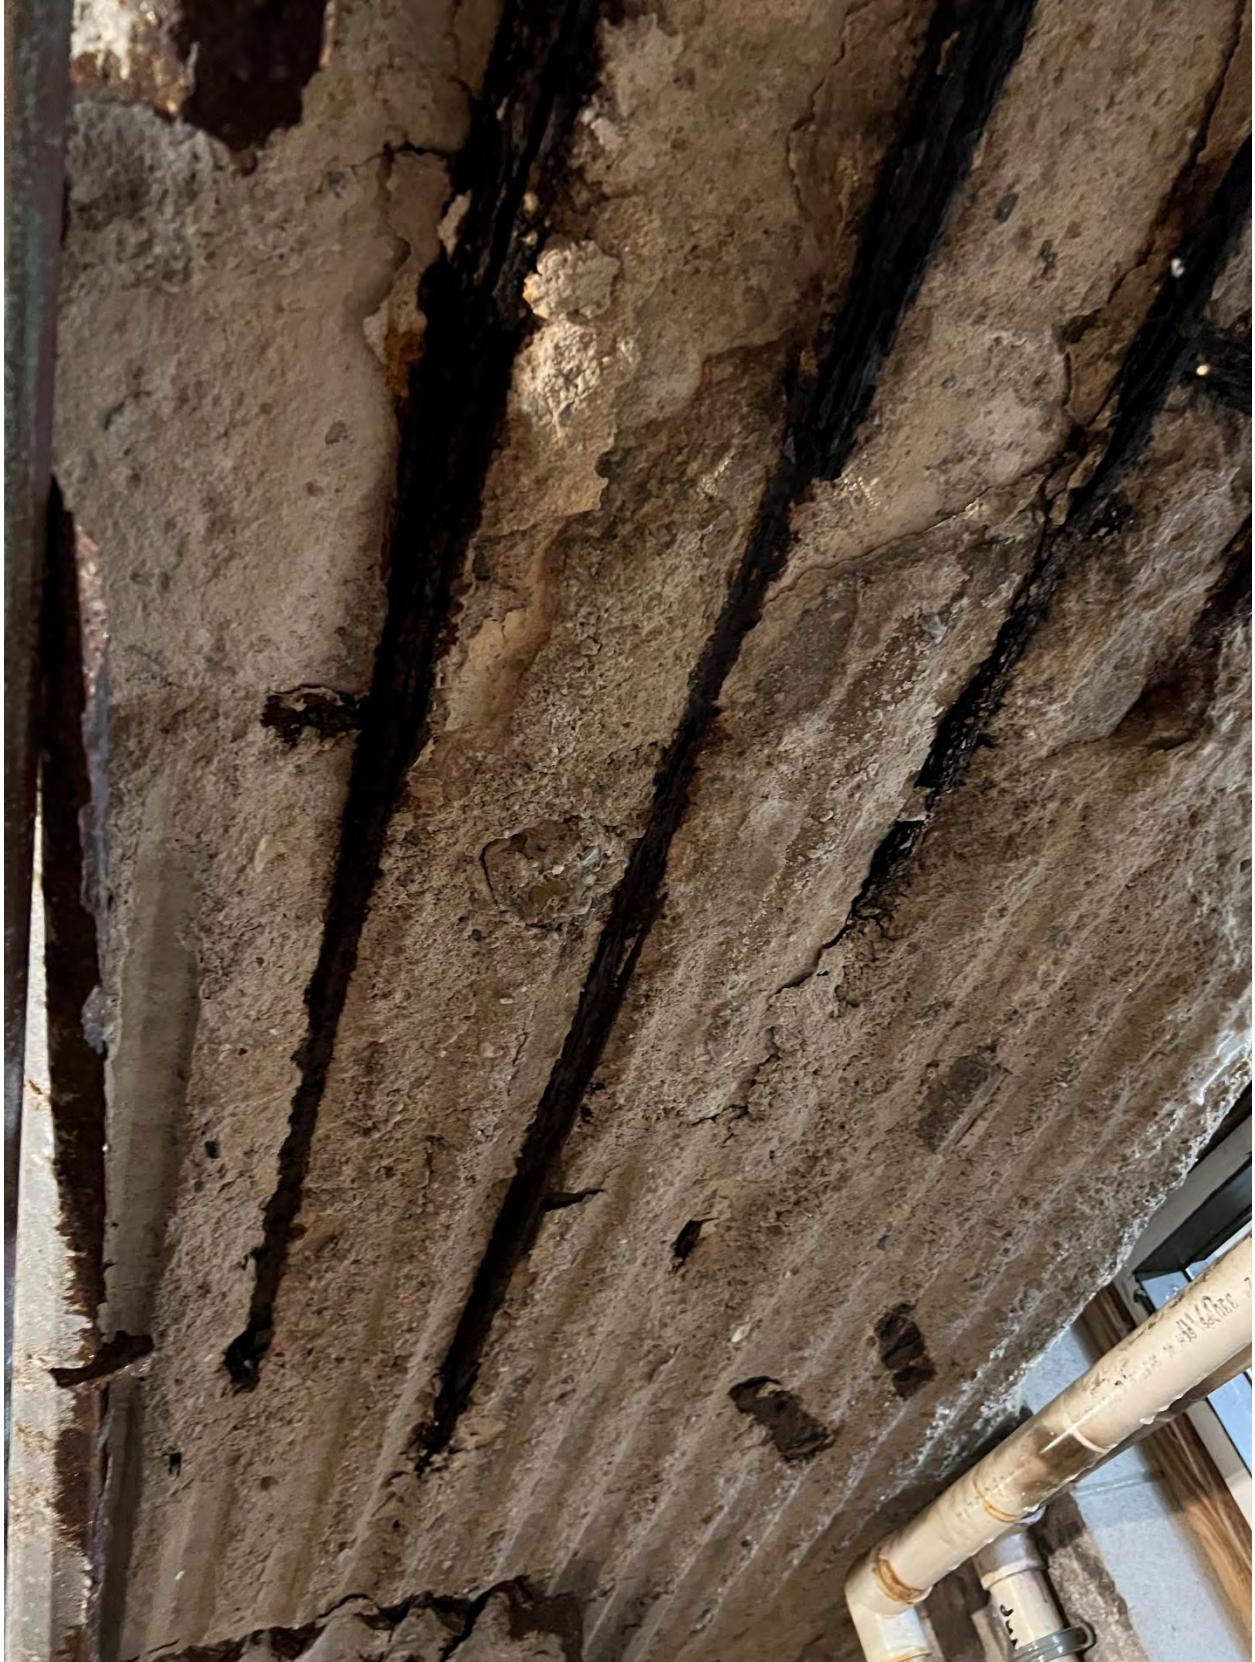
Photo #18 – Close-up view of corroded reinforcing showing signs of significant loss of section

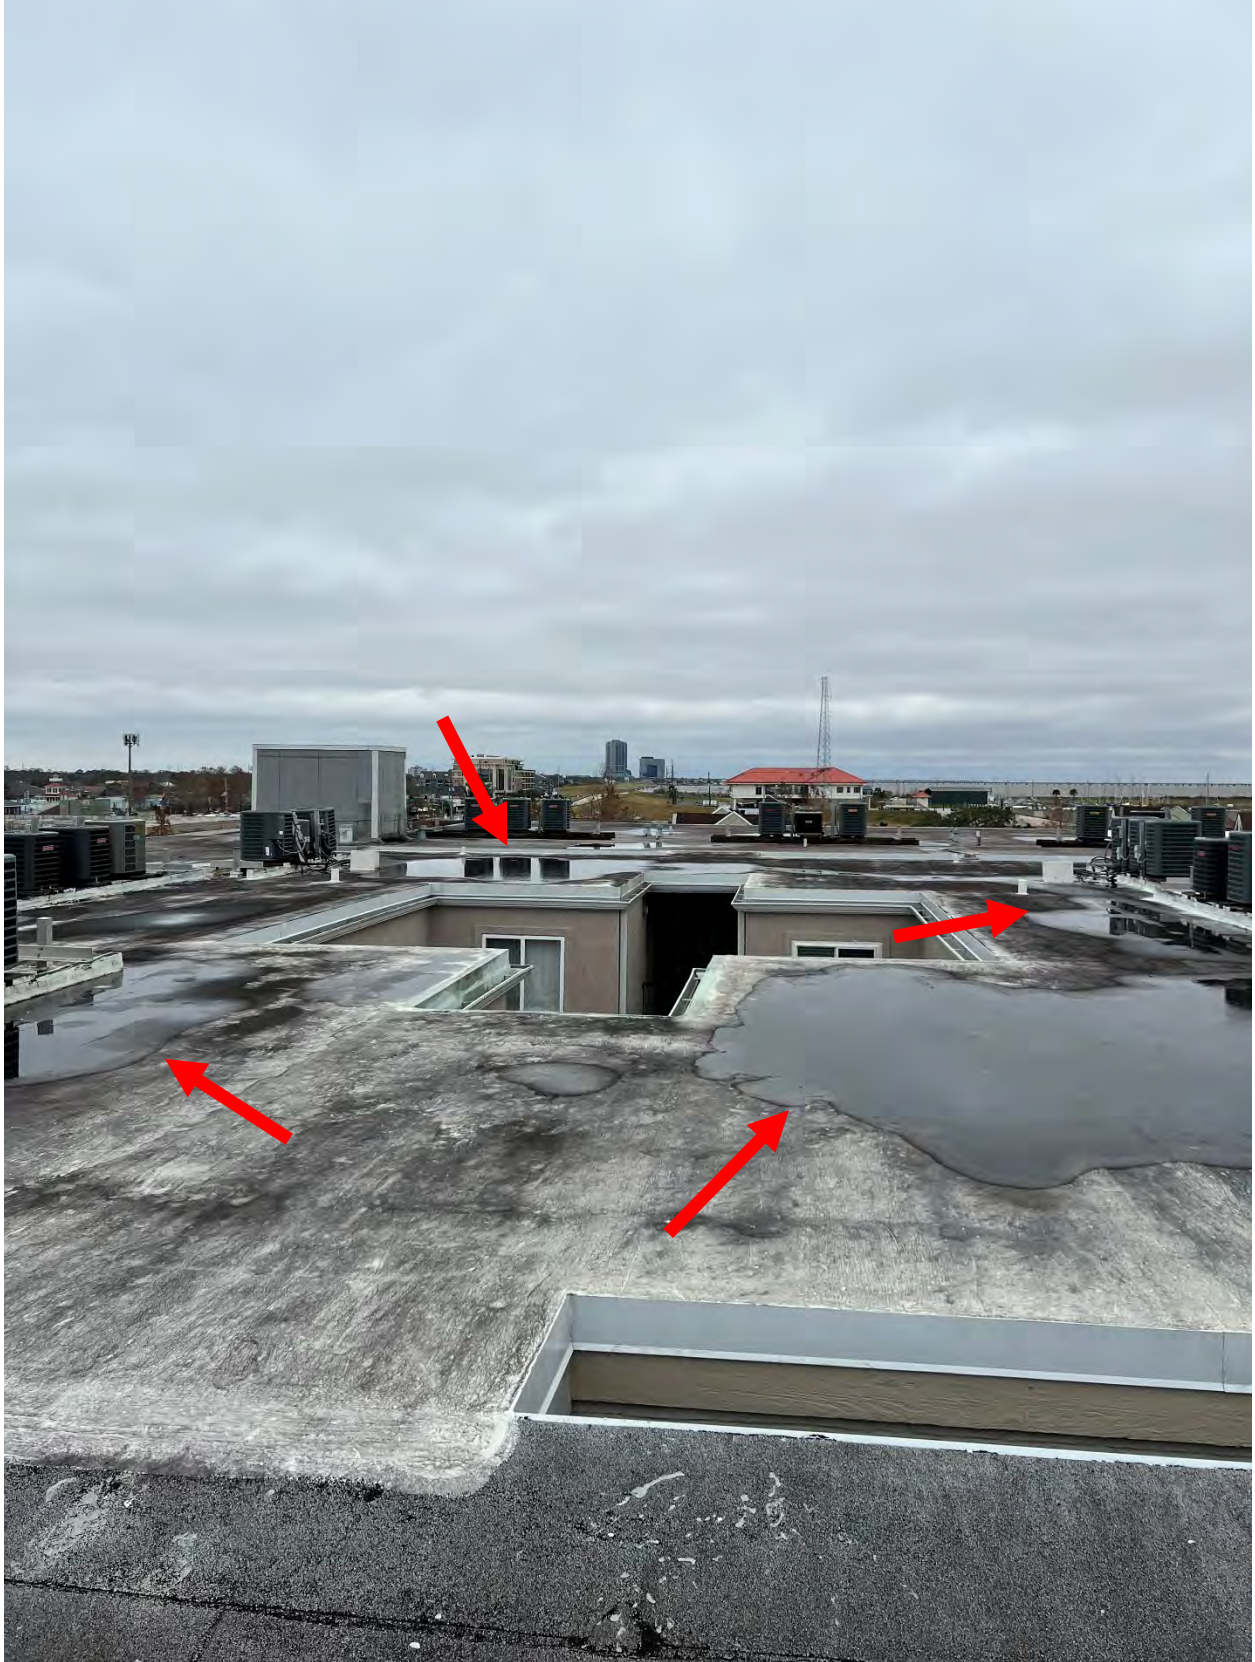
Photo #19 – View of typical ponding at roof.

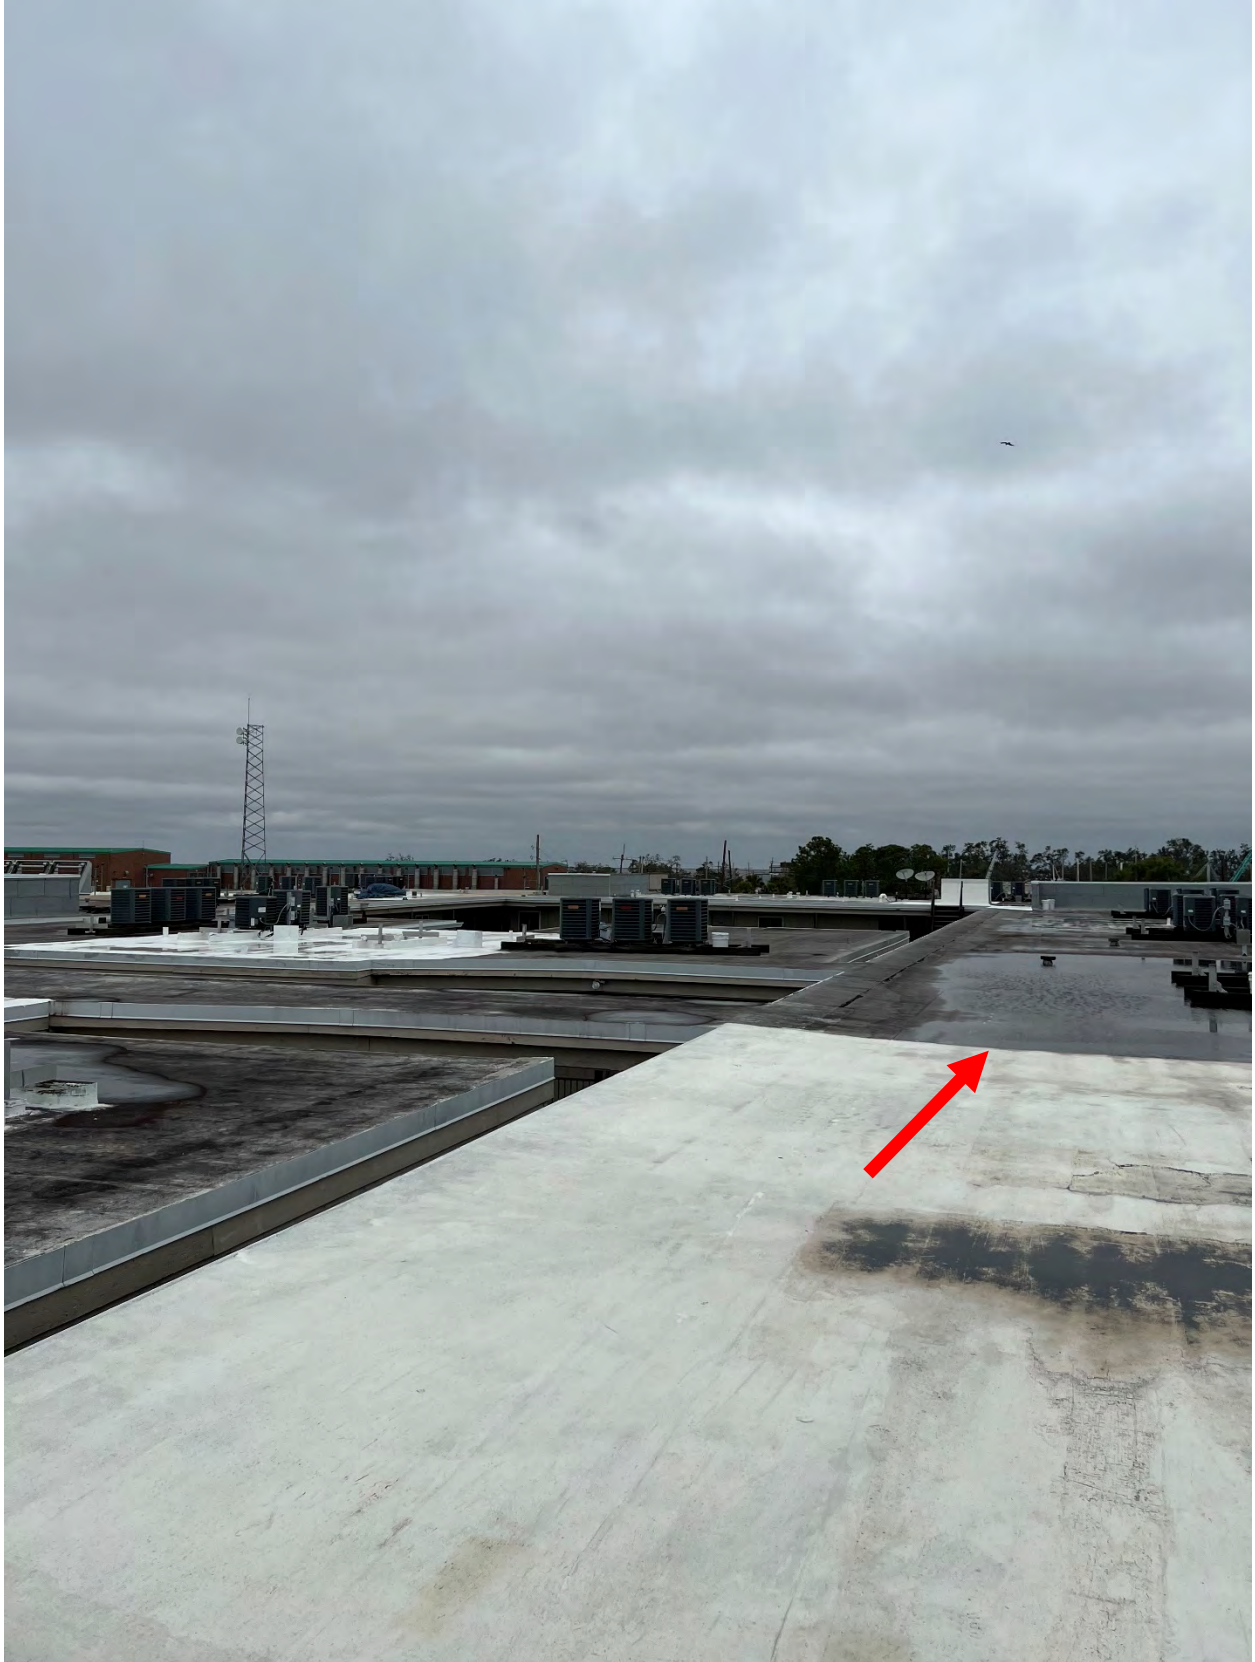
Photo #20 – View of typical ponding at roof.

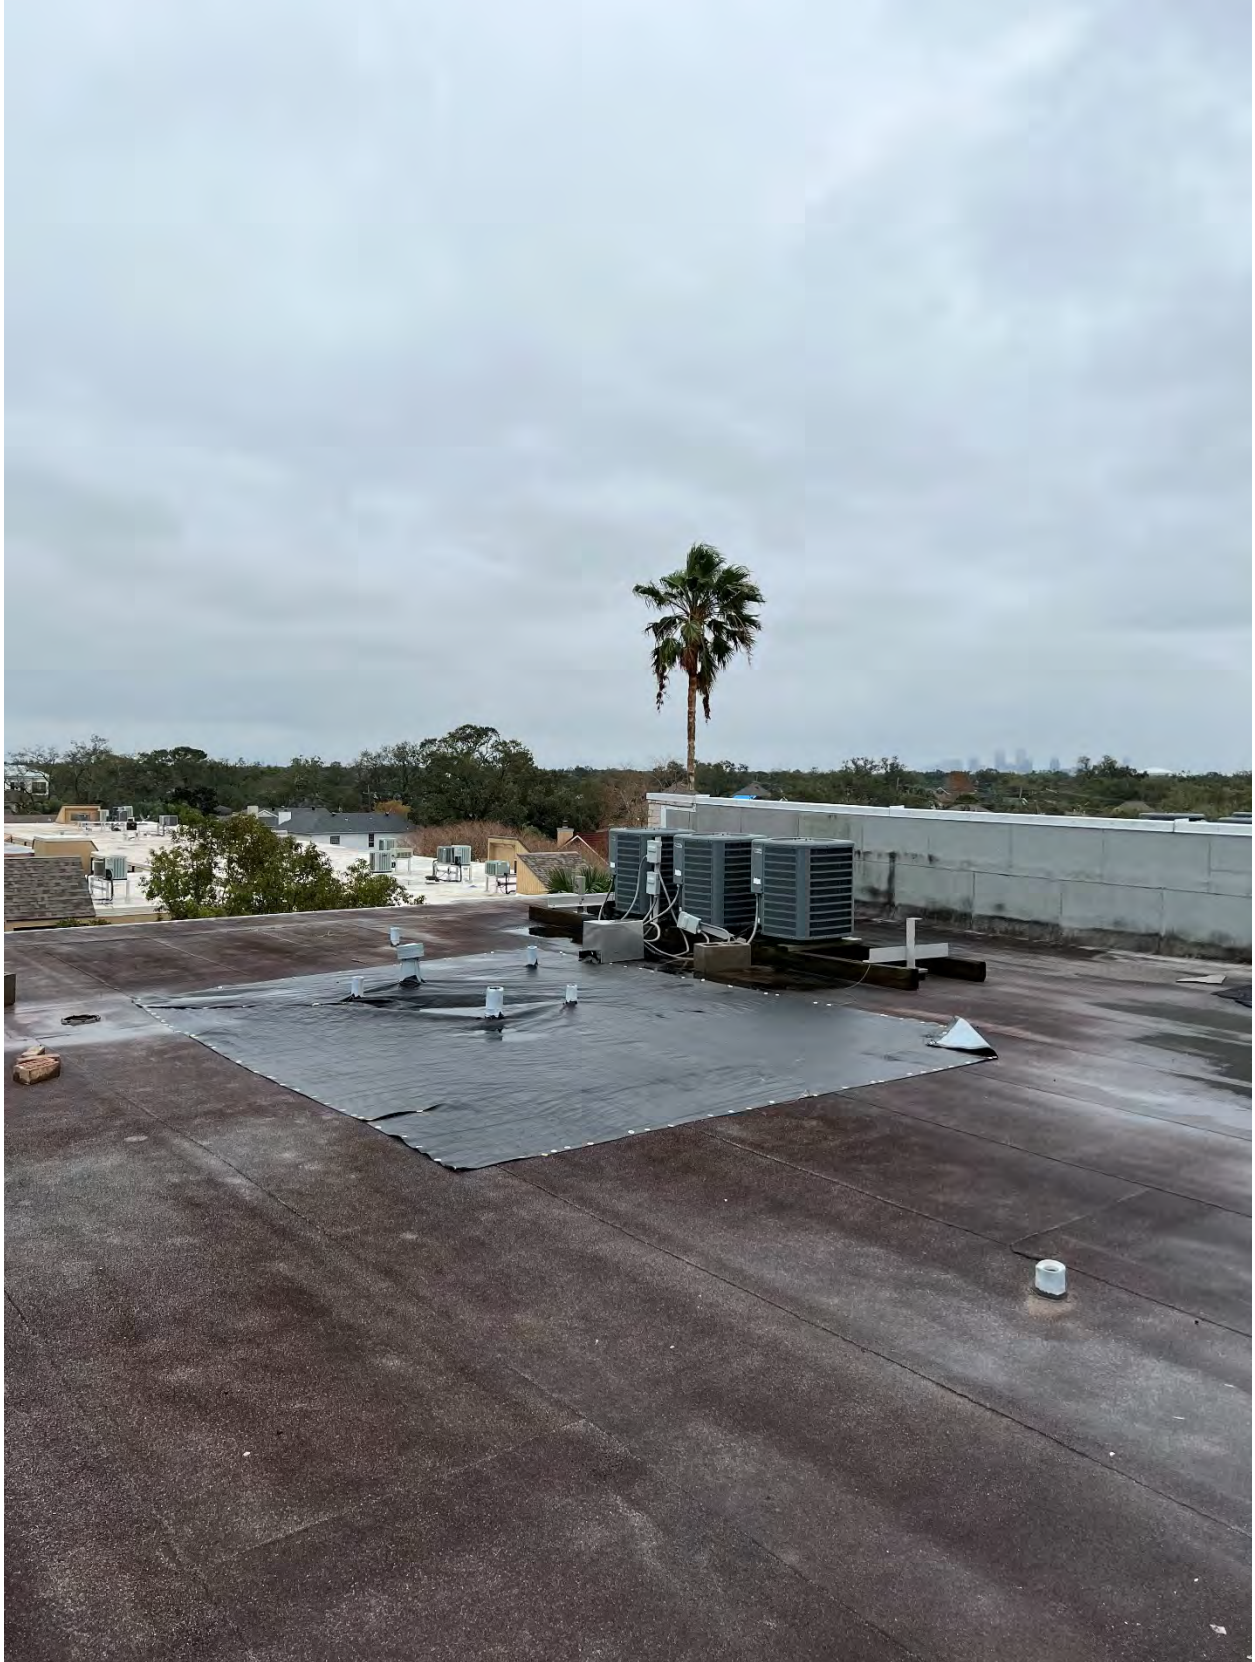
Photo #21 – View of tarped roof area presumably the result of hurricane related wind damage.

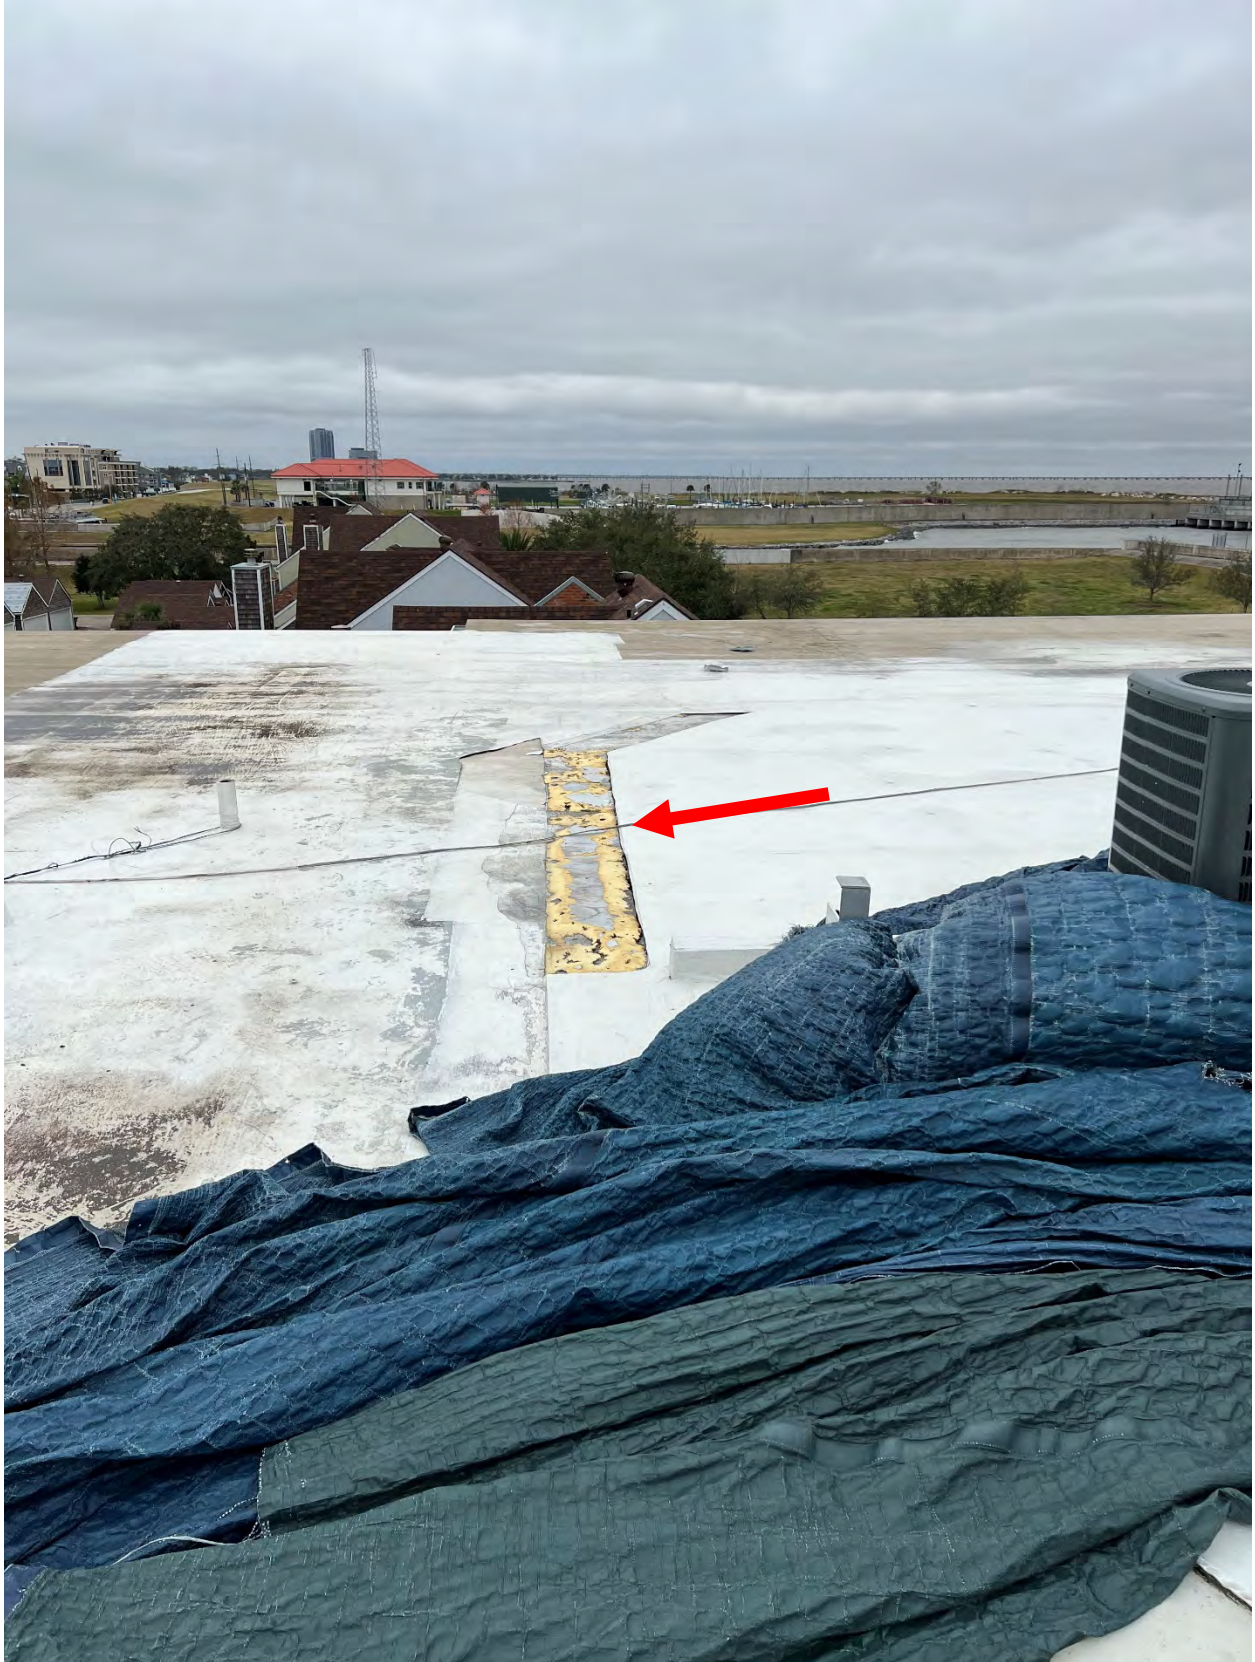
Photo #22 - View of missing roof membrane as a result of hurricane related wind damage
