APPENDIX

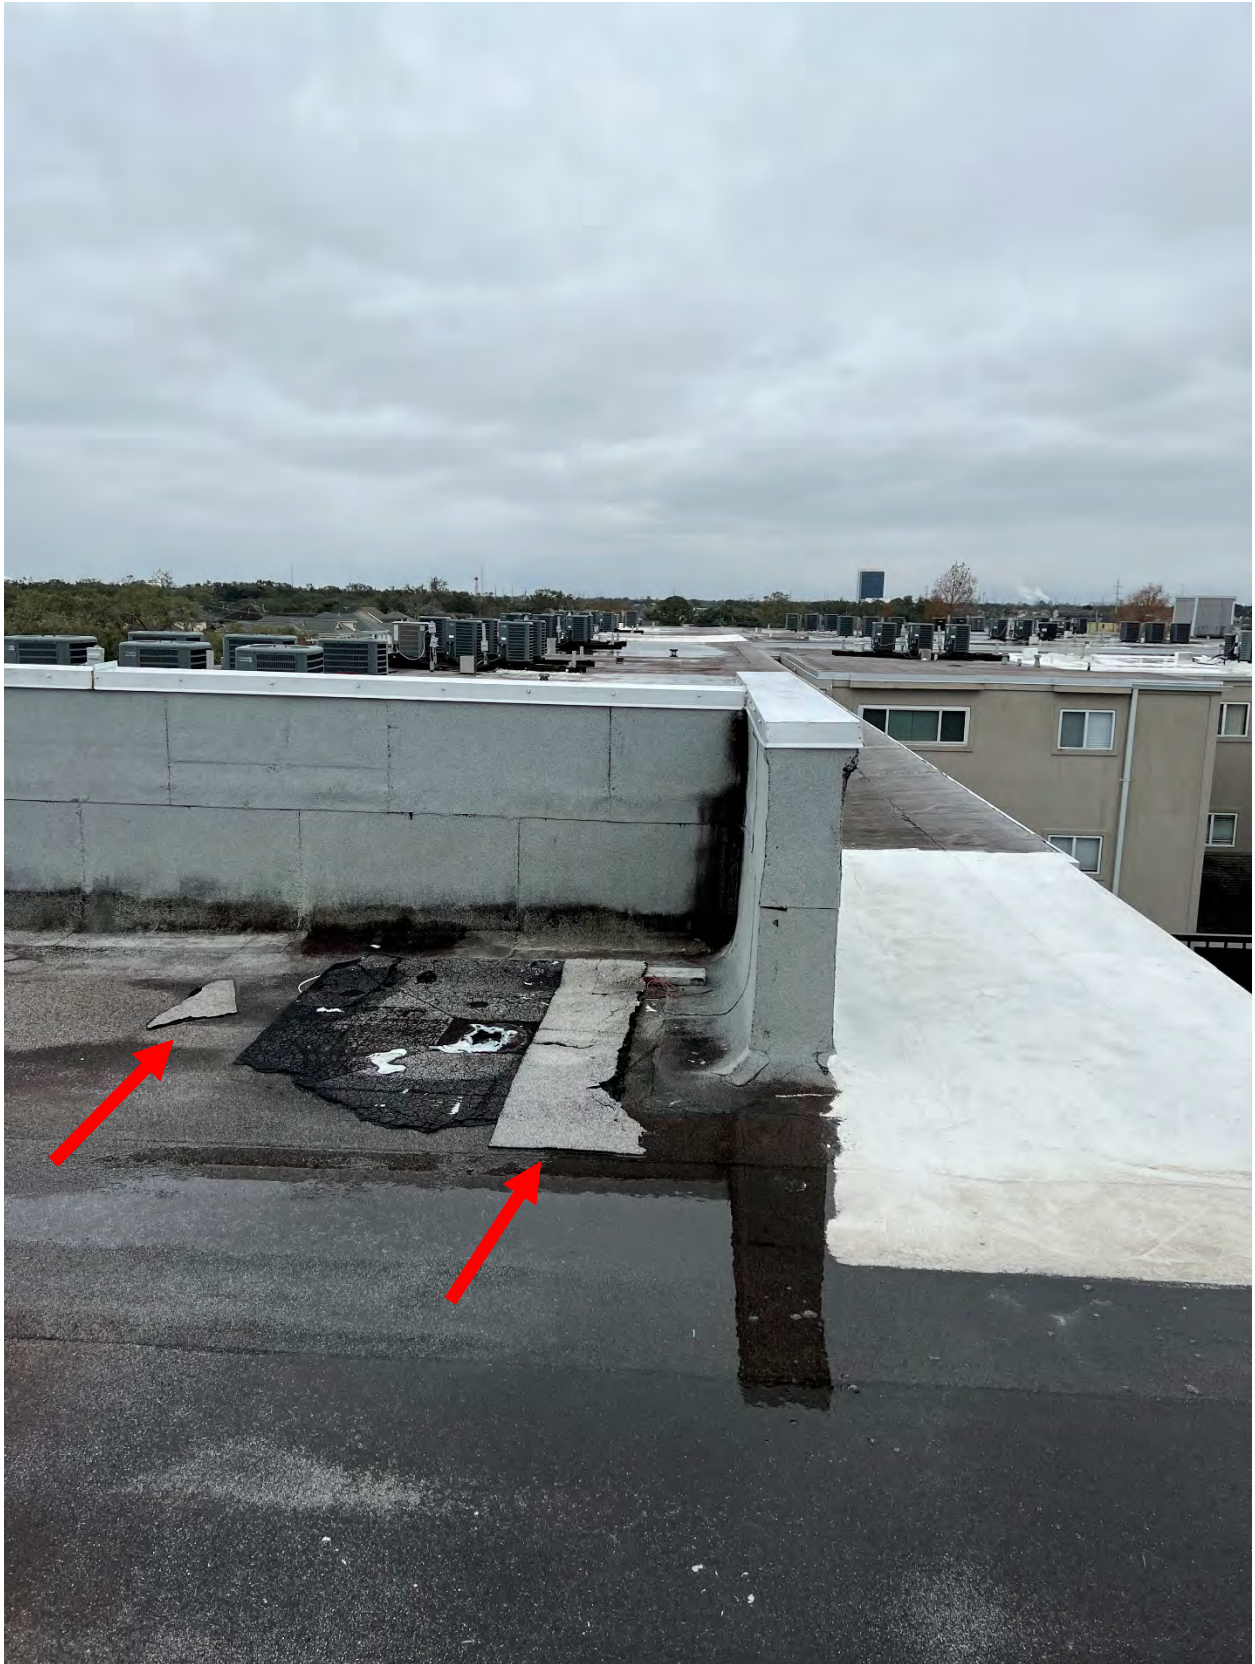
Photo #23 – View of roofing debris scattered as a result of hurricane related wind damage.

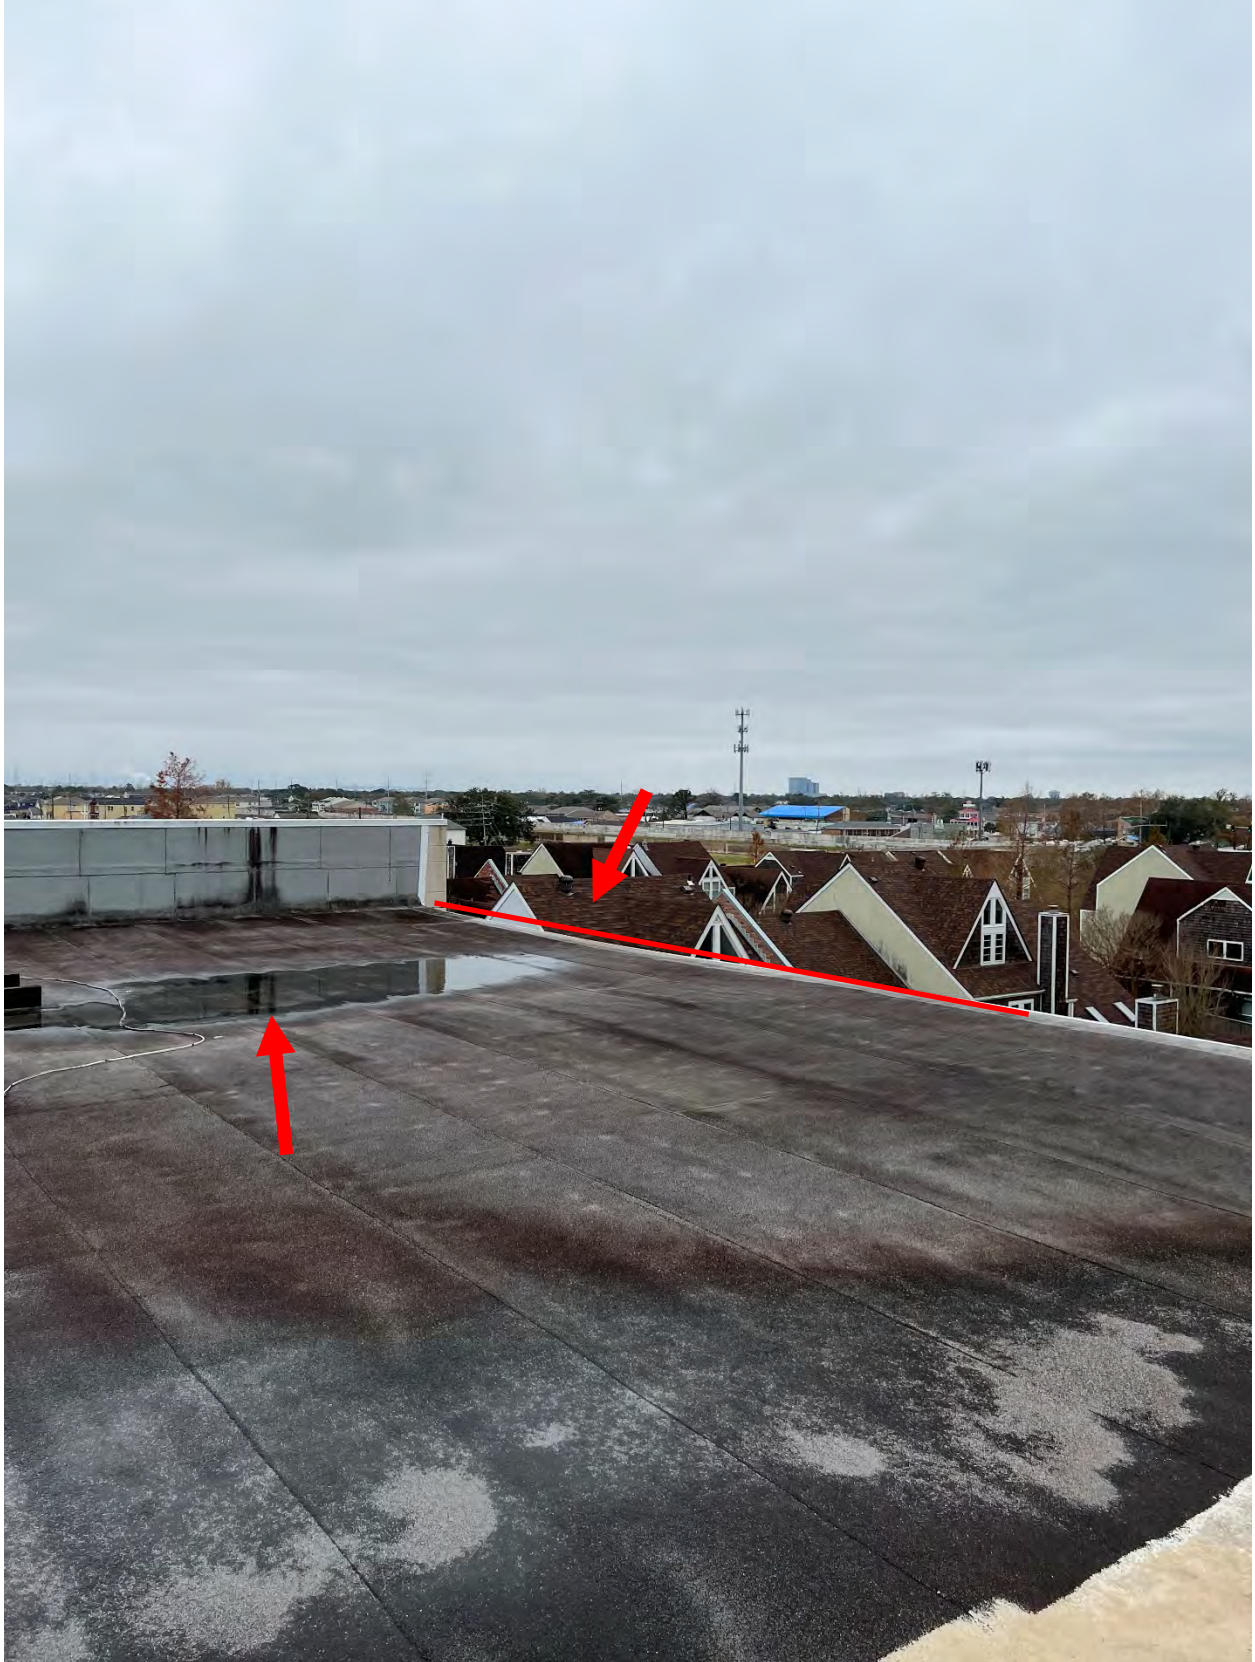
Photo #24 – View of noticeable sag at roof edge and concerning ponding in the near vicinity.
