October 26, 2021

**Re: Storm Damage Assessment
Harborview Homeowner's Association Property – New Orleans, Louisiana
Claim No.: 4186938
Date of Loss: August 29, 2021
SDII Project No.: 8125715**

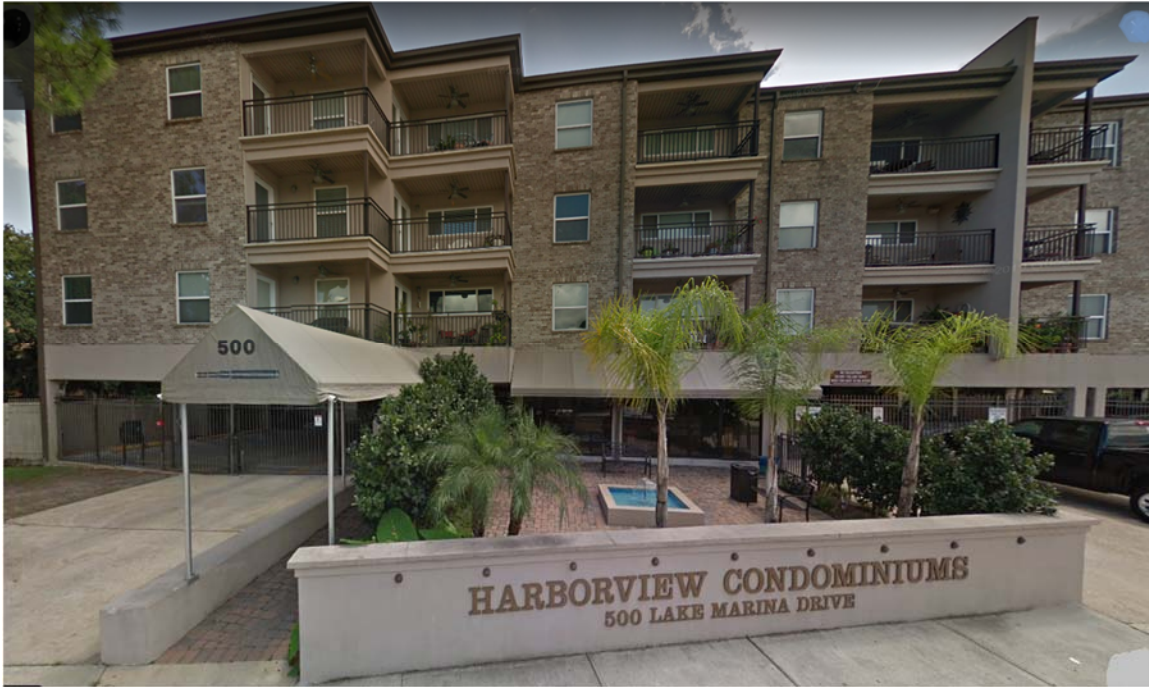
Photograph 1 - Front (north) elevation of building – 1 of 2

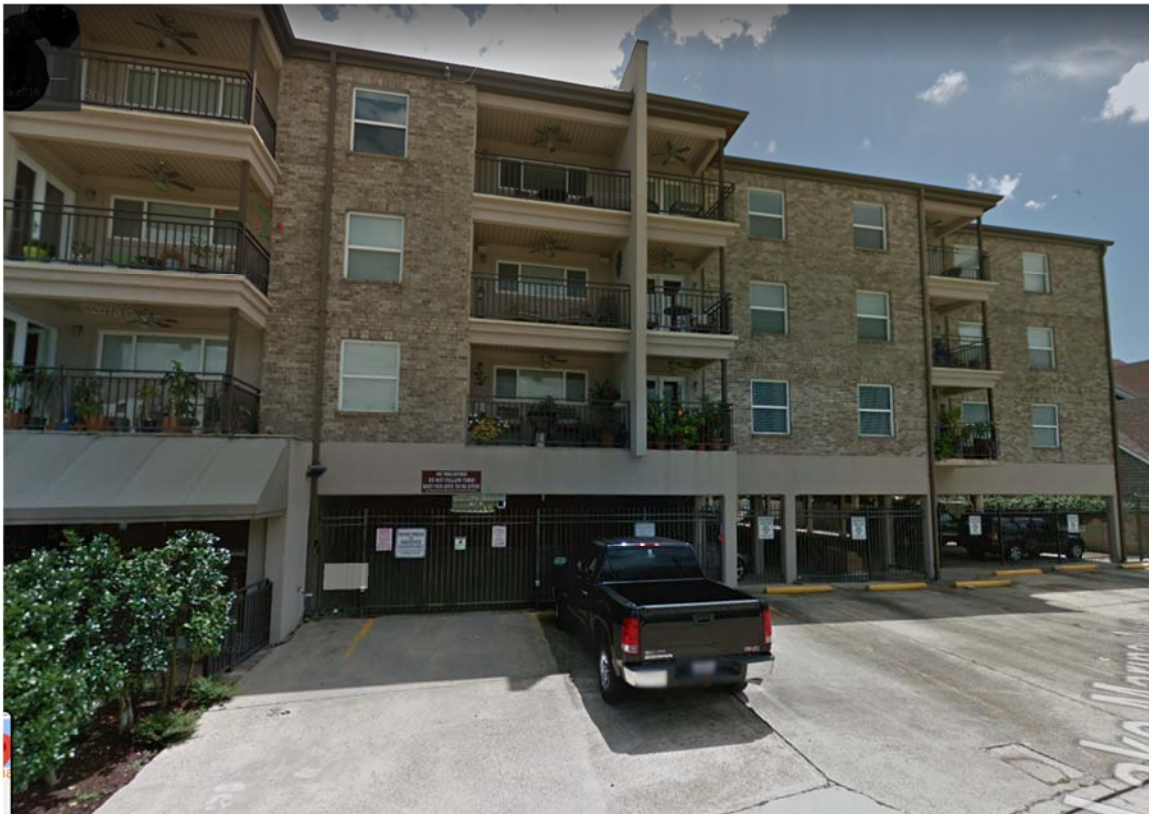
Photograph 2 - Front (north) elevation of building – 2 of 2

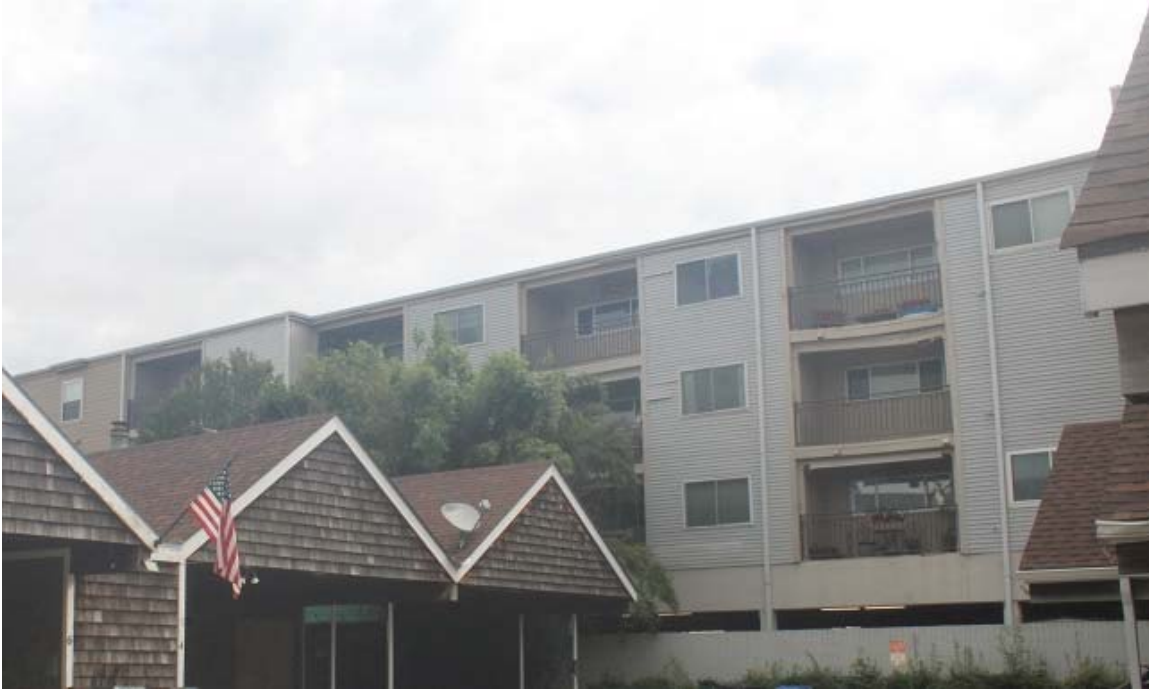
Photograph 5 - West side of building – Note upper side galleries – 2 of 3

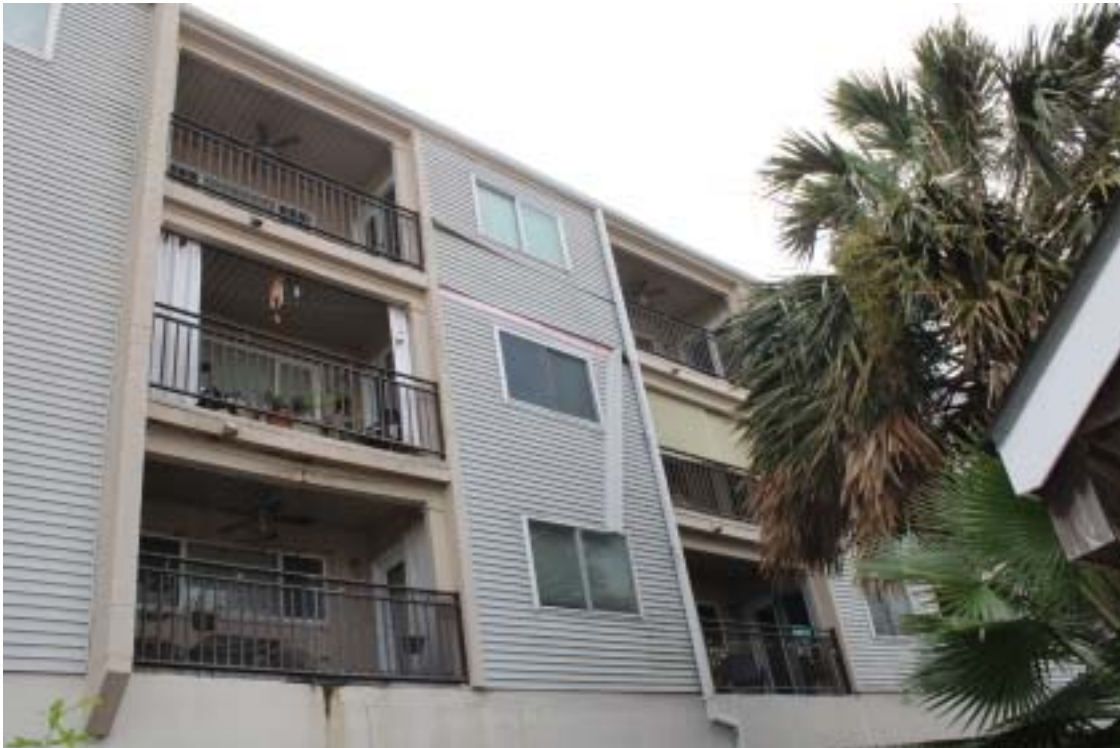
Photograph 6 - West side of building – Note upper side galleries – 3 of 3

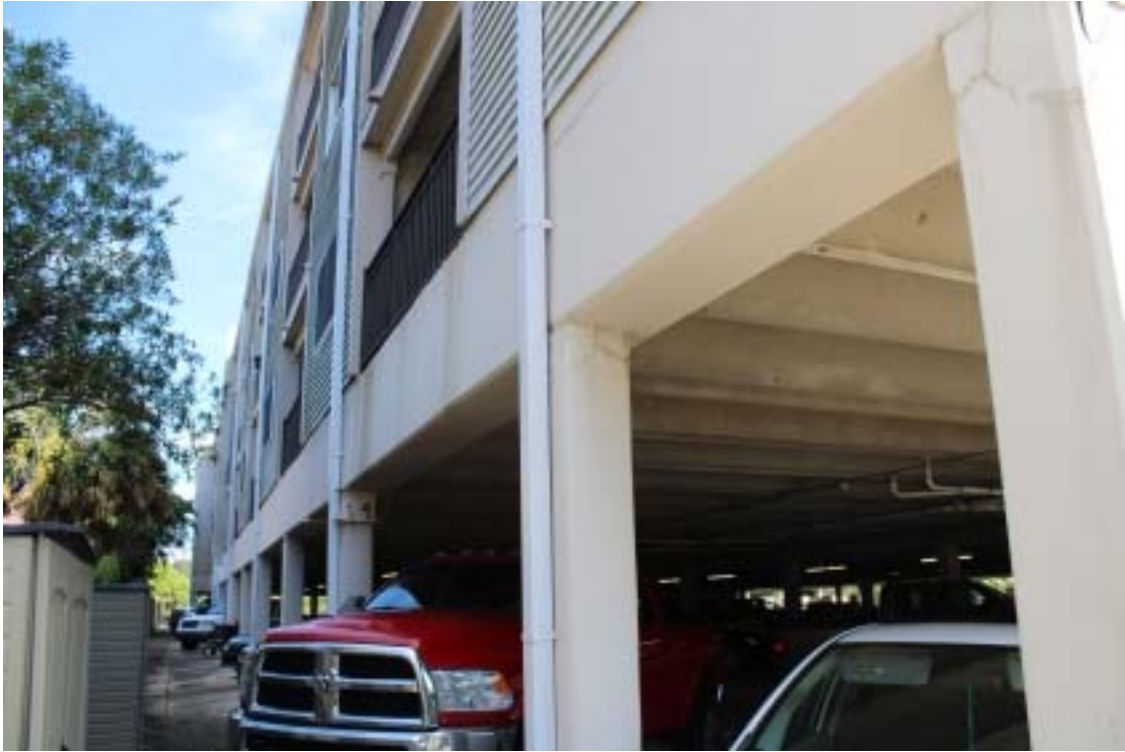
Photograph 7 - West side of building – From southwest corner

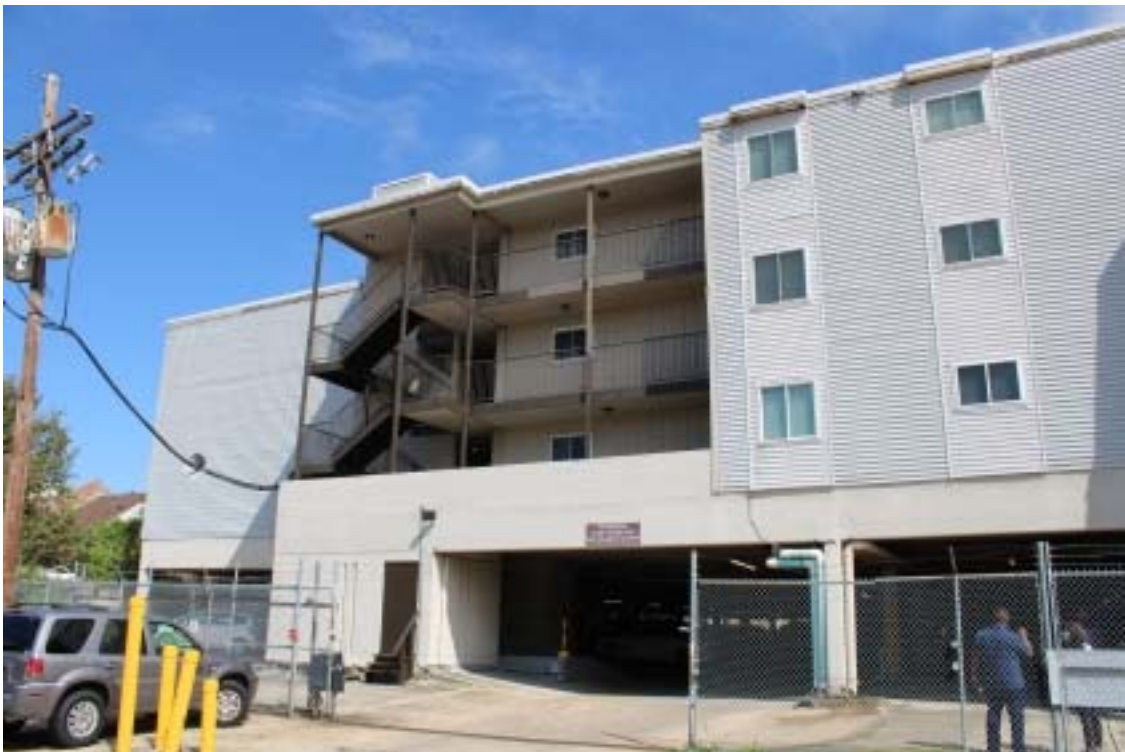
Photograph 8 - South side of building – 1 of 2

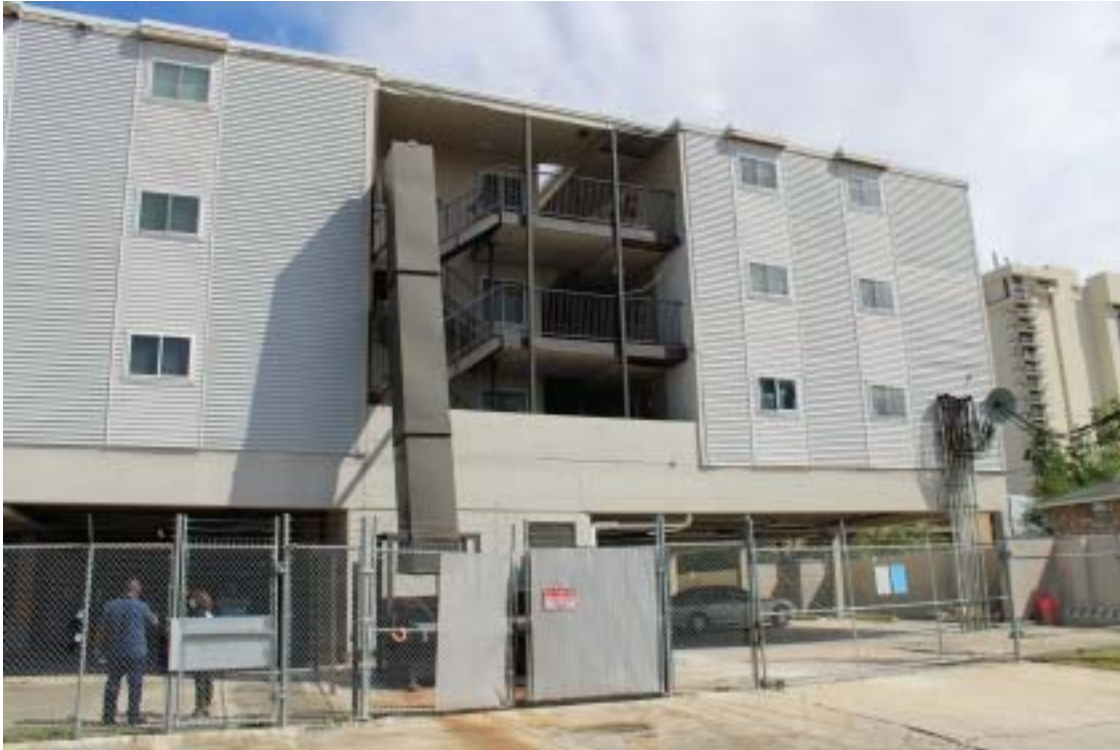
Photograph 9 - South side of building – 2 of 2

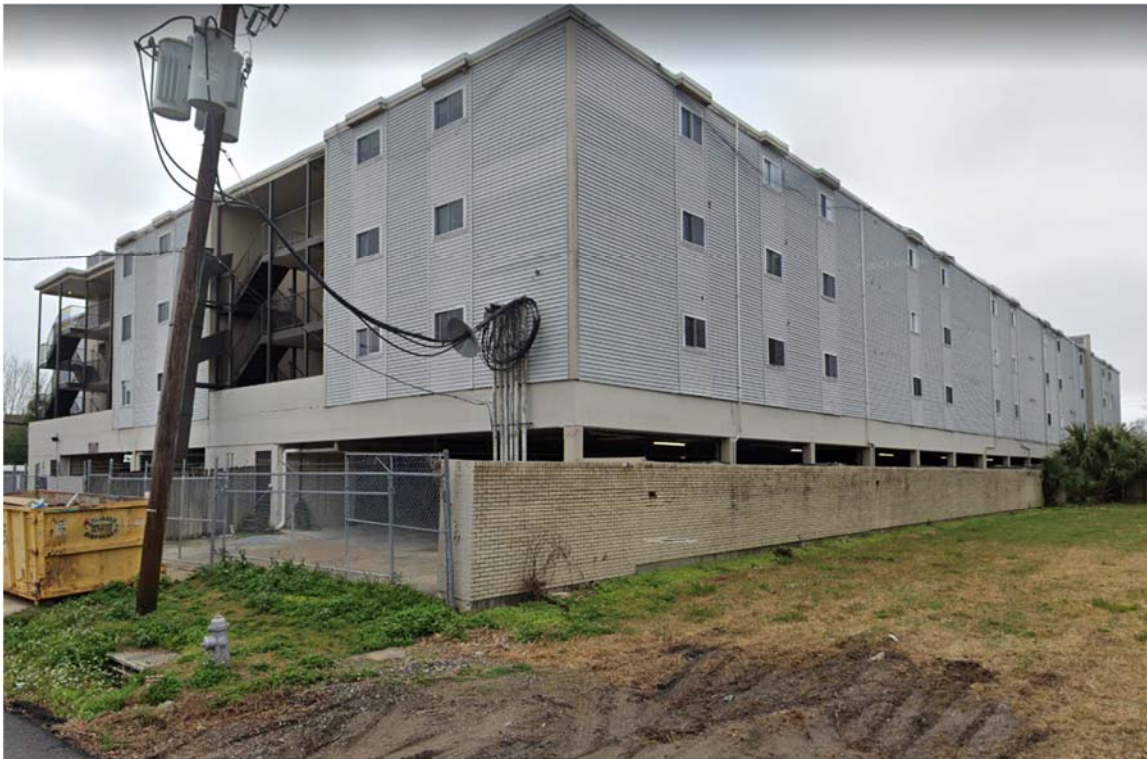
Photograph 10 - Southeast corner and east side of building

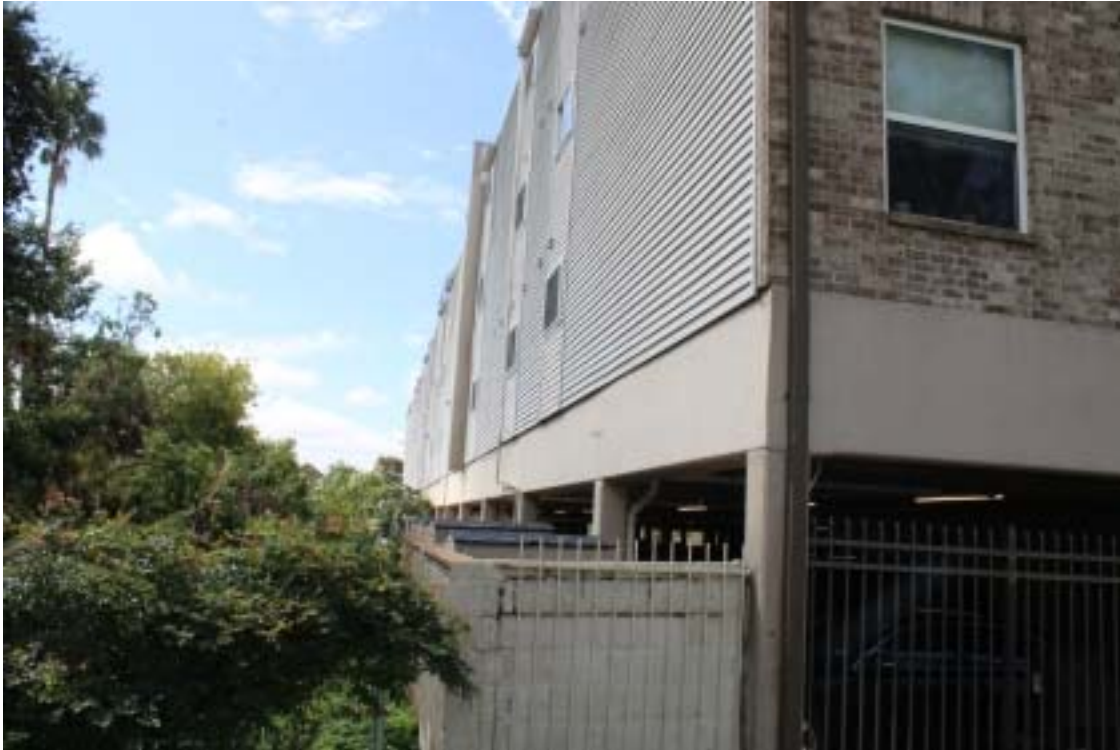
Photograph 11 - Northeast corner and east side of building

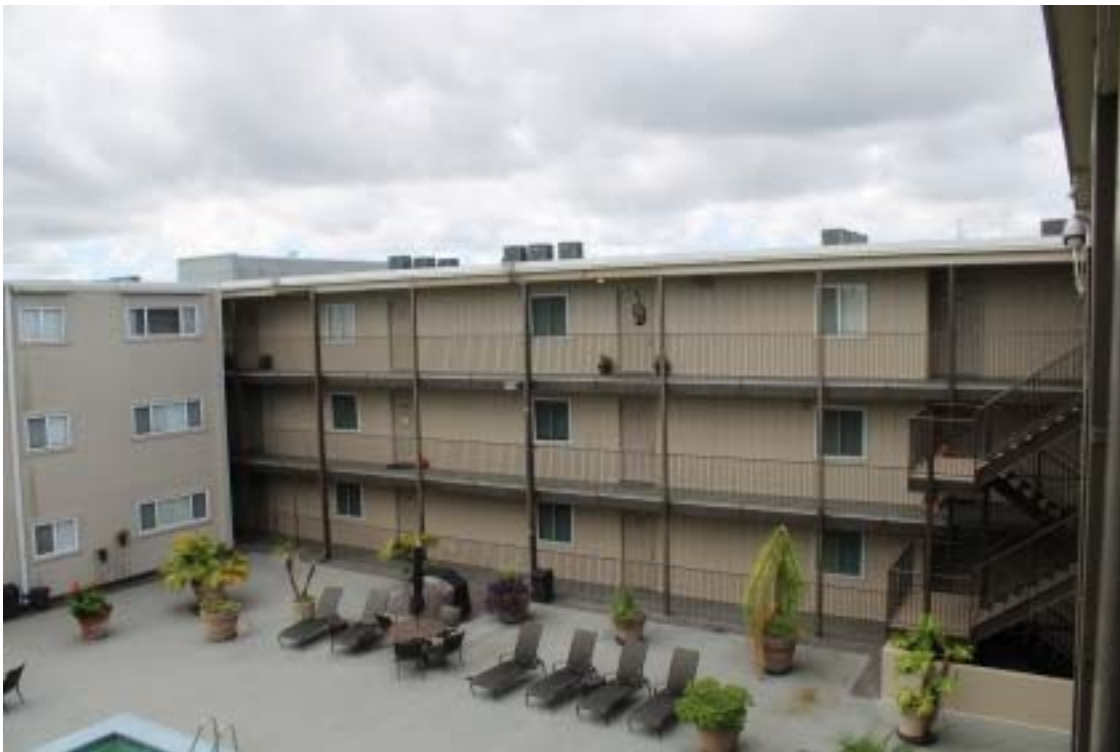
Photograph 12 - Interior upper hallway galleries – west side of pool area

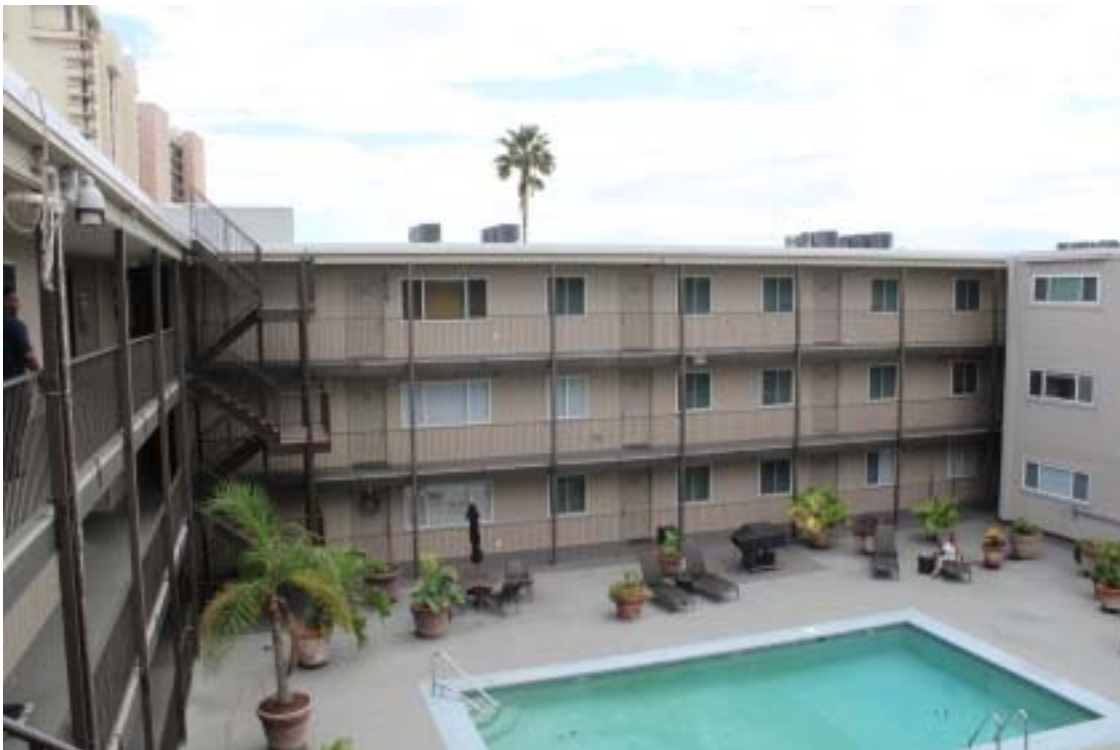
Photograph 14 - Interior upper hallway galleries – North and east sides of pool area

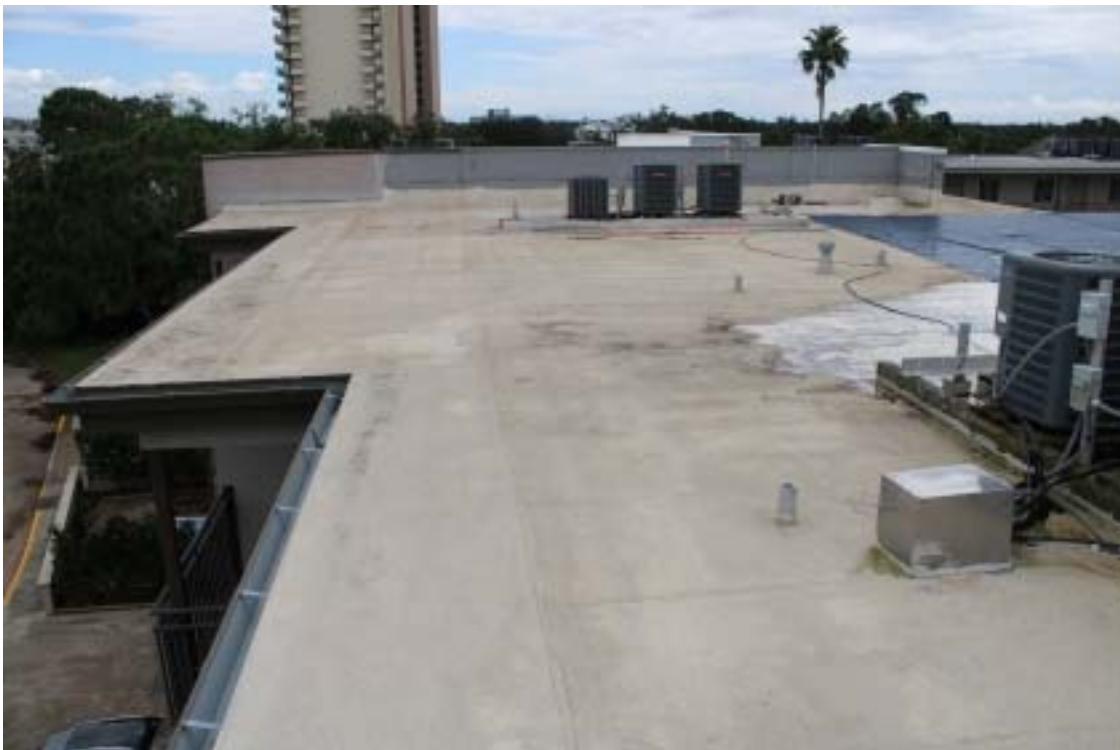
- The roof covering on the low-slope roof was covered with modified bitumen roll roofing with granule surfacing. The modified bitumen roofing was top coated with lighter colored substances in certain areas and tarped in other areas. Ponding areas of over 100 square feet were observed and no tarps were removed to allow careful examination of the areas beneath. Mechanical equipment, including condensing units, were located across the roof surface. For overviews of the roof, see Photographs 15 through 31.

Photograph 18 - Rooftop from northwest corner – Note color and tarp to right

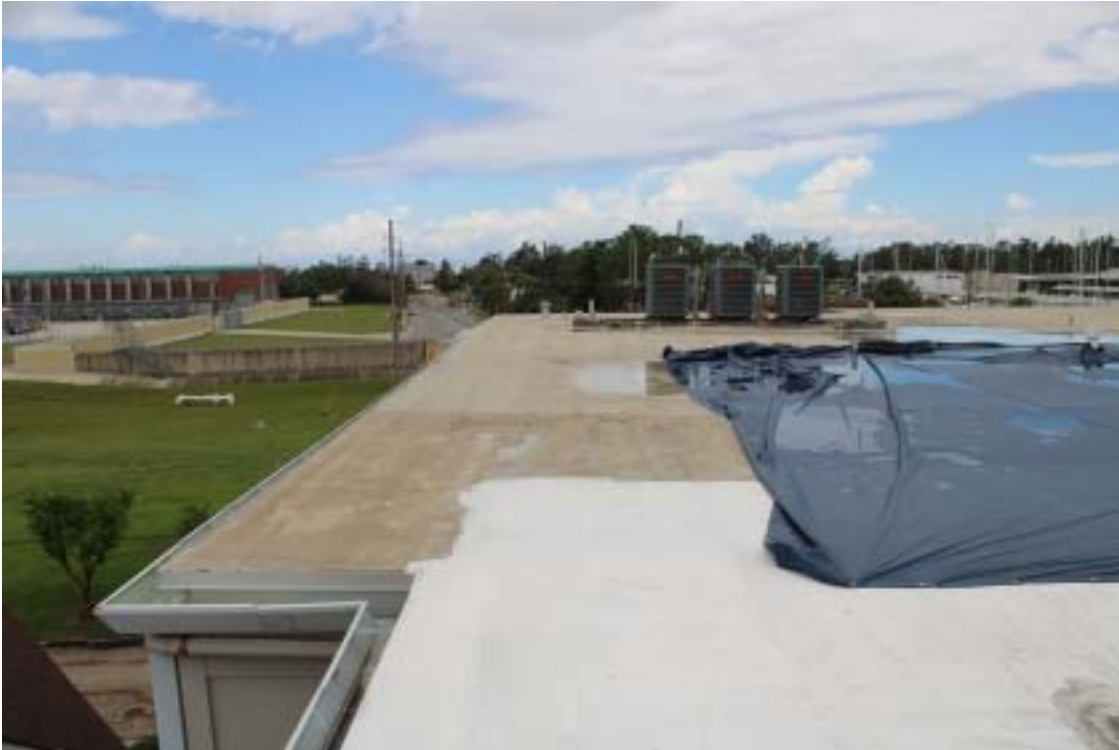
Photograph 19 - Rooftop from west edge – Looking north – Note roof colors and tarp to right

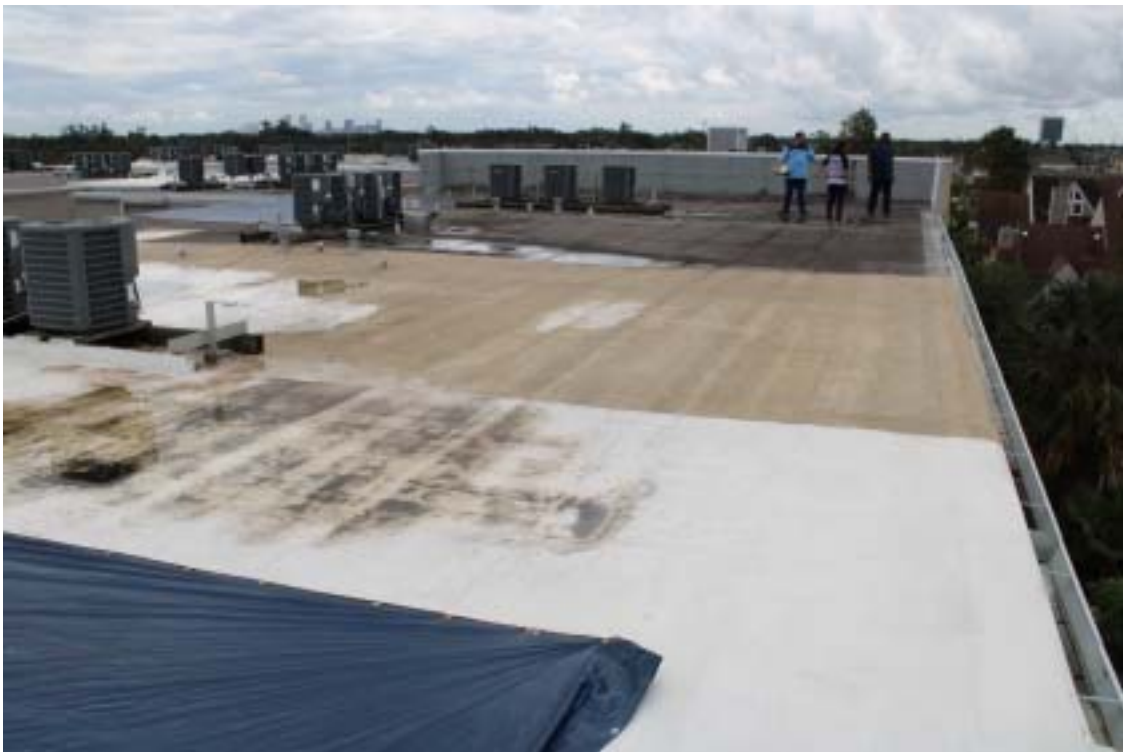
Photograph 22 - Rooftop from west edge – Looking south – Note varying roof colors

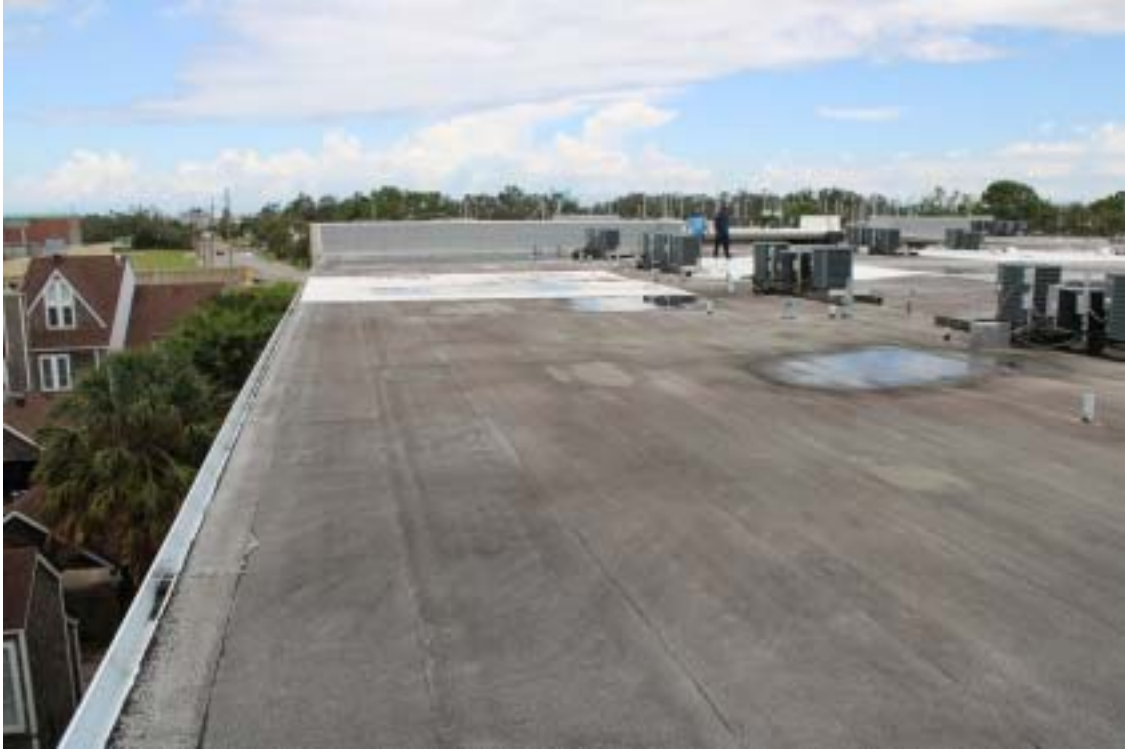
Photograph 25 - Rooftop from west edge – Looking north – Note varying roof colors

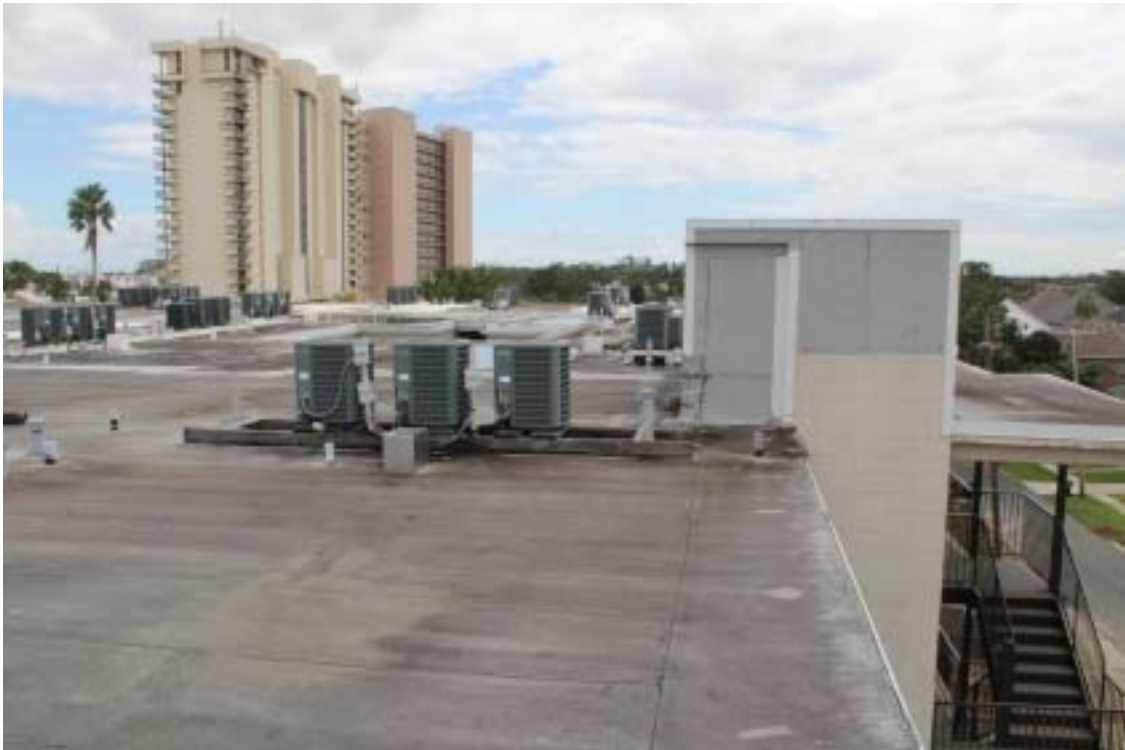
Photograph 26 - Rooftop from southwest corner – Looking east

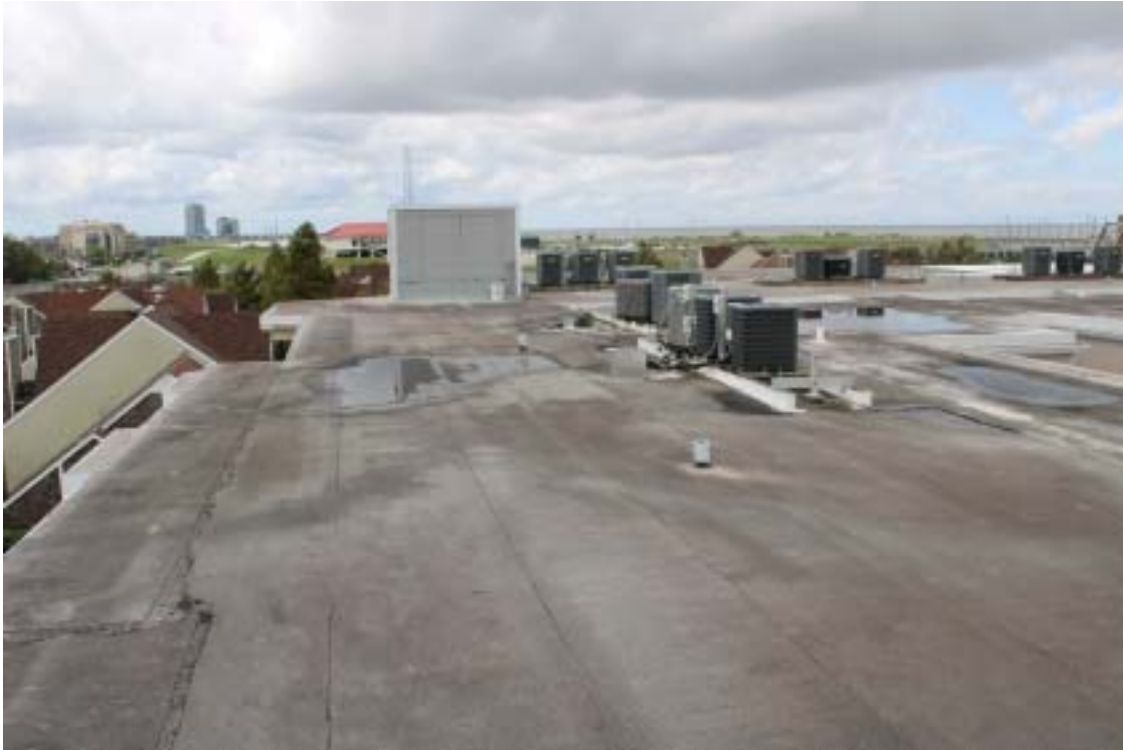
Photograph 27 - Rooftop from south edge – Looking west

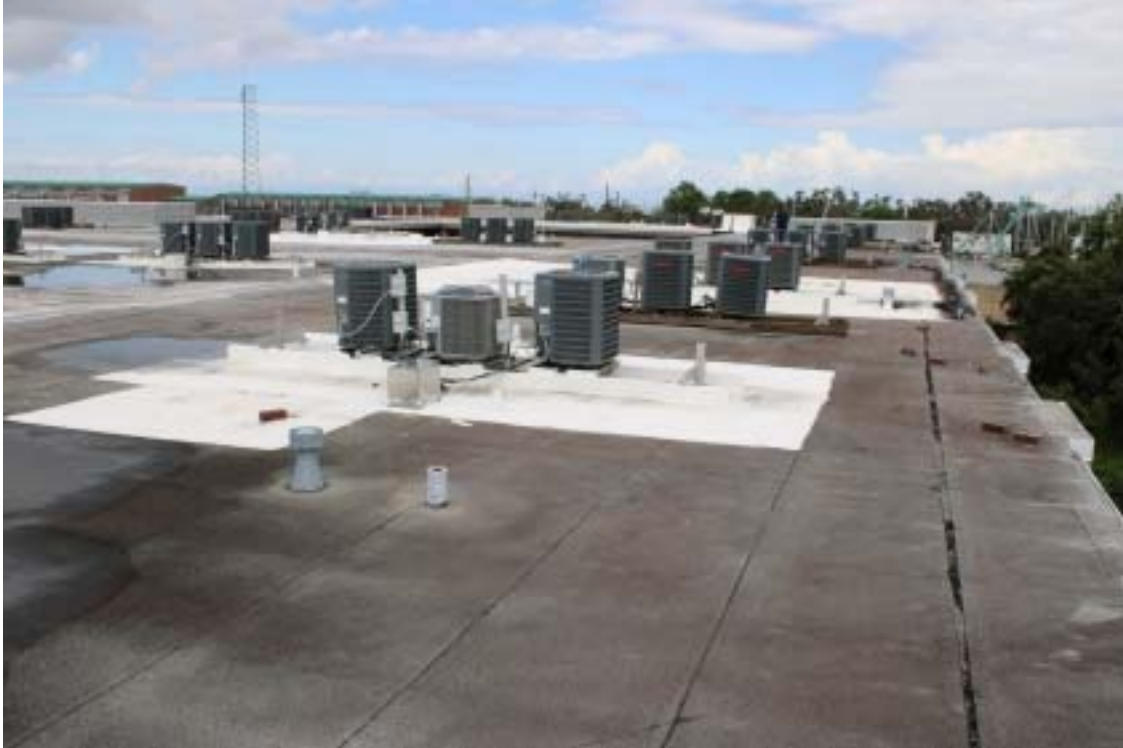
Photograph 29 - Rooftop from southeast corner – Looking north at light-colored roof areas

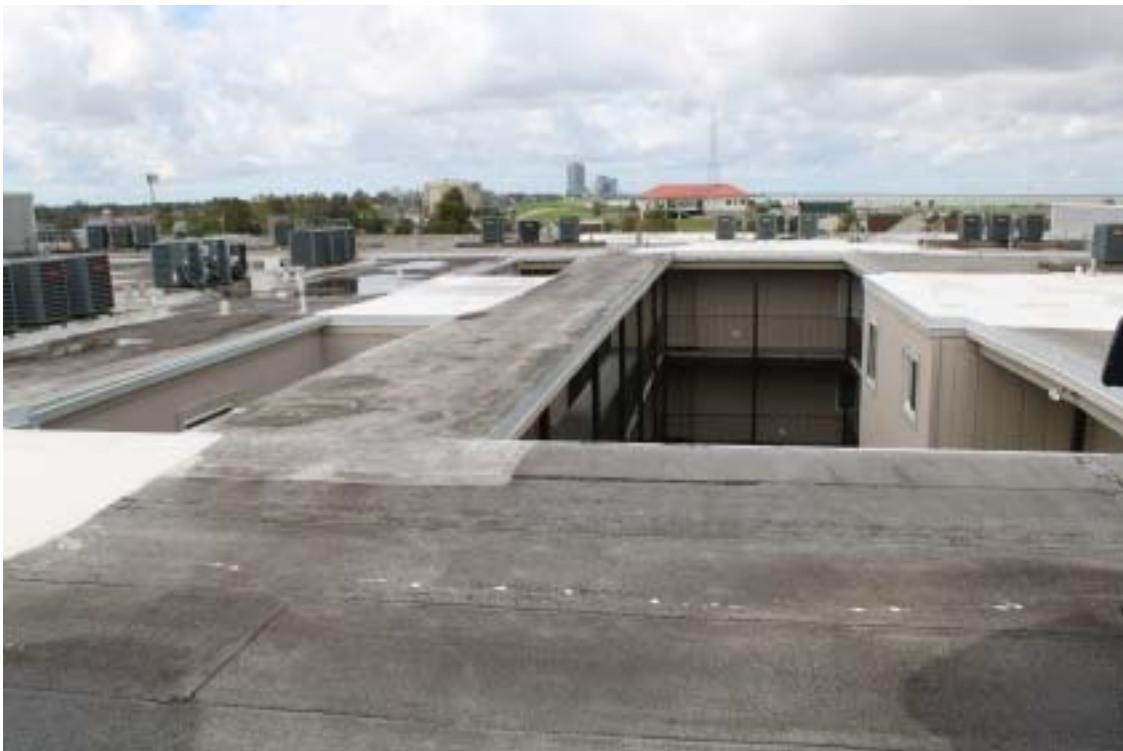
Photograph 30 - Rooftop from east edge – Looking west over open area below

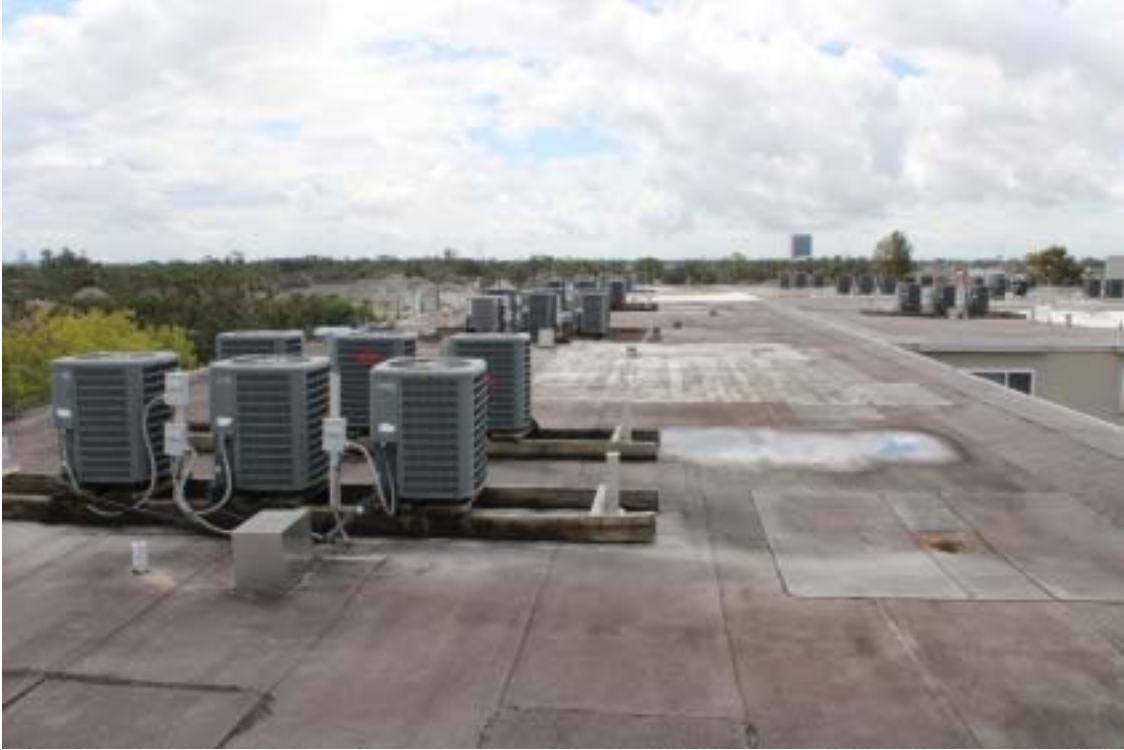
Photograph 31 - Rooftop from northeast corner – Looking south

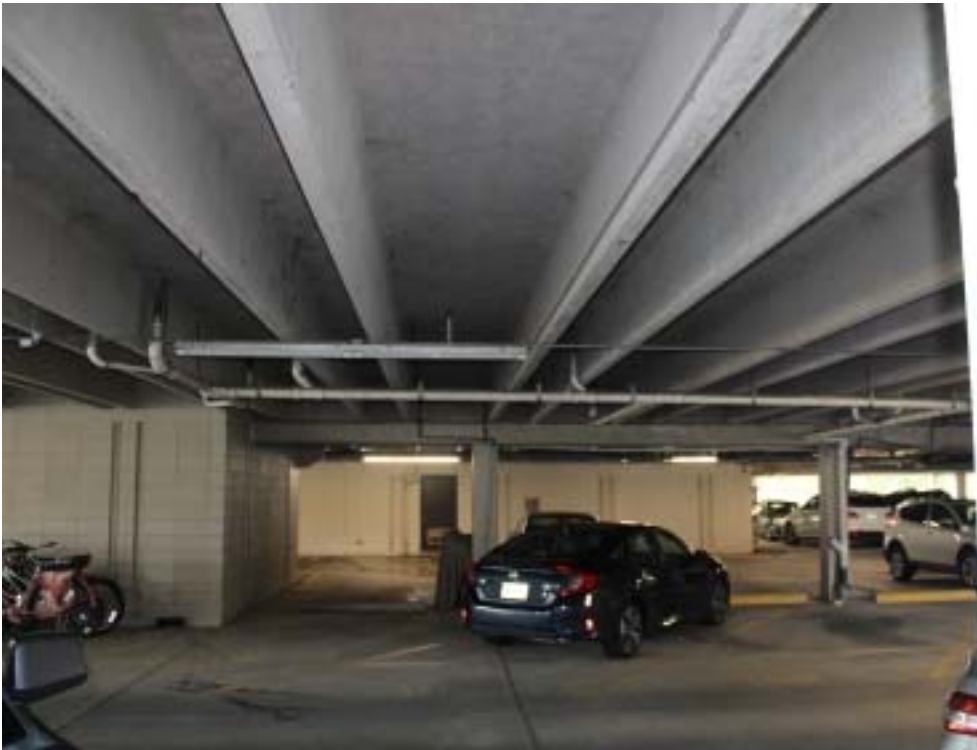
- The ground-level portion of the building consisted of five rows of concrete columns mostly at 18 feet on center with the rows being positioned at an average of approximately 39 feet on center. These were supported by foundations below paved surfaces with precast concrete beams supported by the columns. Upon the precast beams were precast concrete double-tee beams spanning between the column rows with an approximate 39 feet average span (Photographs 32 through 39); and

Photograph 32 - Concrete structure above parking level

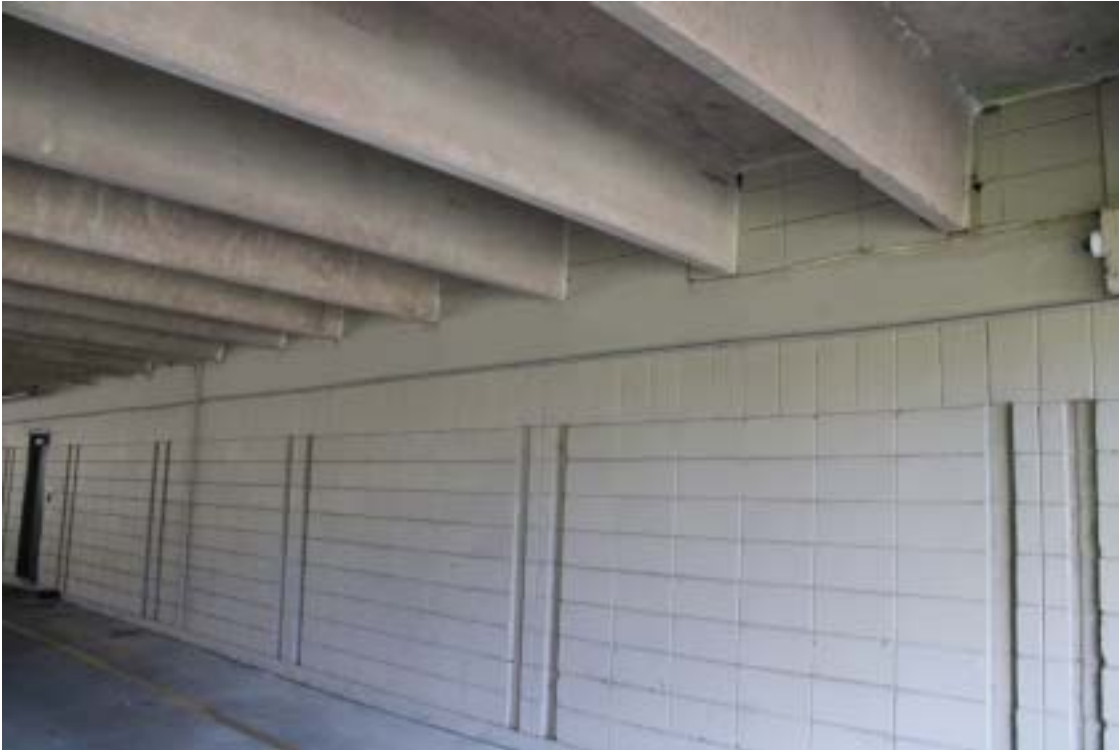
Photograph 33 - Concrete structure above parking level – Wall along office area

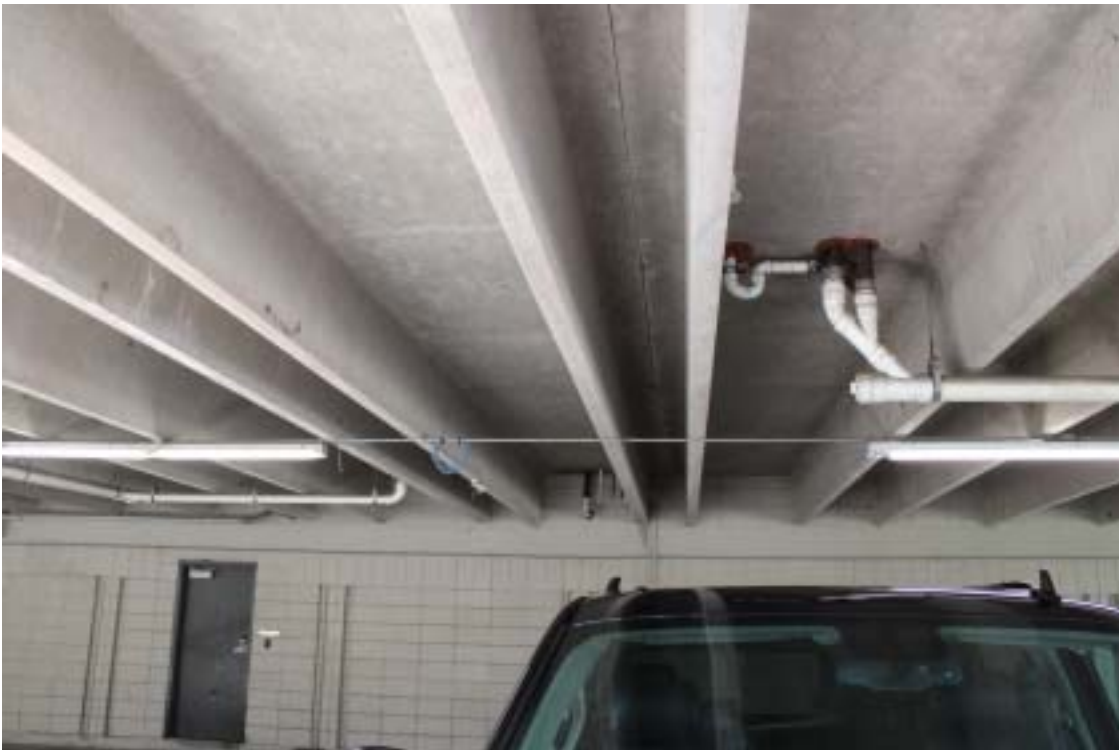
**Photograph 34 - Concrete structure above parking level – Wall along office area -
Note precast elements**

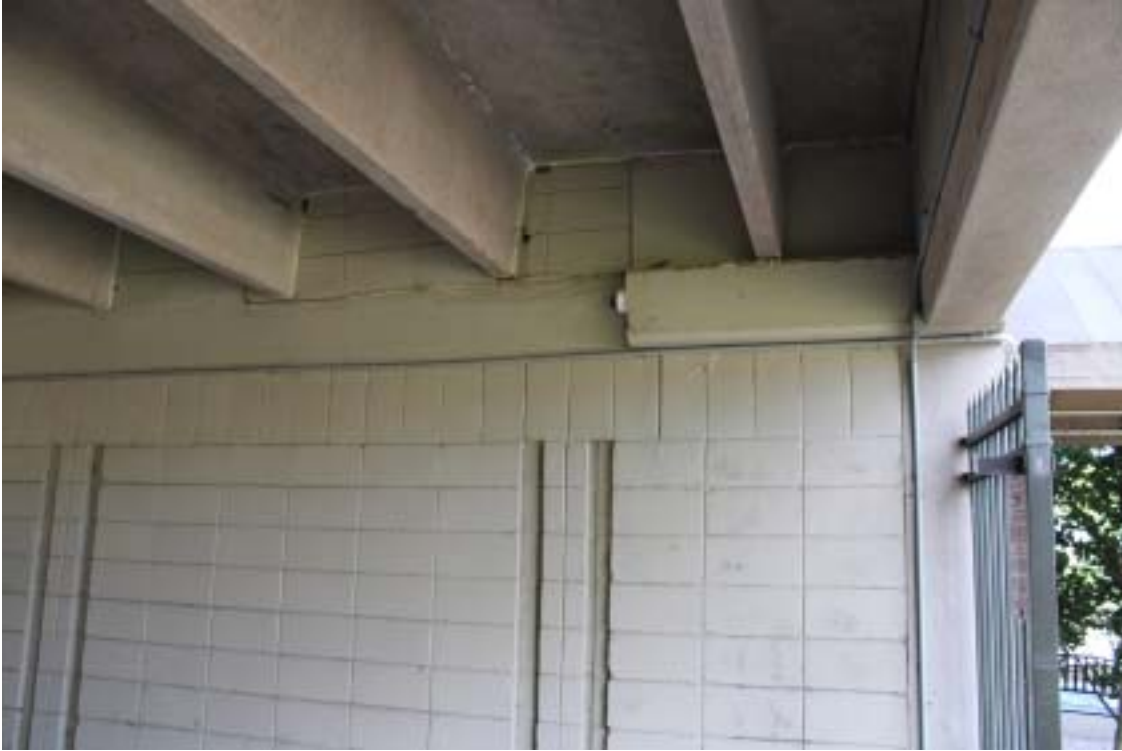
**Photograph 35 - Concrete structure above parking level – Wall along office area -
Note precast elements**

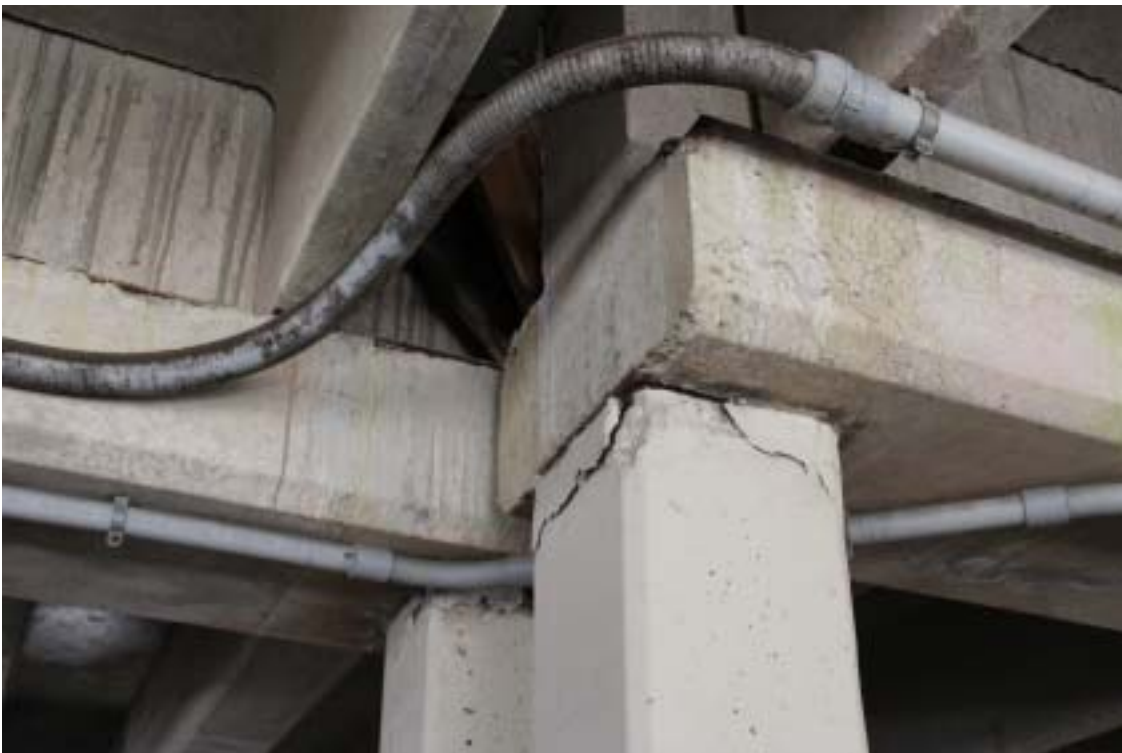
Photograph 36 - Concrete structure above parking level – Note precast elements

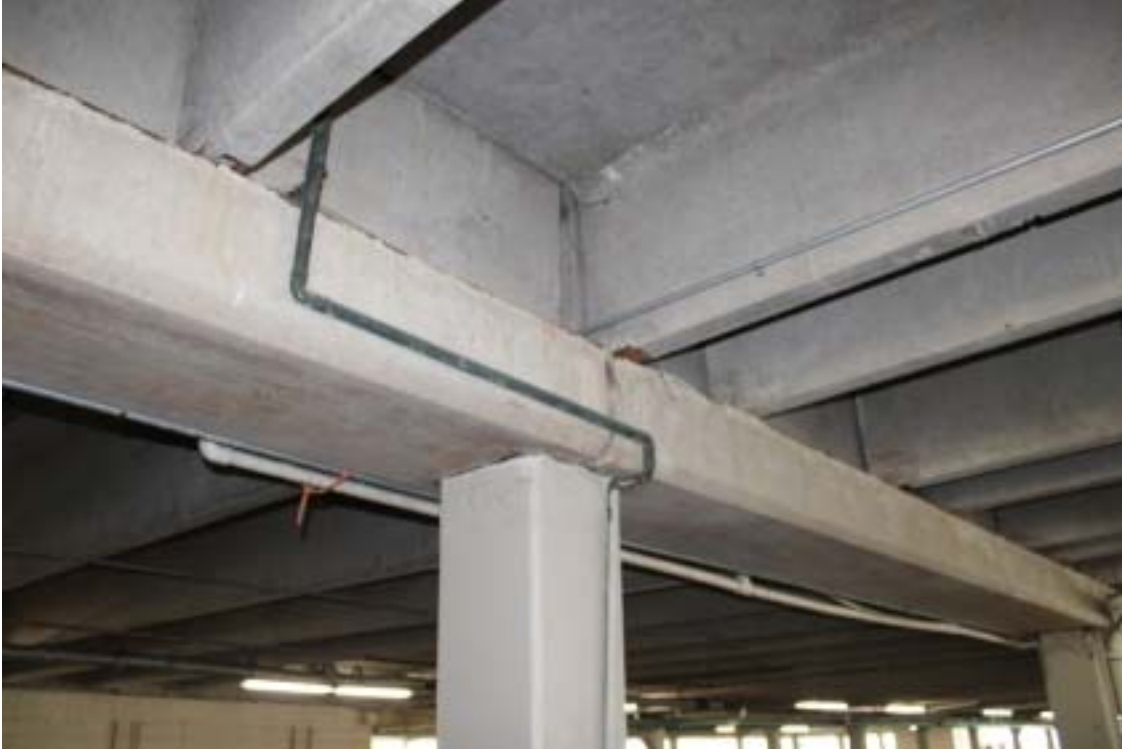
Photograph 39 - Concrete structure above parking level – Note precast elements
