October 26, 2021

**Re: Storm Damage Assessment
Harborview Homeowner's Association Property – New Orleans, Louisiana
Claim No.: 4186938
Date of Loss: August 29, 2021
SDII Project No.: 8125715**

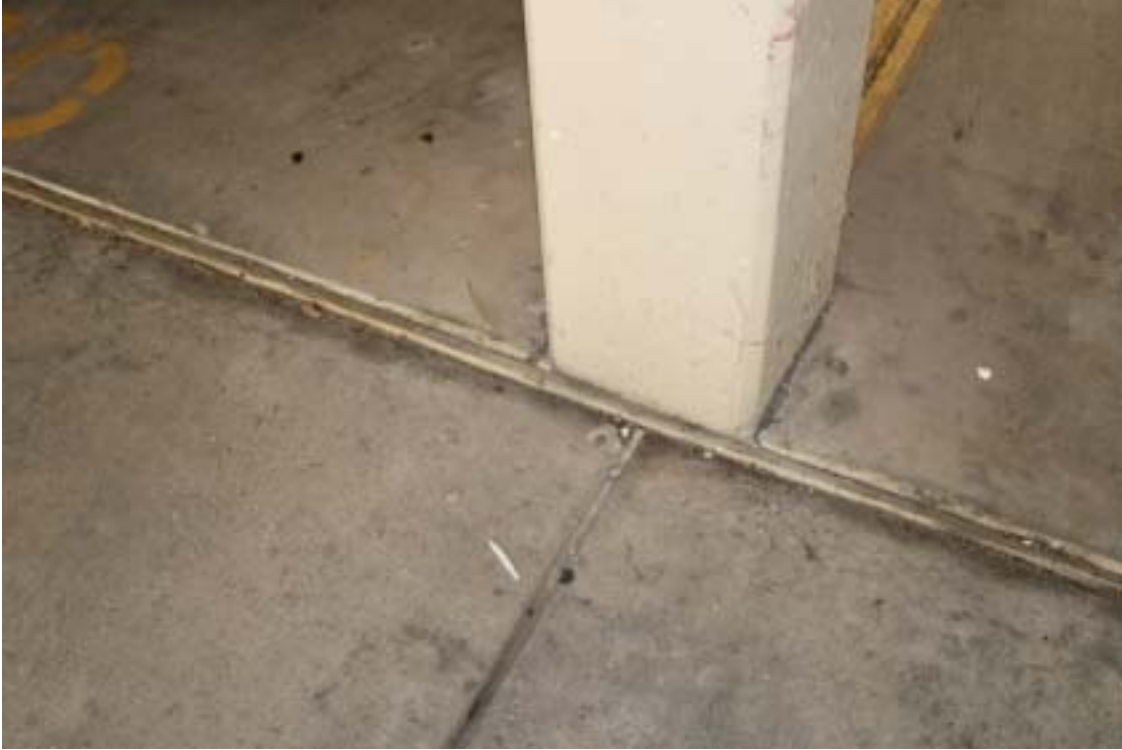
- The concrete was spalled at the top of nearly every one of the 80 (approximate) columns. There was evidence of repairs on approximately 30% of the columns and the column tops appeared to have been constructed with a mild steel-bearing plate embedded in the column tops. Bearing plates were also cast into the precast beams as well as into the ends of the double tees where they contacted the precast beams. The exposed areas of these plates were rusted. The column bases were typically in serviceable condition with exceptions. There was one column along the south edge of the building that had spalled concrete at the base with an exposed steel base plate and anchor bolts. Another column base along the east edge of the building was also a potential steel column encased in concrete (Photographs 40 through 58).

Photograph 51 - Concrete column below precast elements – Note typical base

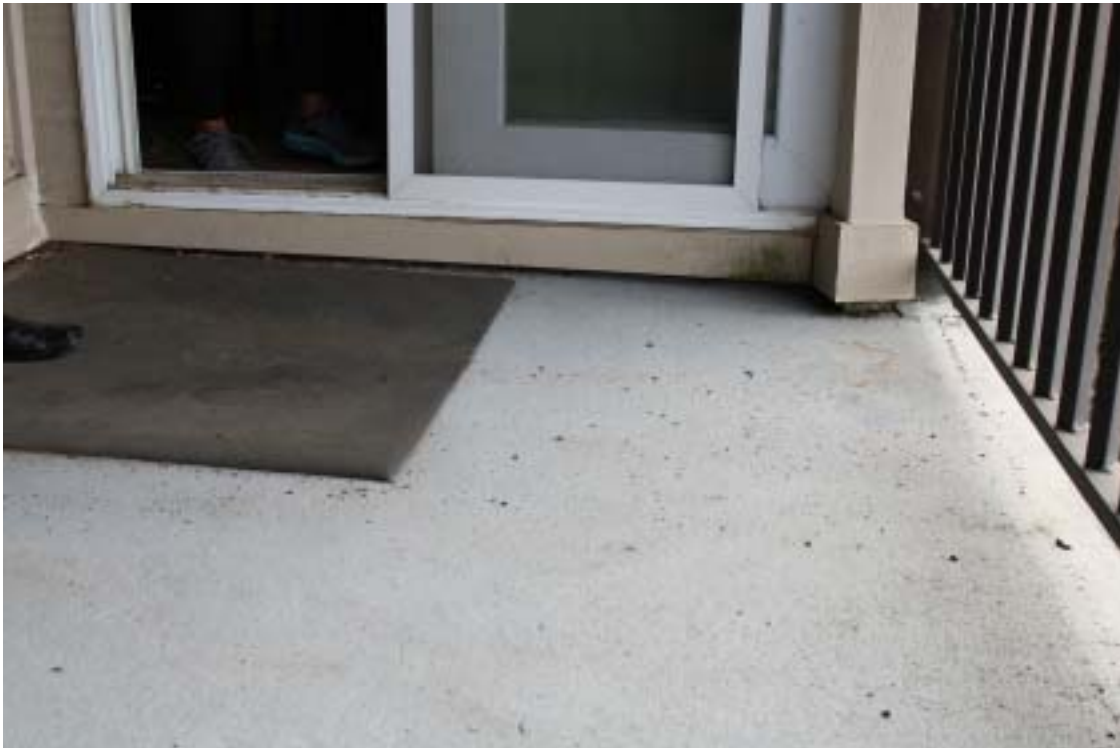
Photograph 60 - West side gallery floor – Concrete topping

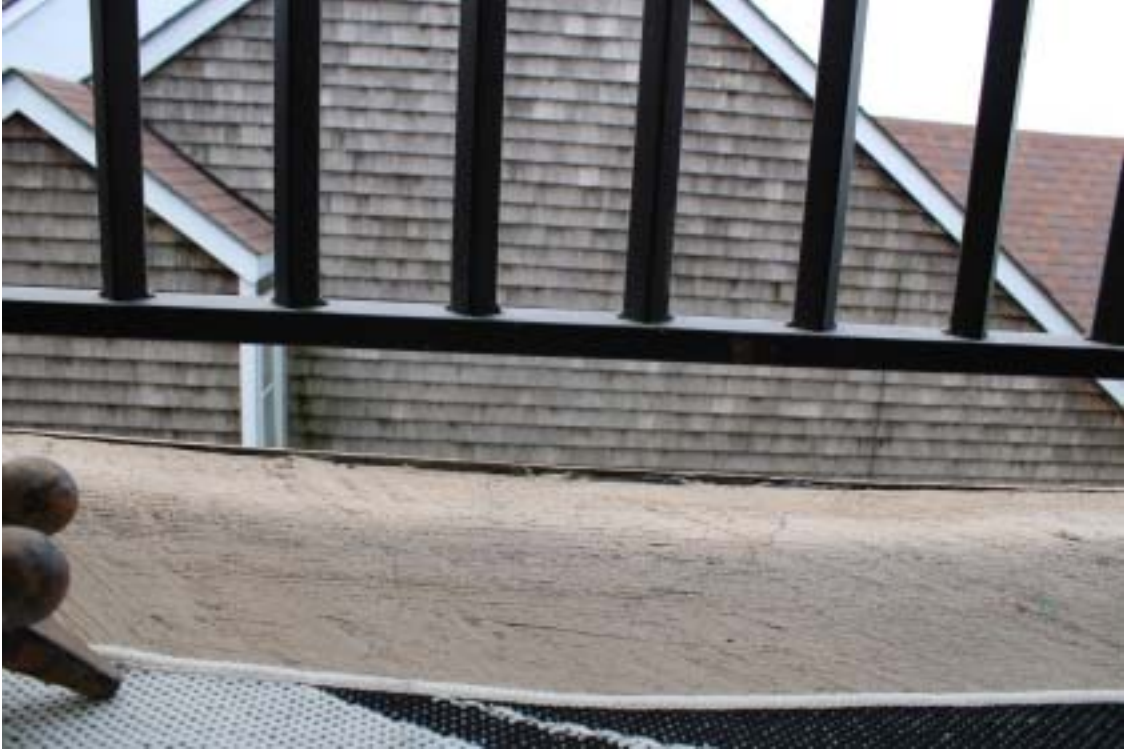
Photograph 61 - West side gallery floor – Concrete topping

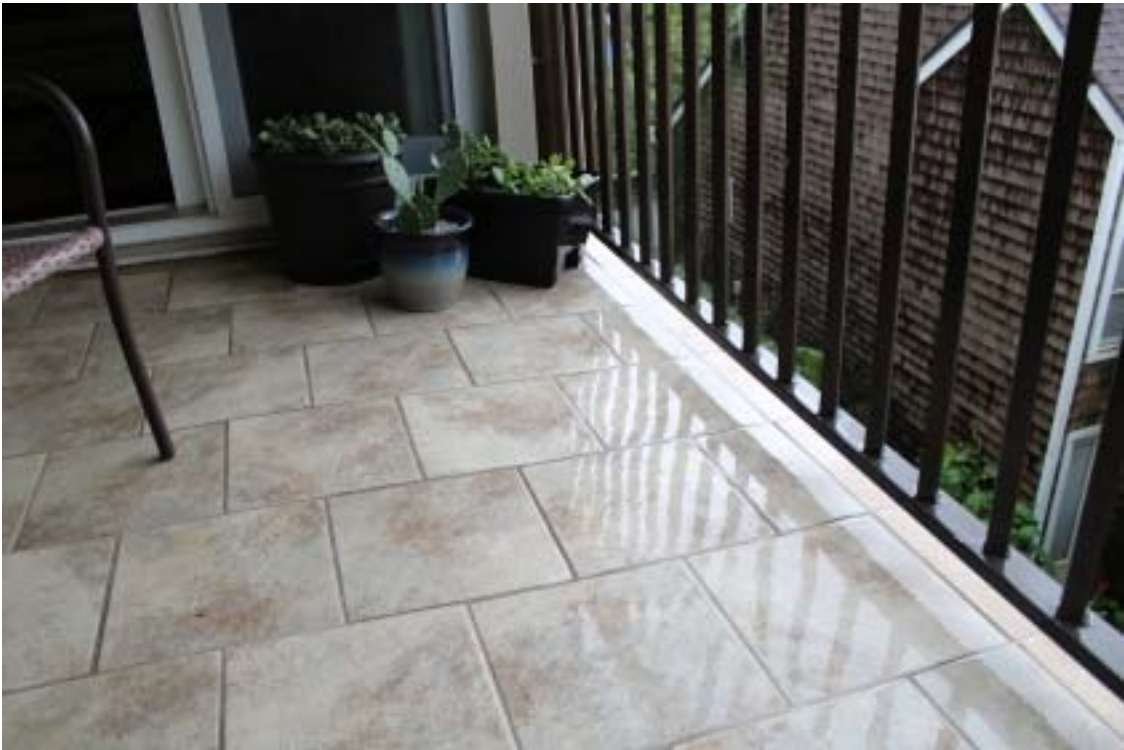
Photograph 62 - West side gallery floor – Tile over concrete topping

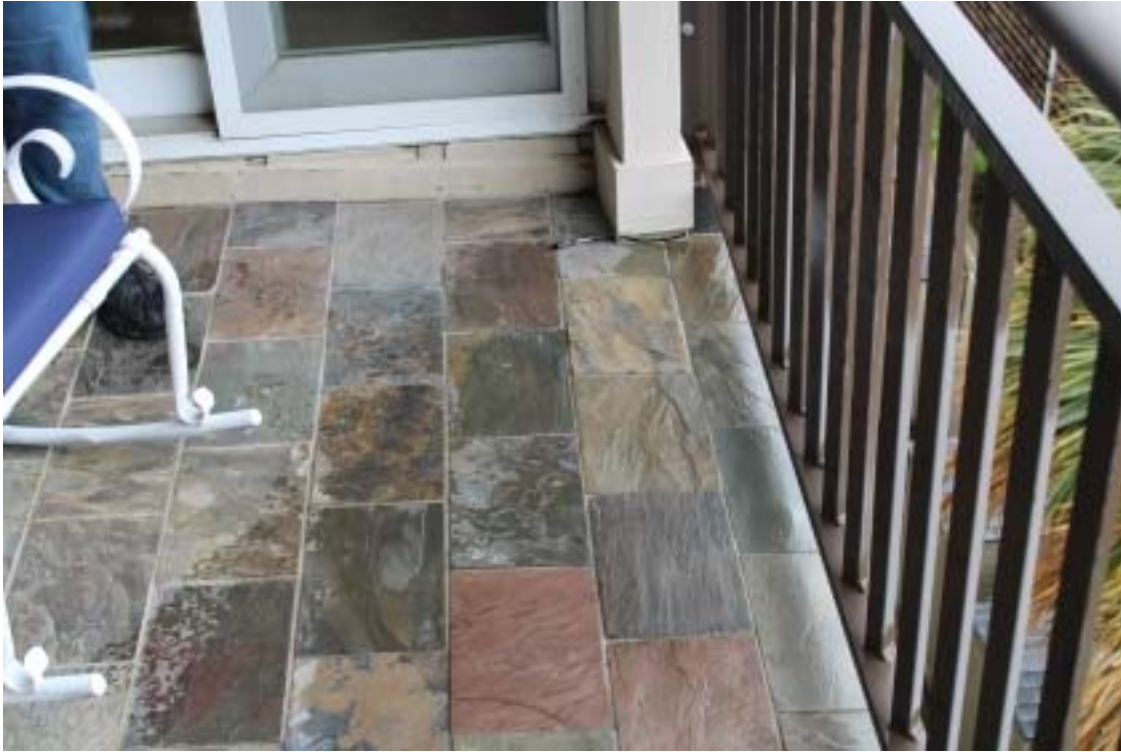
Photograph 63 - West side gallery floor – Tile over concrete topping

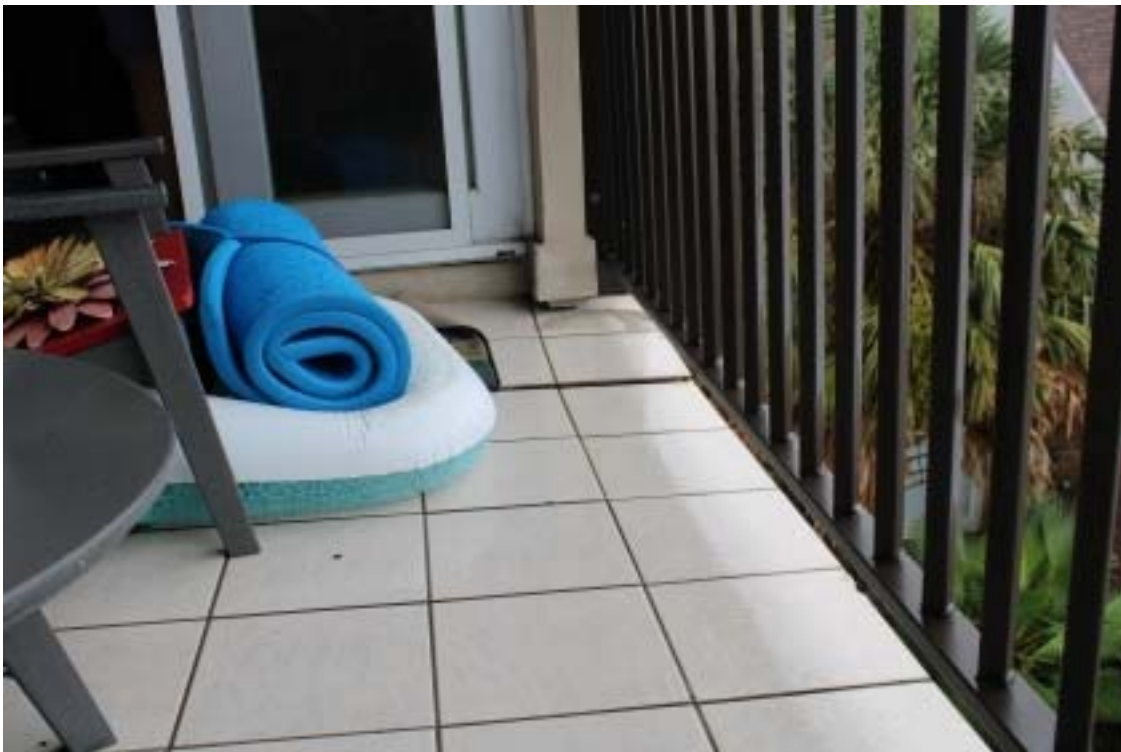
Photograph 64 - West side gallery floor – Tile over concrete topping

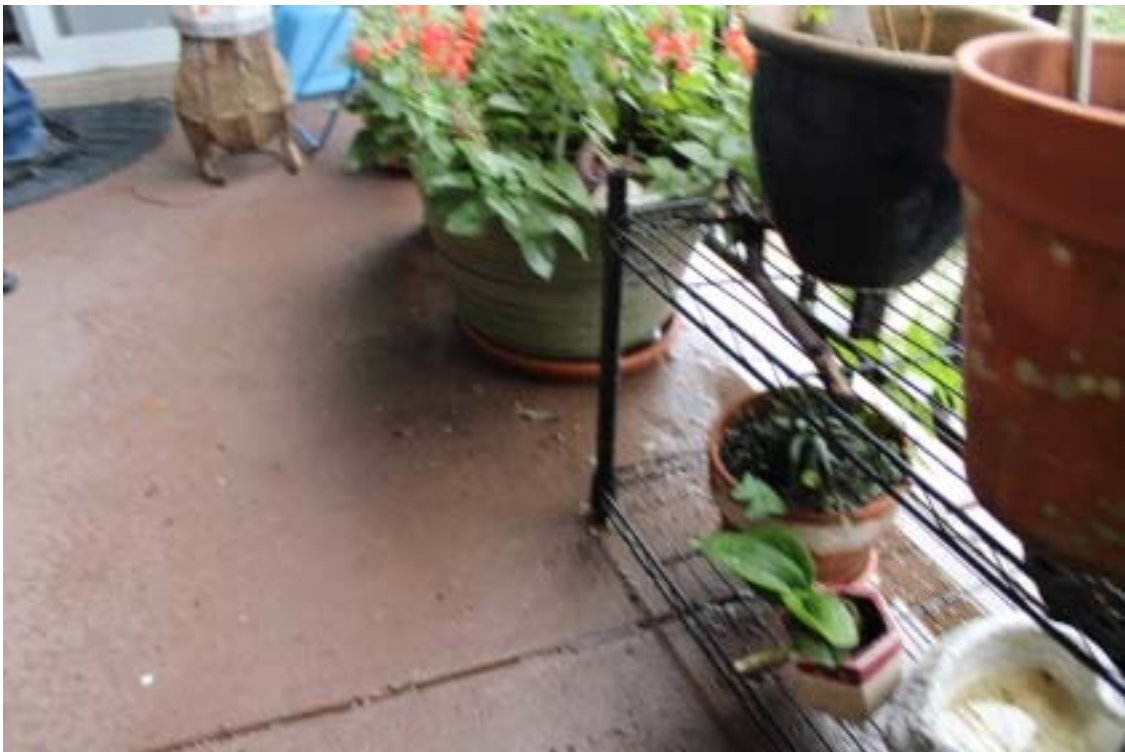
Photograph 66 - West side gallery floor – Concrete topping

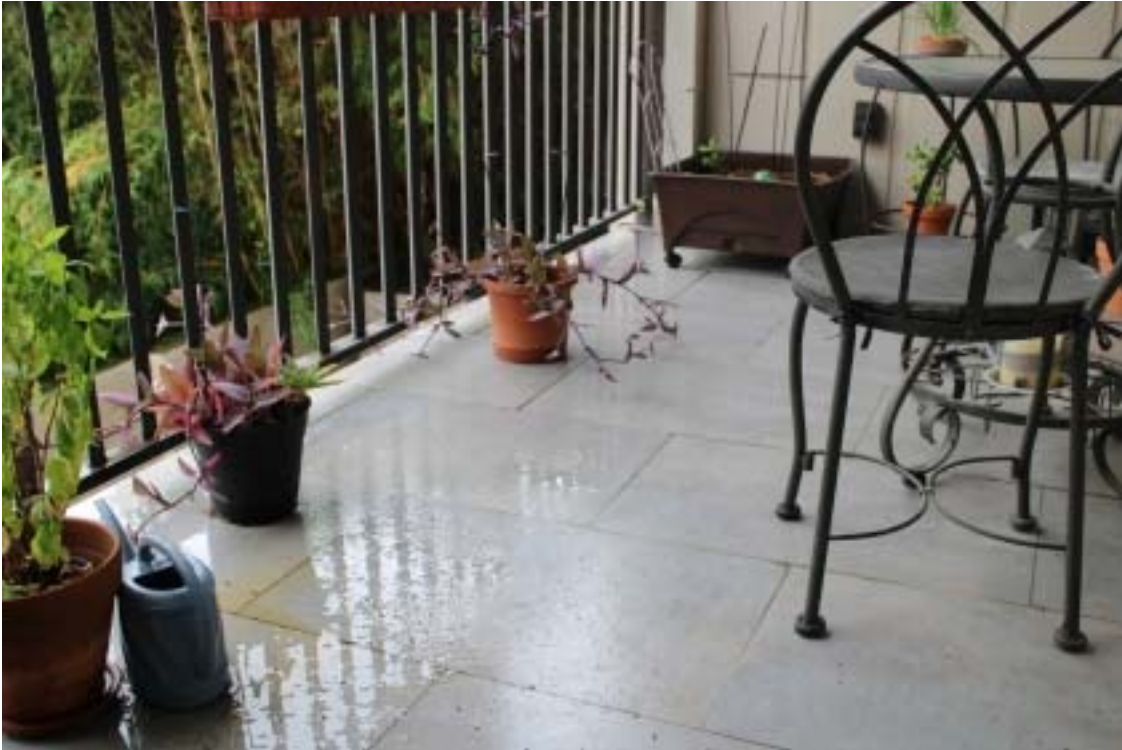
Photograph 67 - West side gallery floor – Tile over concrete topping
