October 26, 2021

**Re: Storm Damage Assessment
Harborview Homeowner's Association Property – New Orleans, Louisiana
Claim No.: 4186938
Date of Loss: August 29, 2021
SDII Project No.: 8125715**

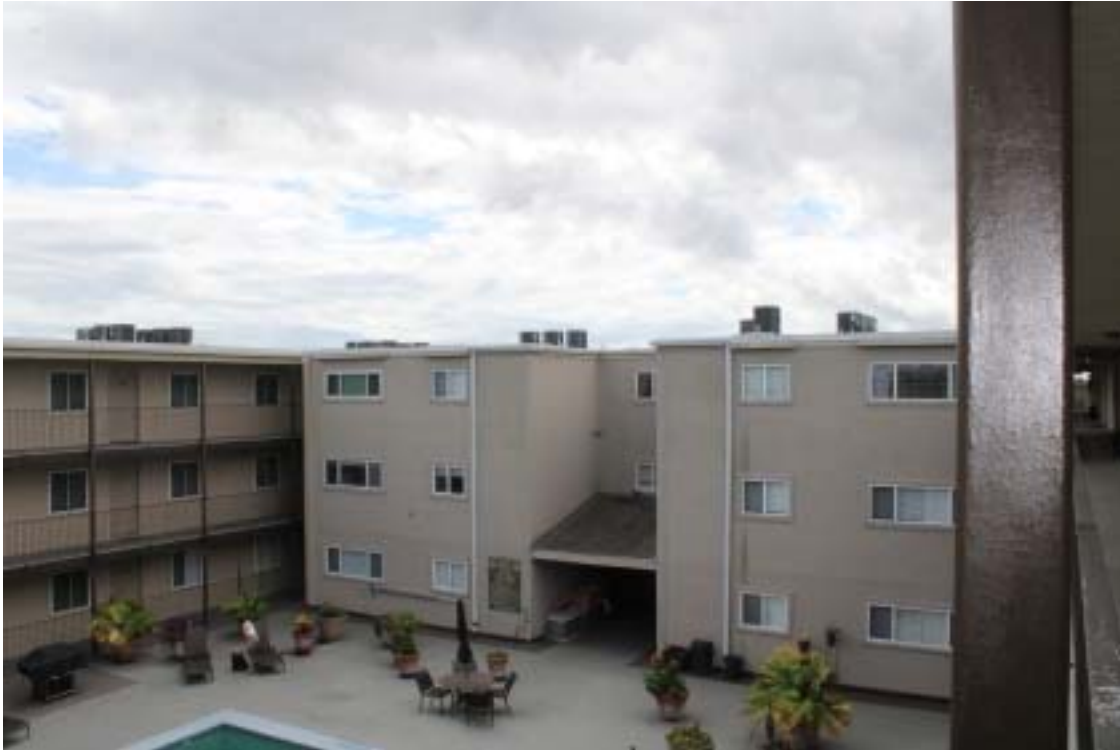
Photograph 13 - Interior walls of central building area

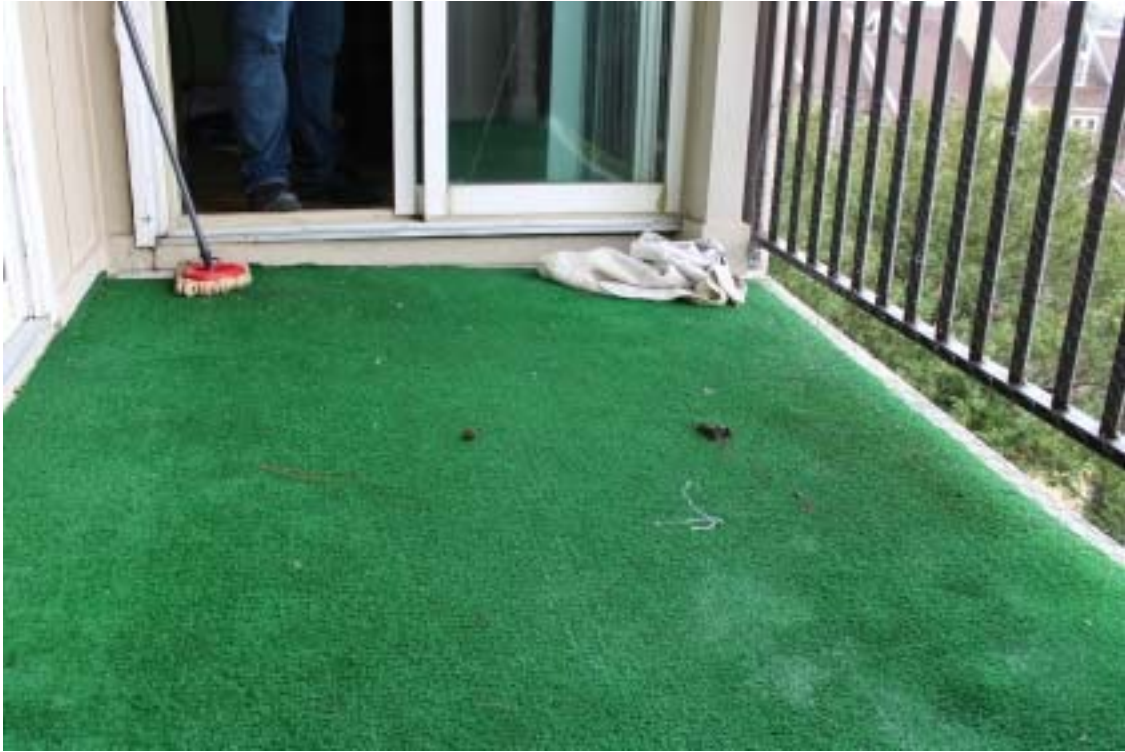
Photograph 65 - West side gallery floor – Outdoor carpet over deck
